### **3.12.2 LOCKLAND INCINERATOR**

Facility Name: Lockland Incinerator

Location: West terminus of Davis Avenue along the east side of I-75 south  
339 Wilson St, Lockland OH

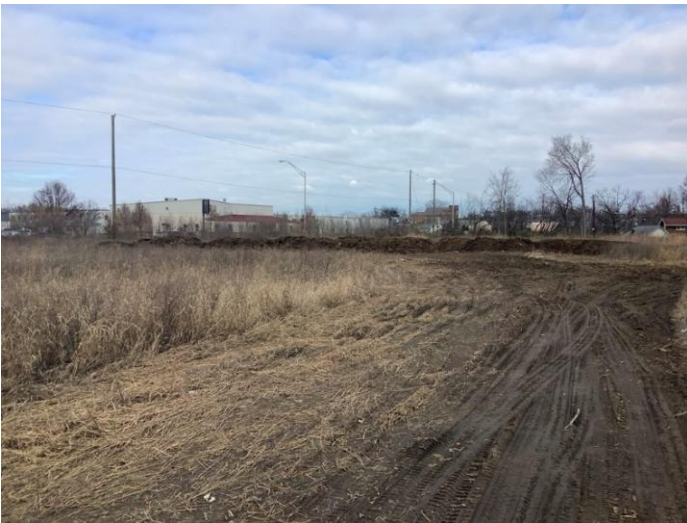
Northern Parcel

The site was inspected by HCPH on December 22, 2023. The inspector noted the site has grass and weed growth established over the site after completion of the rule 513 activities in 2022. Some soil had been stockpiled on the northern parcel.

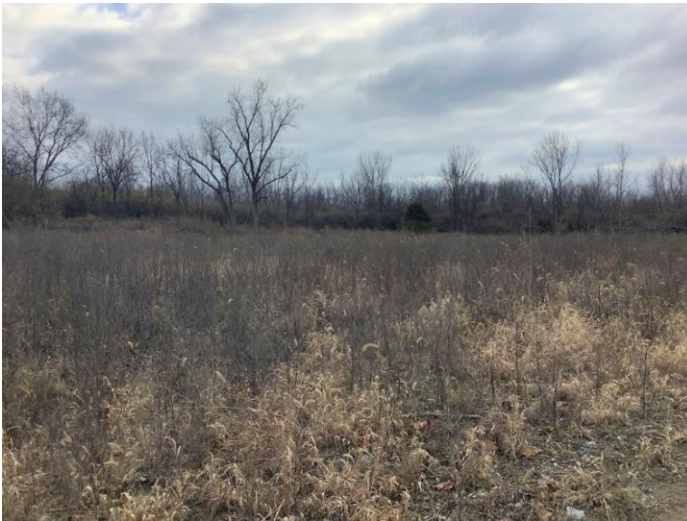
Southern Parcel

The site is currently vacant undeveloped land. The old incinerator building is still present on the southern parcel.

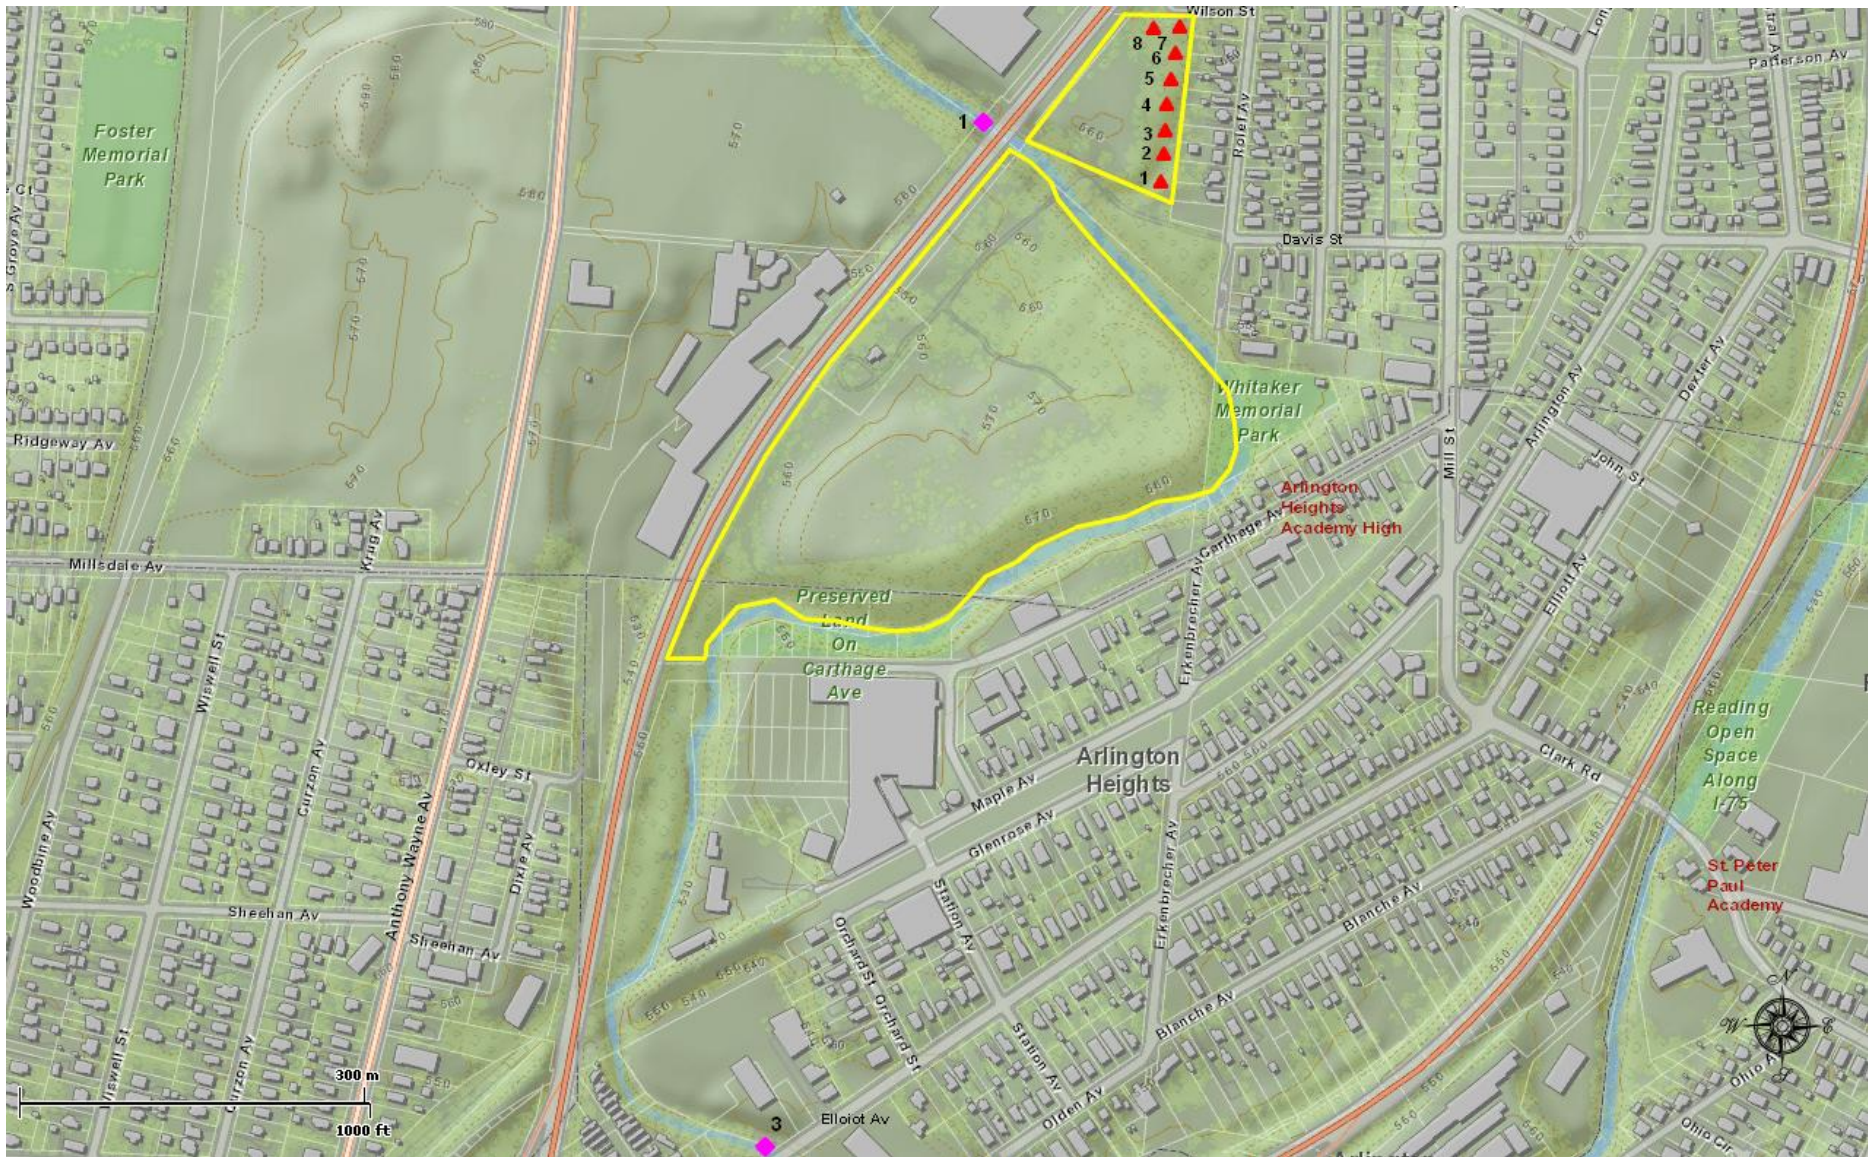
**Figure 3.12.2-C**  
**Lockland Incinerator**  
**Closed Landfill**

Gas monitoring was conducted at the Lockland (Incinerator) Landfill on December 22, 2023. The sampling locations are shown on Figure 3.12.2-C and results are provided in Table 3.12.2-B. In 2023, one detection of methane occurred at sample point 8 with a concentration of 3% LEL. One detection (sample #8) of methane occurred during 2022 monitoring at a concentration of 4% LEL. During 2021 monitoring there were 3 detections of methane ranging in concentration from 2 to 44% LEL. Due to the detection of methane at >25% LEL, additional puchbar locations were monitored to the east of sample # 4 until concentrations of <25% LEL were observed. During 2020 monitoring there were 3 detections of methane. The concentrations encountered ranged from 3 to 5% LEL. During 2019 monitoring there were no detections of methane. During the 2018 monitoring, methane was detected at each sample point excluding sample location 5. Methane concentrations ranged from 2-20% LEL.

During 2023 gas monitoring carbon monoxide (CO) was detected in sample points 1 and 8 with concentrations of 3 ppm and 40 ppm respectively. During March 2010 monitoring a concentration of 211 ppm of CO was detected at sample point 3. During monitoring events from 2010-2020 CO was detected in various locations with concentrations ranging from 3 to 92 ppm. During 2021 monitoring CO was detected in six sample locations with the highest reading being 152 ppm at sample point 4. CO was detected at 4 locations during 2022 monitoring with concentrations between 3 and 36 ppm. According to landfill fire experts, CO levels over 1000 ppm with lab confirmation indicate a subsurface fire. CO levels between 100 – 1000 ppm are suspicious. Since 2010 and 2021 sampling resulted in a level of 211 ppm and 152 ppm respectively HCPH will continue to closely monitor this area. OSHA’s eight-hour time weighted average (TWA) for carbon monoxide is 50 ppm. The immediate danger to life and health (IDLH) level for carbon monoxide is 1200 ppm. This is an open area, so one would not expect carbon monoxide levels to reach the IDLH level. *(Sampling data for this landfill is in the files at Hamilton County Public Health)*
