3.16.1 PAUL WILLIS CLOSED LANDFILL

Facility Name: Paul Willis Landfill
A.K.A.: Furlong Clean Fill Site
Location: 8073 Furlong Drive
Parcel #: 63000300122
Lat, Long: 39.204671 -84.703800
Region: Cleves, OH 45002
Owner: Mt Hope LLC
Operation (yrs): 1966 – 1976 (based on records)

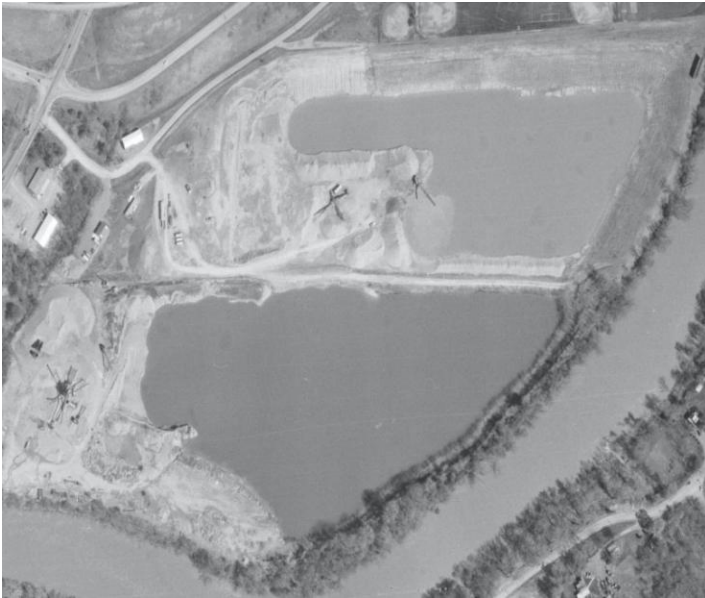
FIGURE 3.16.1-A (1981)

Continued mining at the property is evident through the early 1980’s (Figure 3.16.1-A) and filling is evident in the southwest portion of the property at this time. Filling of the former gravel pit occurred on a nearly continual basis but at some point transitioned to only clean hard fill. The property was eventually partially reclaimed and was used as a recreation area. Aerials from 1985 show a driving range and batting cages and by 1994 (Figure 3.16.1-B) a miniature golf course and go-kart track have been added.
