3.7.2 GLENDALE LANDFILL

Facility Name: Glendale Landfill

FACILITY OVERVIEW

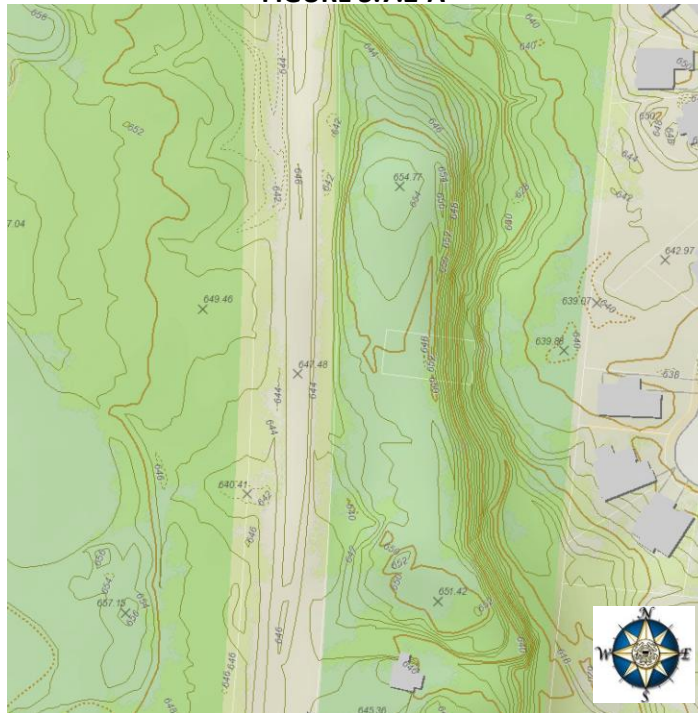
FIGURE 3.7.2-A

A well-defined creek or drainage course proceeds from the northwest corner to the southeast corner, flowing south into the tributary of Mill Creek. Figure 3.7.2-A illustrates the topography of the site.

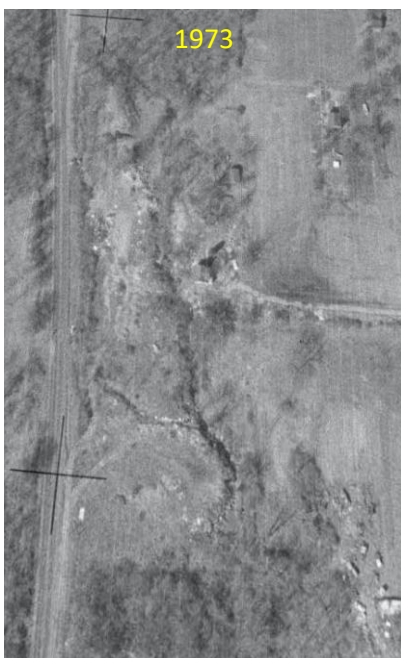
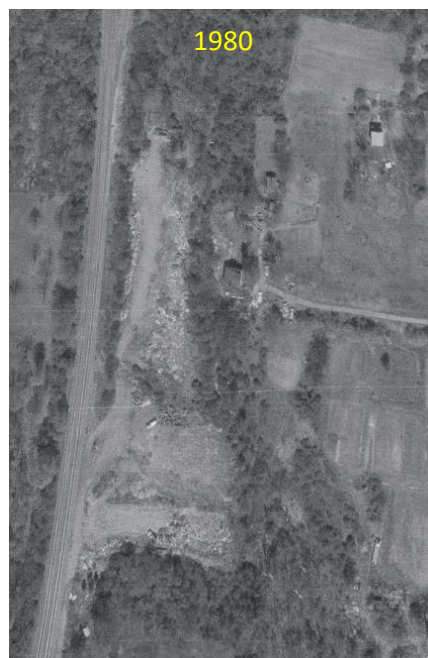
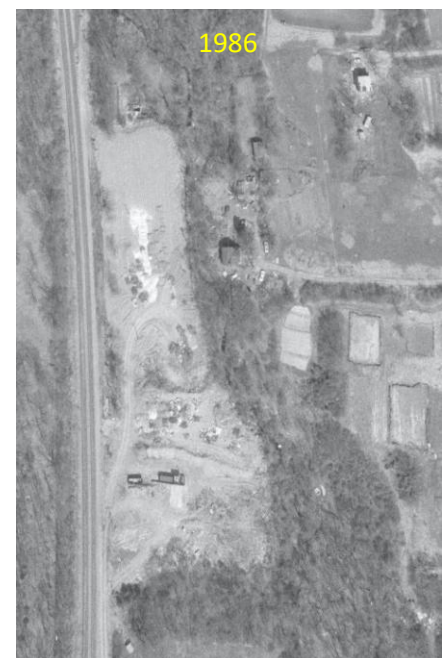
FIGURE 3.7.2-B

An August 29, 1969, letter from the village indicated that combustible waste is burned at an incinerator in Sharonville while non-combustible waste is "disposed of in the deep ravine in the extreme northeast corner of the village". The letter also indicates that burning of "trimmings from shrubs, tree limbs and trunks" occurs on the "south end of the dump". No documentation exists for the site from 1970 through 1985 and therefore activities at the site are unknown. In 1986 an Ohio EPA letter to the village indicates that a solid waste transfer station is operating on the site. The letter also thanks the village for "your cooperation in closing the old dump and the measures taken to provide a complete earth covering of the site." Figure 3.7.2-B shows the progression of filling from 1973 through 1986.

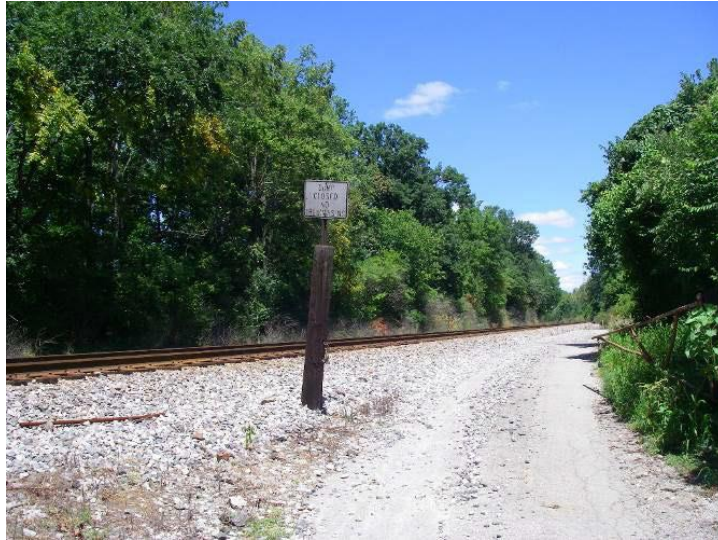
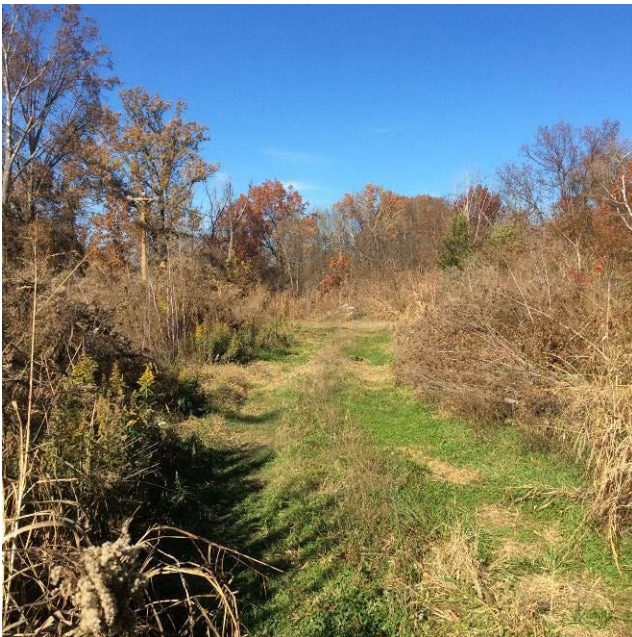
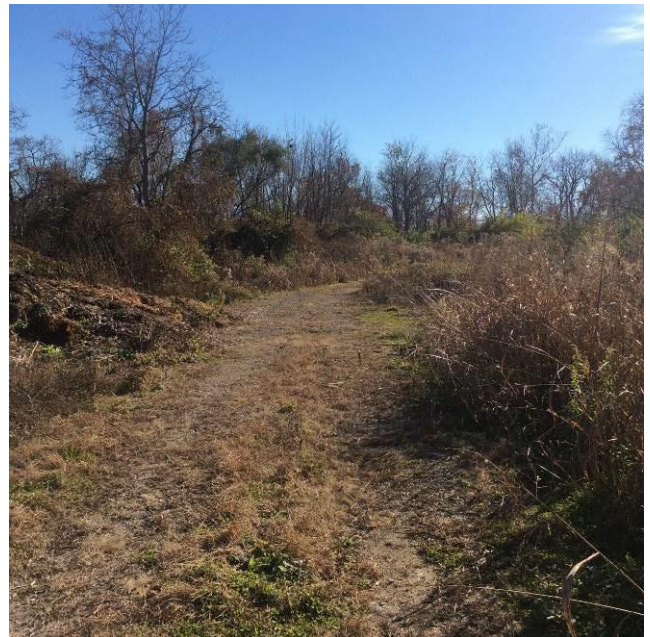
The site was inspected by HCPH on December 22, 2023. No violations or nuisance conditions were observed on the site. An area of exposed waste remains on the southeast corner of the former landfill. The area remains unchanged when compared to previous inspections and is already covered with established vegetation therefore removal/re-covering is not practical at this time.

Today, the entrance to the site is gated off. The site is mostly overgrown with trees and honeysuckle on the slopes of the landfill and tall weeds and grass on top of the landfill. The Village occasionally dumps clean hard fill (soil and/or concrete) at the site. A dumpster is maintained on the site for disposal of solid waste generated by the village.

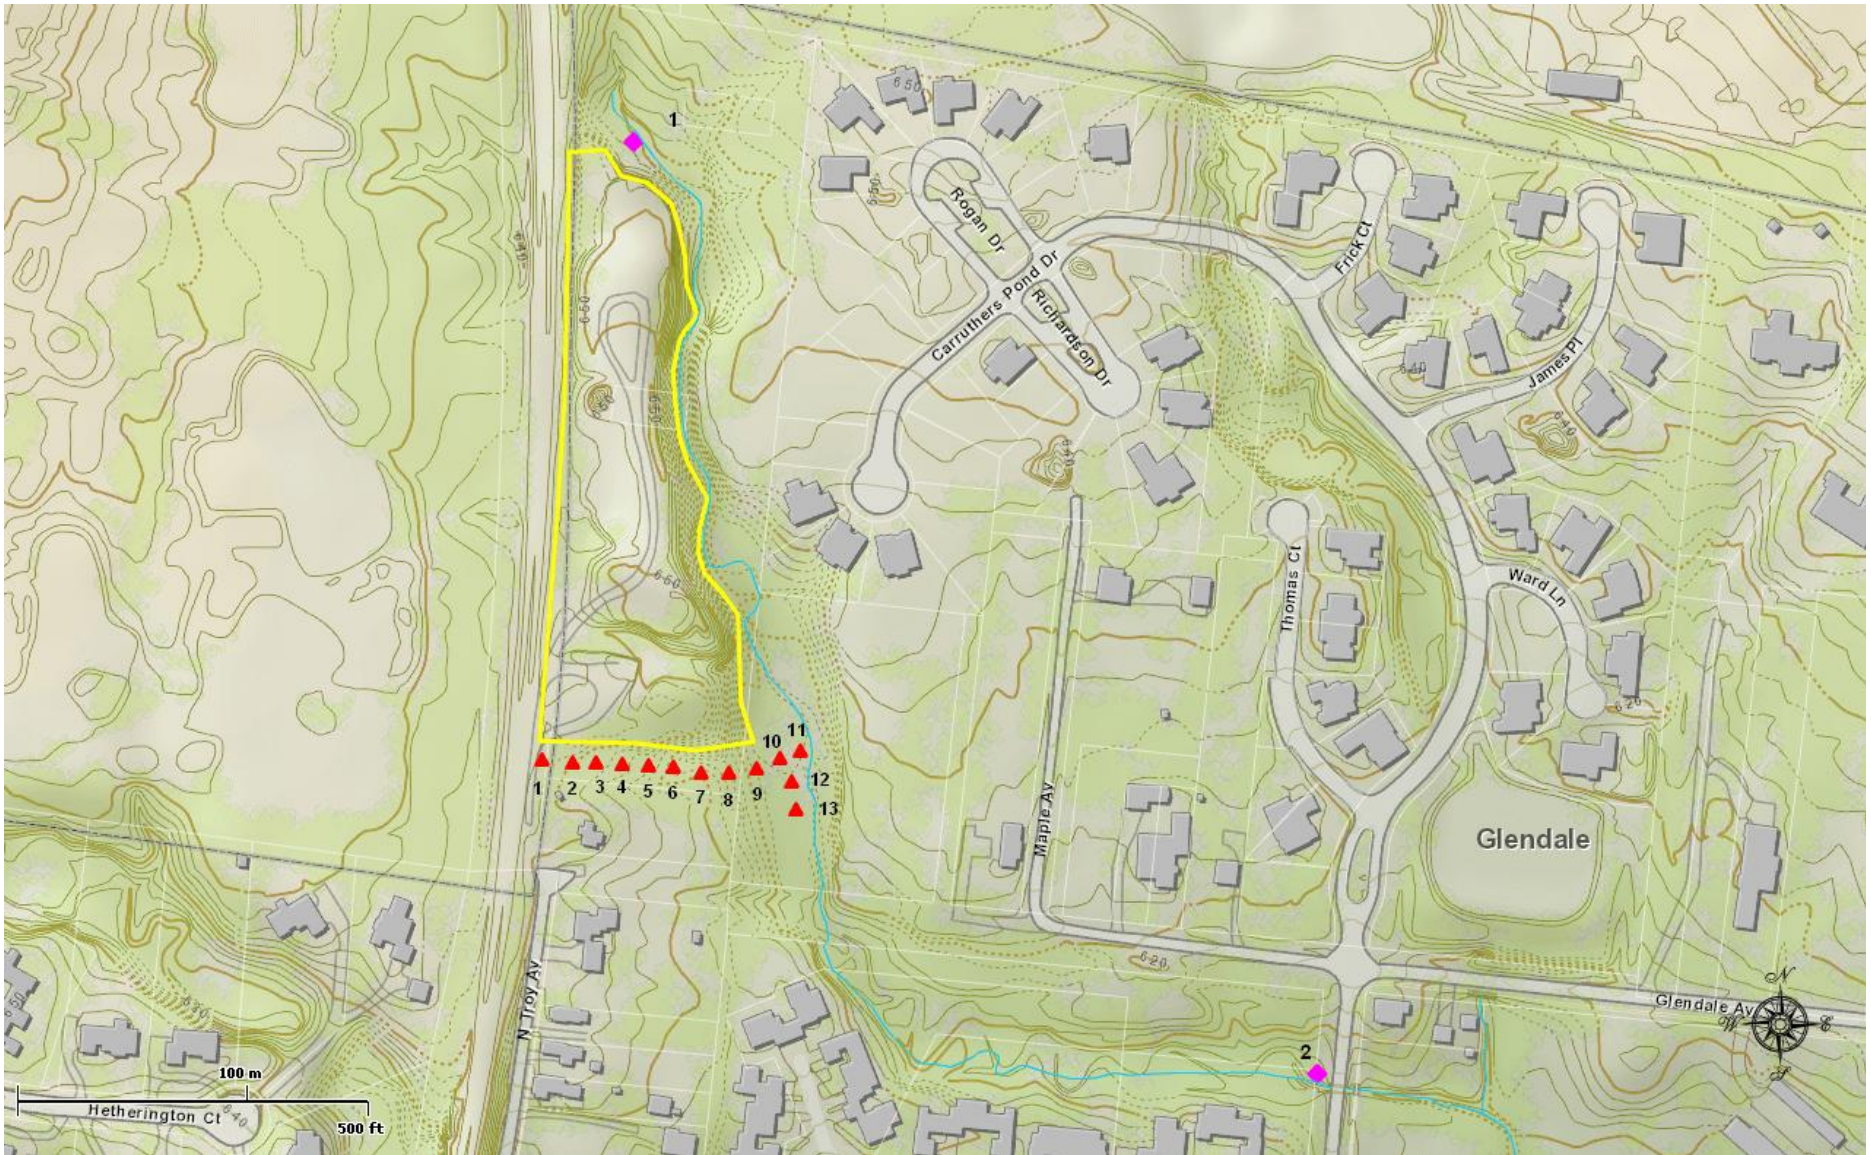
Figure 3.7.2-C
Glendale Closed Landfill
North Troy Avenue

A small, unnamed stream flows from north to south along the eastern side of the Glendale Landfill. Samples are taken near the north end of the landfill (S-1) and below the landfill (S-2). Samples around Glendale Landfill were collected on October 19, 2022 (Appendix A). The northern and southern sample sites are comprised of a series of small, shallow pools and low flow areas over a gravel bottom. A surface water pipe discharges from an upstream area to a pool and then a riffle area north above the landfill. The referenced locations are shown on Figure 3.7.2-C.

Gas monitoring was conducted along the south and southeast perimeter of the Glendale Landfill on December 22, 2023 (Table 3.7.2-B). The punch bar locations are shown on the Glendale map (Figure 3.7.2-C). During 2023 there was one detection of methane at a very low level (2% LEL) at sample point 13. There were no methane detections from 2019 - 2022. In 2018 methane was detected in sample points 6 through 12 at very low concentrations (0.1 – 0.2% methane). During 2017 sampling only one detection of 0.1% methane was encountered at sample point 4. Methane was detected at sample point 11 at 1.35% during 2016 sampling. Prior to 2016 sampling, no methane had been detected during sampling since 2006 when 0.4% methane was detected at sample location 12. When required, sampling further out from the landfill in these areas has indicated no methane gas. There was one detection (2 ppm) of Carbon monoxide (CO) at sample point 9 in 2023. Carbon monoxide was detected at five sample points in 2022 ranging from 2-10 ppm. Prior to 2022 carbon monoxide (CO) had not been detected since 2016. Carbon monoxide was detected at three sample points in 2016 ranging from 1-3 ppm. Prior to 2016 carbon monoxide had not been detected at any sample points since 2006. *(Sampling data for this landfill is in the files at Hamilton County Public Health)*
