### **3.7.2 GLENDALE LANDFILL**

Facility Name: Glendale Landfill

Location: North Troy Avenue. East of the railroad and immediately south of the north corporate line of the Village of Glendale.

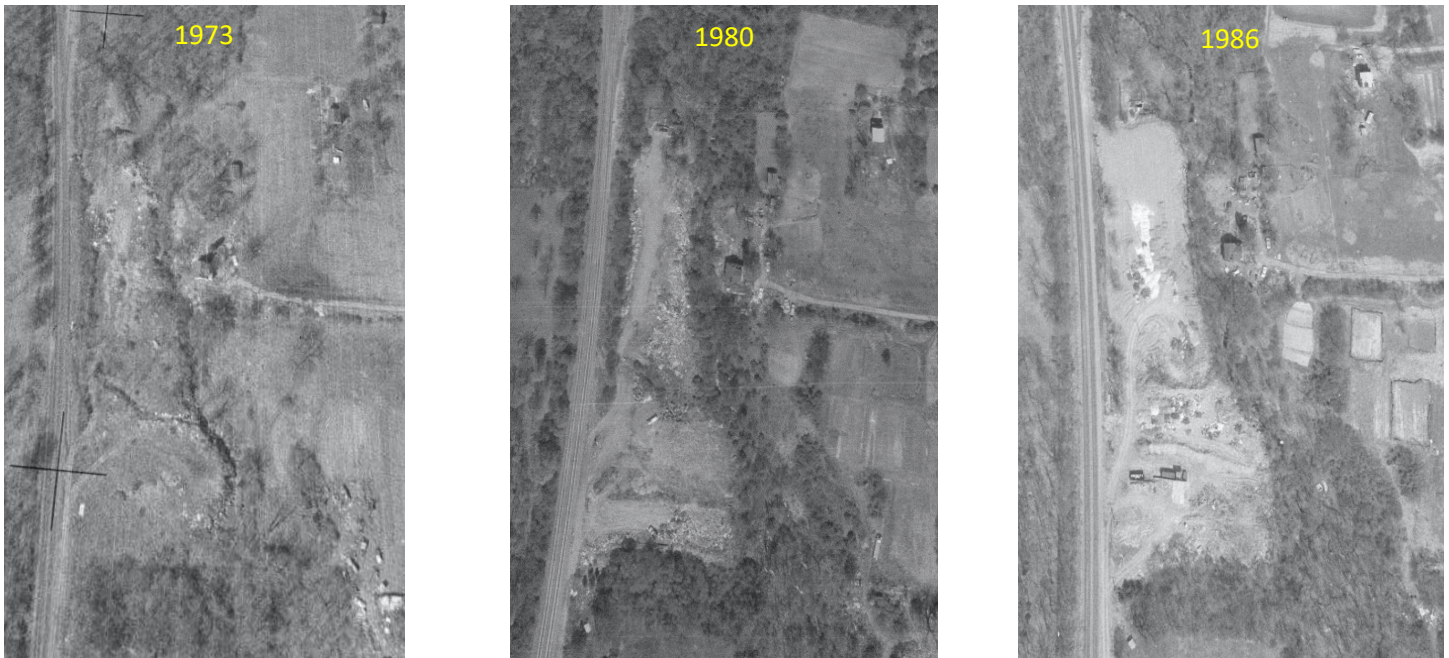
**FIGURE 3.7.2-A**

An August 29, 1969, letter from the village indicated that combustible waste is burned at an incinerator in Sharonville while non-combustible waste is "*disposed of in the deep ravine in the extreme northeast corner of the village*". The letter also indicates that burning of "*trimmings from shrubs, tree limbs and trunks*" occurs on the "*south end of the dump*". No documentation exists for the site from 1970 through 1985 and therefore activities at the site are unknown. In 1986 an Ohio EPA letter to the village indicates that a solid waste transfer station is operating on the site. The letter also thanks the village for "*your cooperation in closing the old dump and the measures taken to provide a complete earth covering of the site.*" Figure 3.7.2-A shows the progression of filling from 1973 through 1986.

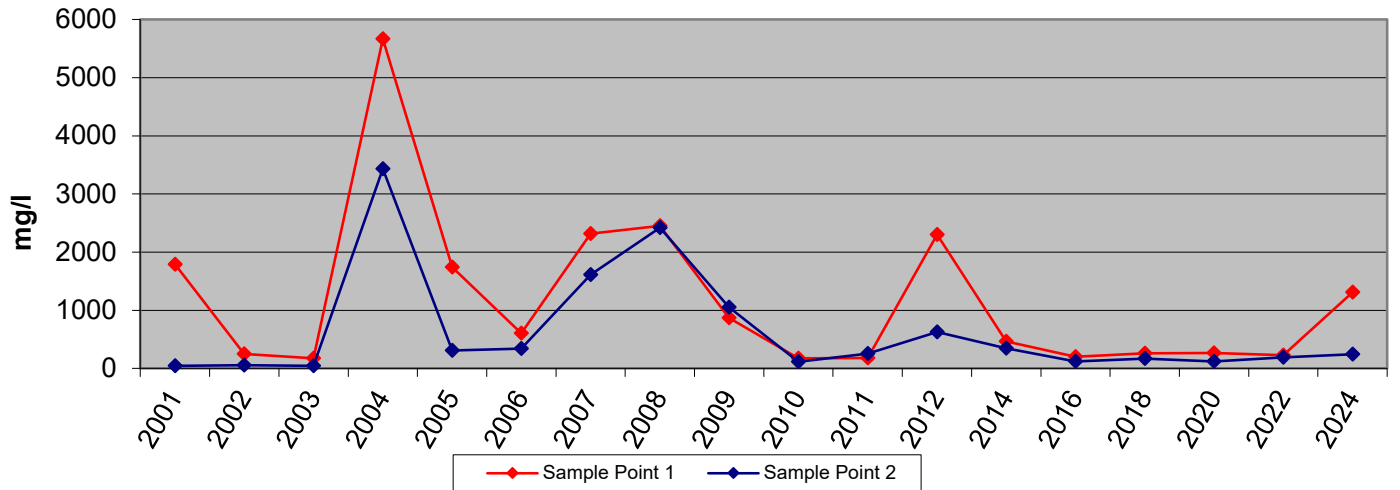
**Glendale Sodium (SMCL: 250 mg/l)**

Both sample points have historically resulted in elevated concentrations of chloride, sodium, and TDS. From 2004 through 2009, sample points demonstrated high levels of these parameters relative to the secondary drinking water standards. In 2010, concentrations dramatically dropped and were below the drinking water standards at S-2 for the first time in seven years. However, in 2011 concentrations of these parameters were again observed at elevated levels although not quite to the levels seen prior to 2010. These parameters have remained at these high concentrations through 2022 sampling. This trend holds true for S-1 during the 2024 sampling with chloride, sodium and TDS all above their SMCLs. Respective SMCLs were exceeded for Chloride and TDS at sample point S-2. However, sodium was slightly below the SMCL at S-2. All downstream concentrations of these 3 parameters were lower than upstream concentrations.

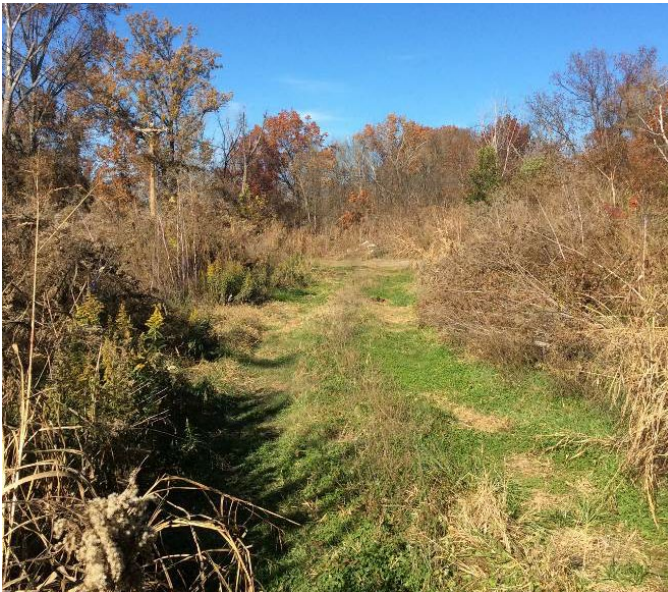
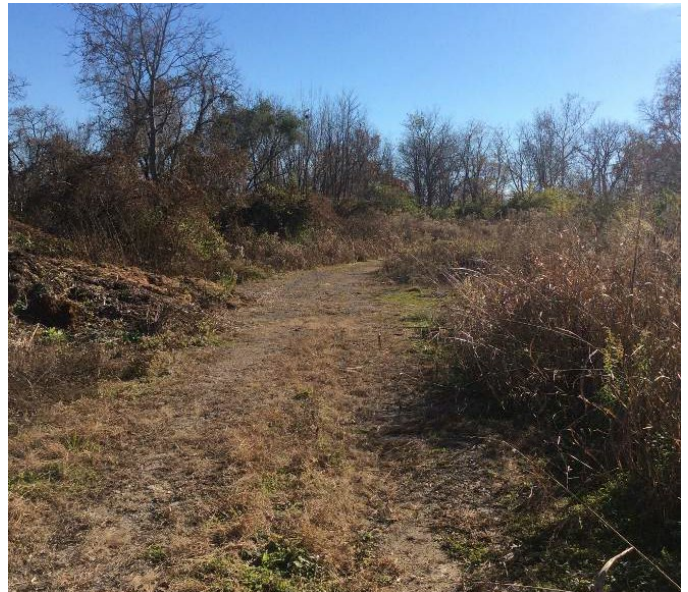
The site was inspected by HCPH on December 23, 2025. No violations or nuisance conditions were observed on the site. An area of exposed waste remains on the southeast corner of the former landfill. The area remains unchanged when compared to previous inspections and is already covered with established vegetation therefore removal/re-covering is not practical at this time.

Today, the entrance to the site is gated off. The site is mostly overgrown with trees and honeysuckle on the slopes of the landfill and tall weeds and grass on top of the landfill. The Village occasionally dumps clean hard fill (soil and/or concrete) at the site. A dumpster is maintained on the site for disposal of solid waste generated by the village.

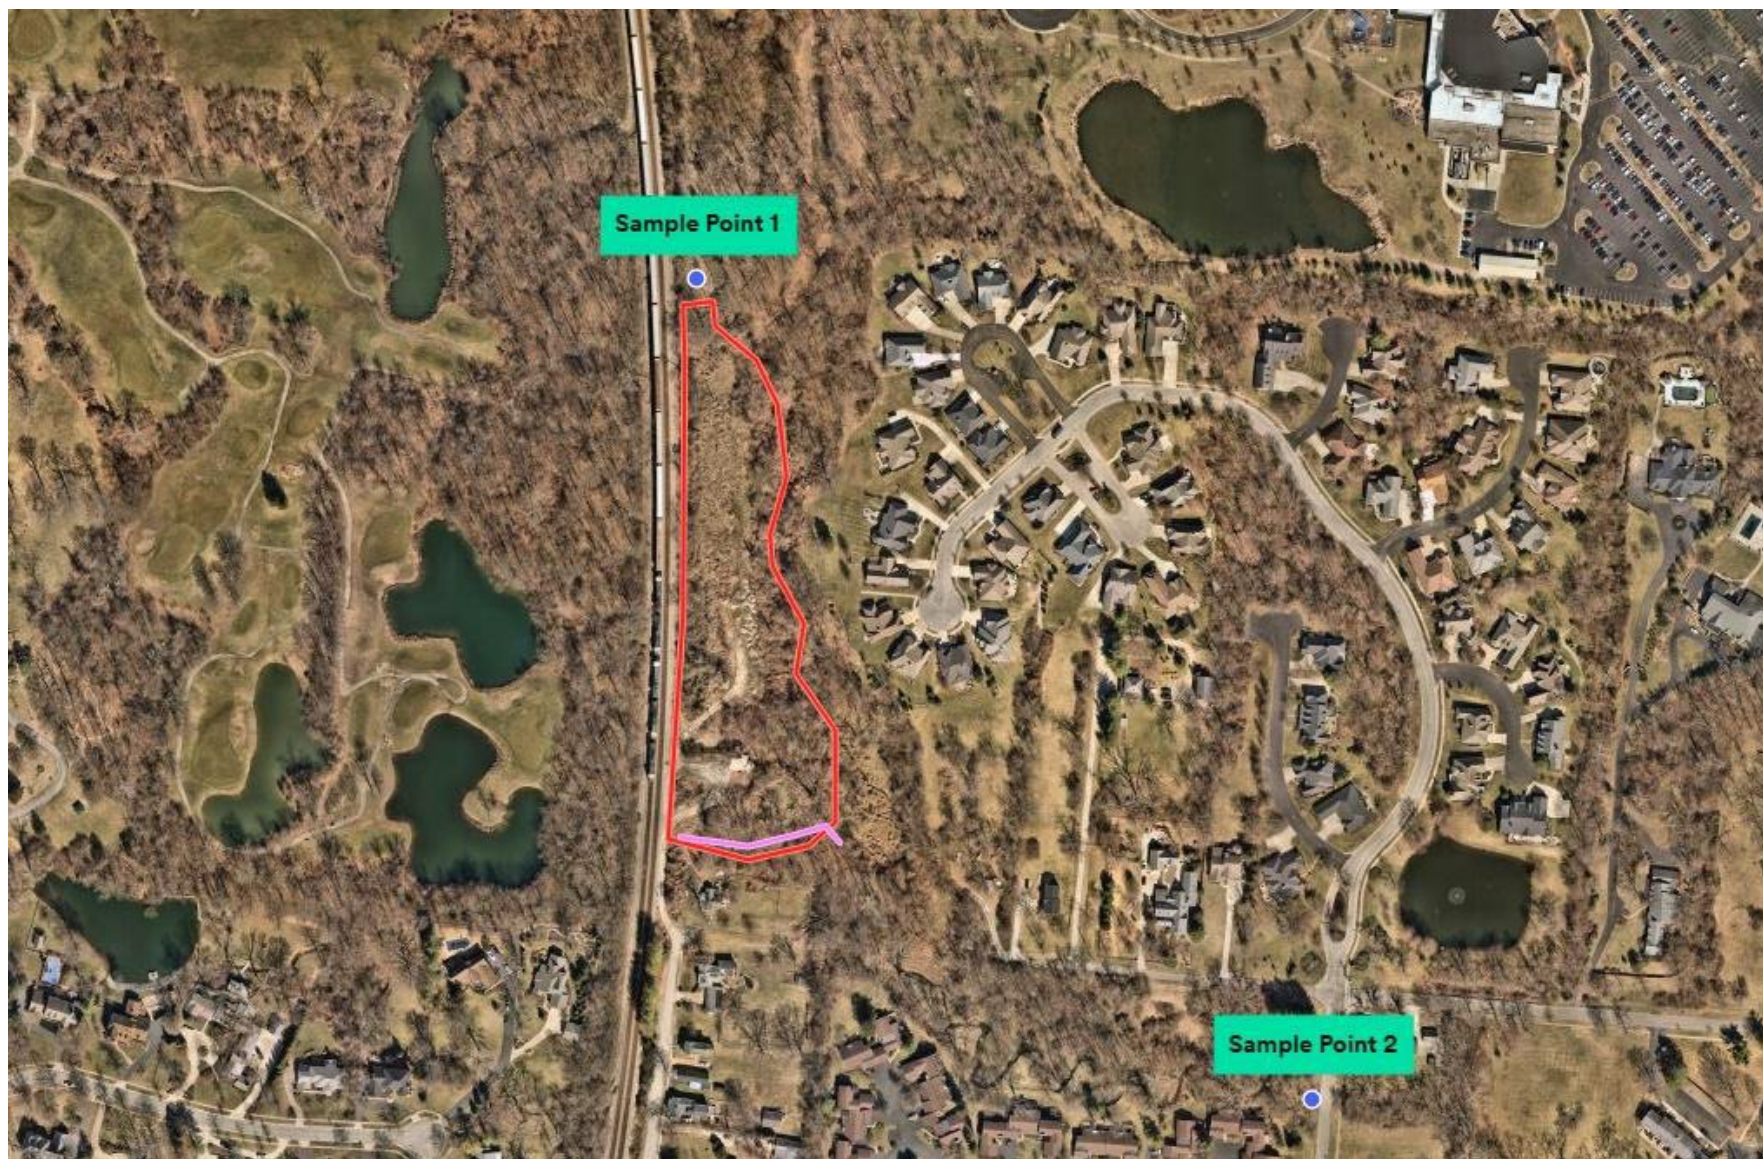
**Figure 3.7.2-B**  
**Glendale Closed Landfill**  
**North Troy Avenue**

A small, unnamed stream flows from north to south along the eastern side of the Glendale Landfill. Samples are taken near the north end of the landfill (S-1) and below the landfill (S-2). Samples around Glendale Landfill were collected on October 23, 2024 (Appendix A). The northern and southern sample sites are comprised of a series of small, shallow pools and low flow areas over a gravel bottom. A surface water pipe discharges from an upstream area to a pool and then a riffle area north above the landfill. The referenced locations are shown on Figure 3.7.2-B.

Gas monitoring was conducted along the south and southeast perimeter of Glendale Landfill on December 23, 2025 (Table 3.7.2-B). Punch-bar monitoring is performed along the perimeter of the landfill in areas highlighted in pink ( — ) on Figure 3.7.2-B. There were no detections of methane during the 2025 sampling. During 2023 there was one detection of methane at a very low level (2% LEL) on the far southeast end of the monitoring area. There were no methane detections from 2019 - 2022. When required, sampling further out from the landfill in these areas has indicated no methane gas. There were no detections of Carbon monoxide (CO) in 2025. There was one detection (2 ppm) of CO at a sample southeast of the landfill in 2023. Carbon monoxide was detected at five sample points in 2022 ranging from 2-10 ppm. Prior to 2022 carbon monoxide (CO) had not been detected since 2016. (*Sampling data for this landfill is in the files at Hamilton County Public Health*)
