3.13.2 MIAMITOWN CONSTRUCTION AND DEMOLITION DEBRIS LANDFILL

Facility Name: Miami town Landfill

Location: 5966 State Route 128. Situated south of State Route 128, approximately 0.75-mile southwest of Interstate 275/74 in Whitewater Township, Ohio.

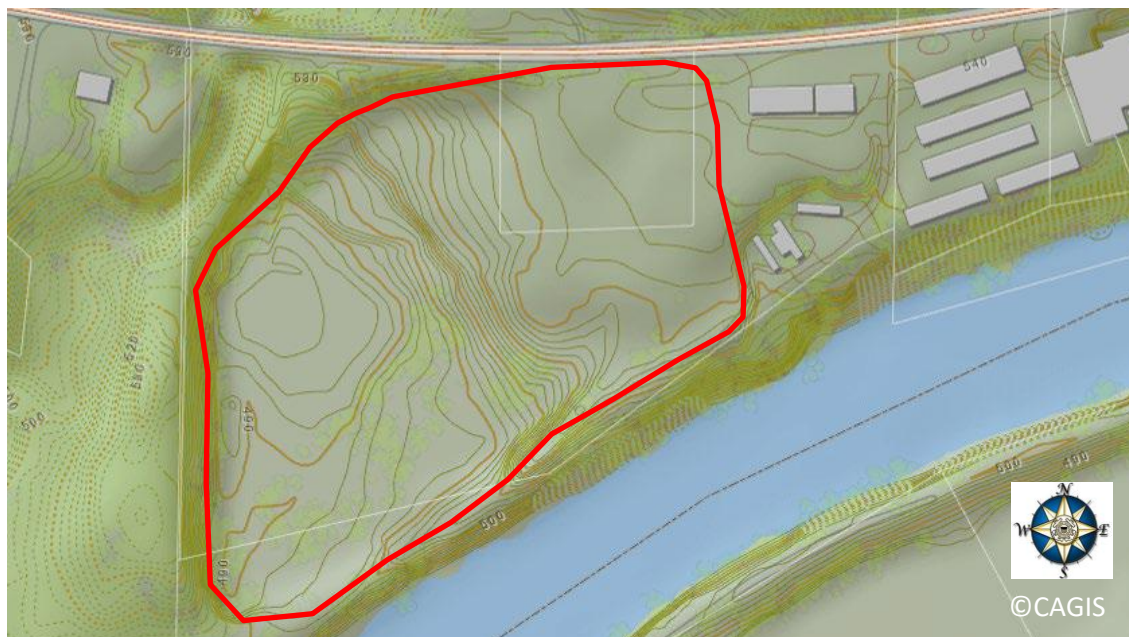
FIGURE 3.13.2-A

The topography of the former landfill primarily slopes moderately to the west-southwest. The property is bordered to the south by the Great Miami River. The property is bordered to the north, across State Route 128, by undeveloped pasture and to the west by undeveloped wooded areas. The property is bordered to the east by the present-day salvage business and other commercial businesses (veterinary office, storage units, etc.). Figure 3.13.2-A illustrates the present-day topography of the site.

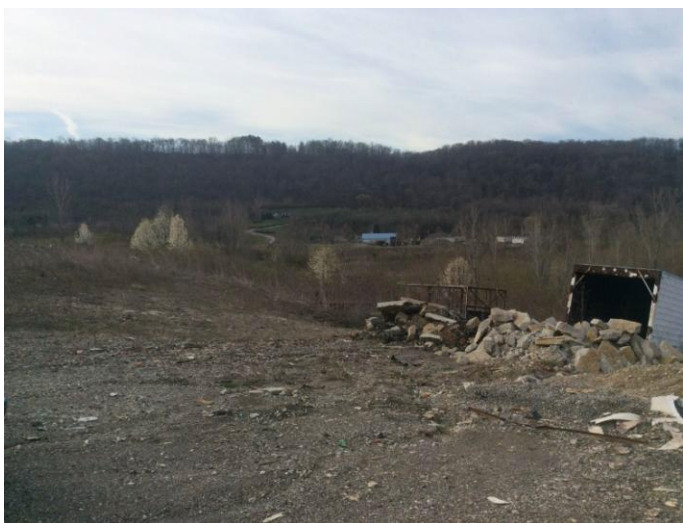
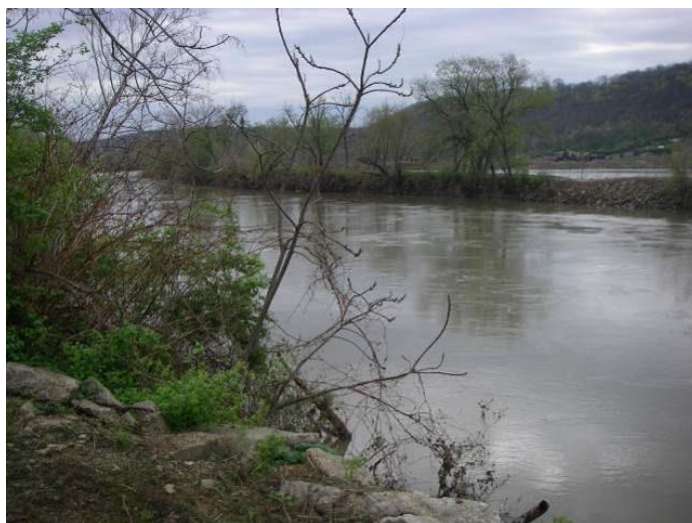
Figure 3.13.2-B
Miami town Landfill
State Route 128

Upstream and downstream sample sites are identical to Carmical Closed Landfill as shown in Figure 3.13.2-B. See Appendix A for chemical data. See section 3.3.2 (Carmical Closed Landfill) for discussion, graphs, and tables of both chemical and biological sampling data.
