3.13.3 MIAMIVIEW ASH LANDFILL

Facility Name: Miamiiview Road Ash Road Landfill

FACILITY OVERVIEW

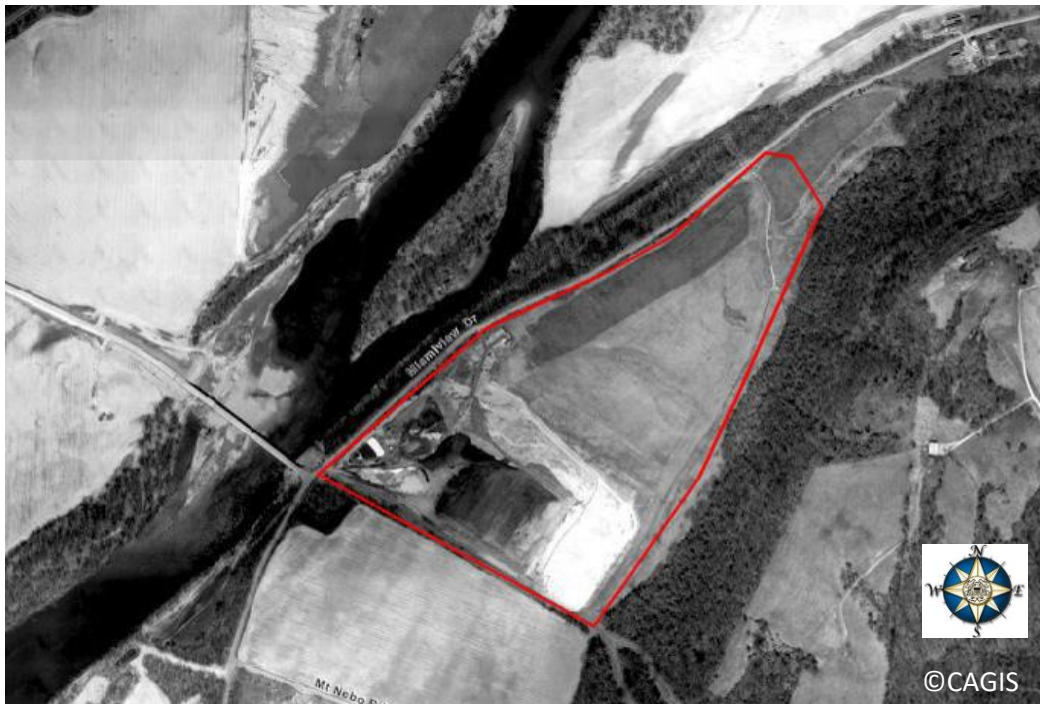
FIGURE 3.13.3-A

In 1993, a Permit to install (PTI) was issued for leachate collection, pH neutralization, and sedimentation systems for the landfill. NPDES monthly reports were provided to the Health District from June 1995 through April 1997. Monitoring for pH, conductivity, TSS, and Oil & Grease as part of the NPDES permit occurred at that time. The NPDES was not renewed when the site ceased operation in 1997. Figure 3.13.3-A is an aerial photograph from 1996. You can see in the aerial that the northern part of the site has been filled and the southern end of the property is used for current disposal of the fly ash and bottom ash.

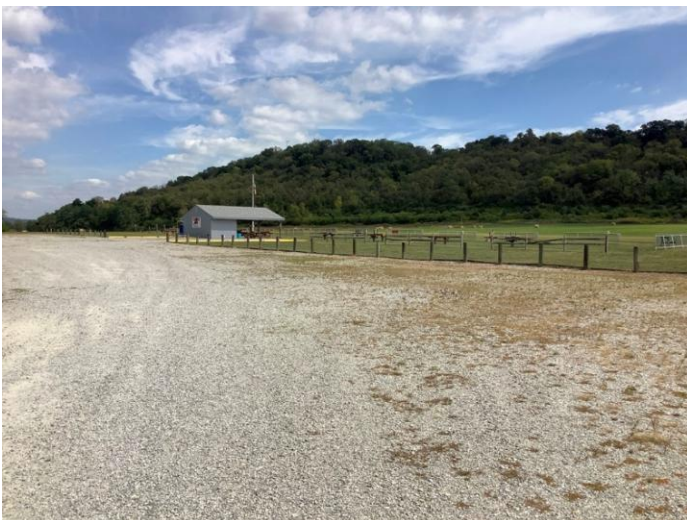
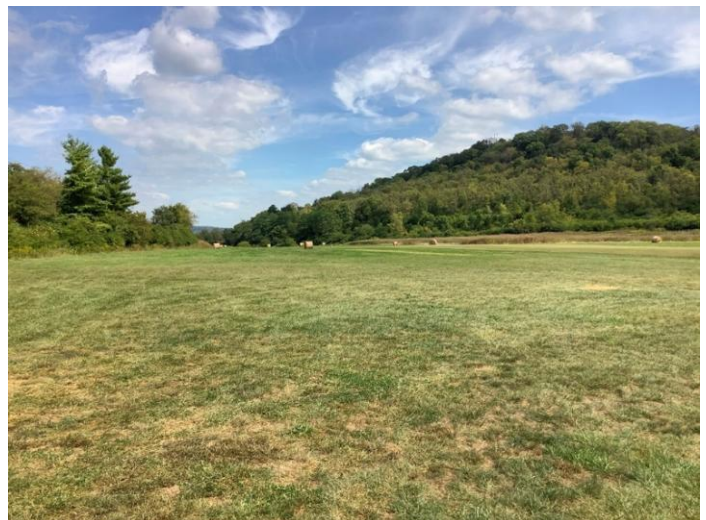
Today, the property is an open field utilized by Air Masters RC Flying Club as a model airplane flying field.
