3.15.3 OLD NEWTOWN LANDFILL

Facility Name: Old Newtown Landfill
A.K.A.: N/A
Location: North/Northeast of Broadwell Road, East of Round Bottom Road
Parcel(s): 50001630001
Lat, Long: 39.142076 -84.325561
Region: Anderson Township
Owner: Martin Marietta Materials Inc.
Operation (yrs): 1980's and 1990's

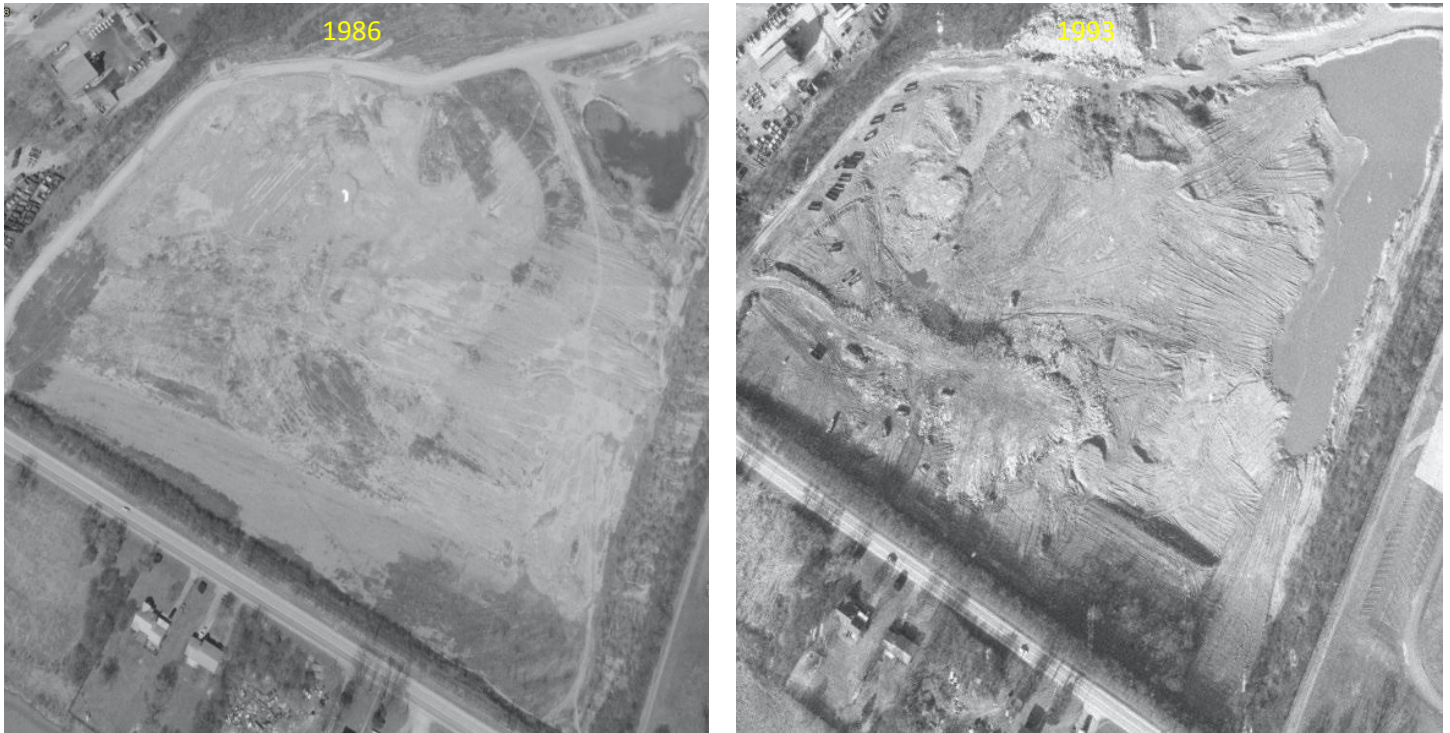
FIGURE 3.15.3-A

From review of aerials, it appears the gravel pit was mined in the 1970's. Filling of the former gravel pit began in the 1980's. Aerials from the 80's appear to show filling with soil. However, aerials from the 1990's appear to show filling with C&DD (Figure 3.15.3-A). An inspection completed by HCPH in 1995 described the facility as a closed C&DD landfill.

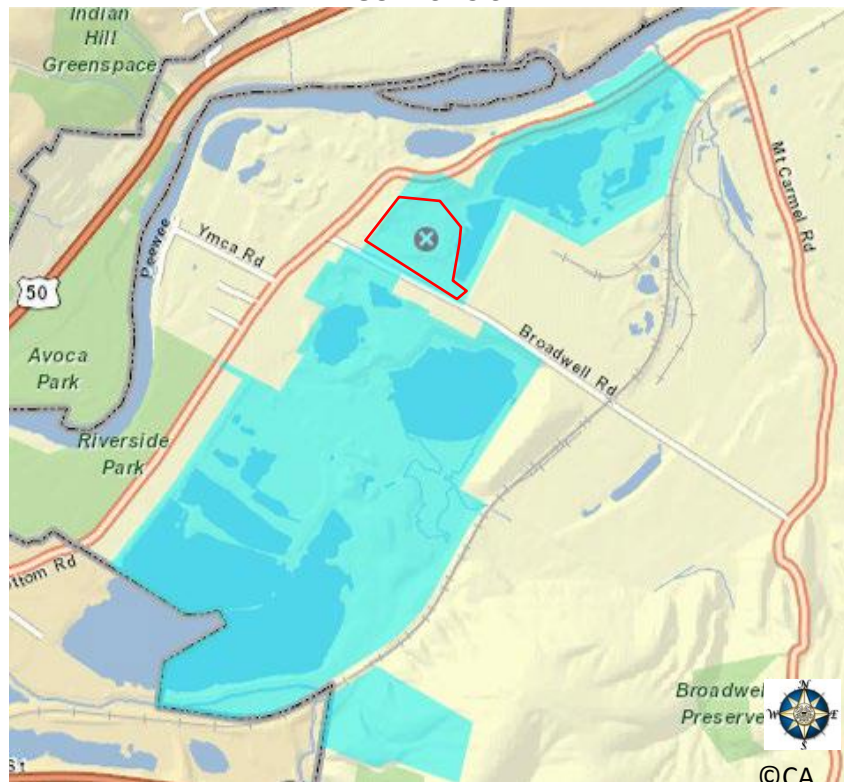
FIGURE 3.15.3-B

During the 2006 purchase of the property by Martin Marietta Materials Inc., a combination plat was created from a group of parcels surrounding the landfill. The created parcel, Parcel #50001630001, encompasses approximately 488 acres. Figure 3.15.3-B illustrates the location of the landfill within Parcel #50001630001:

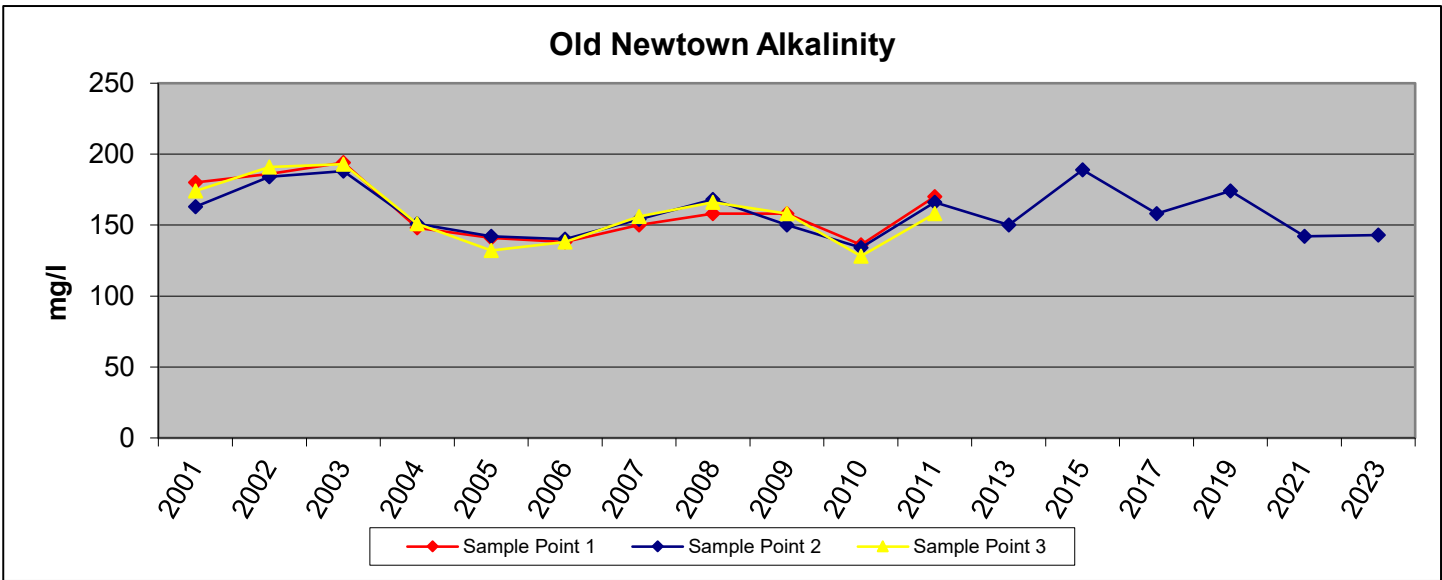
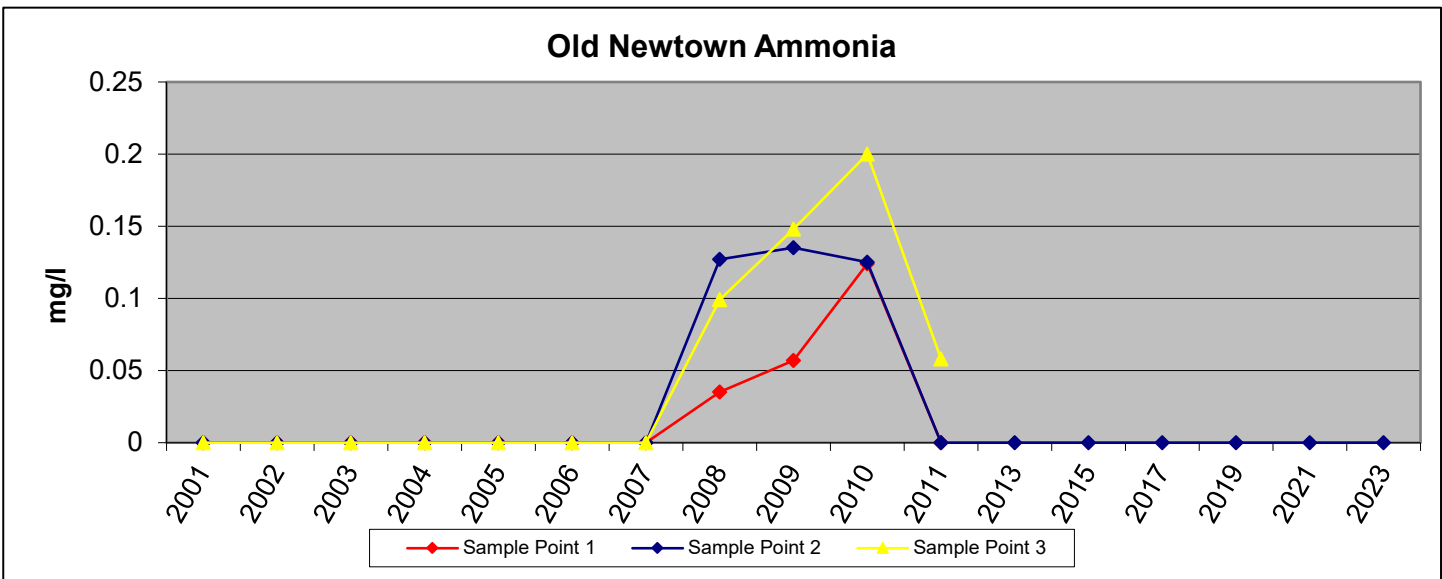
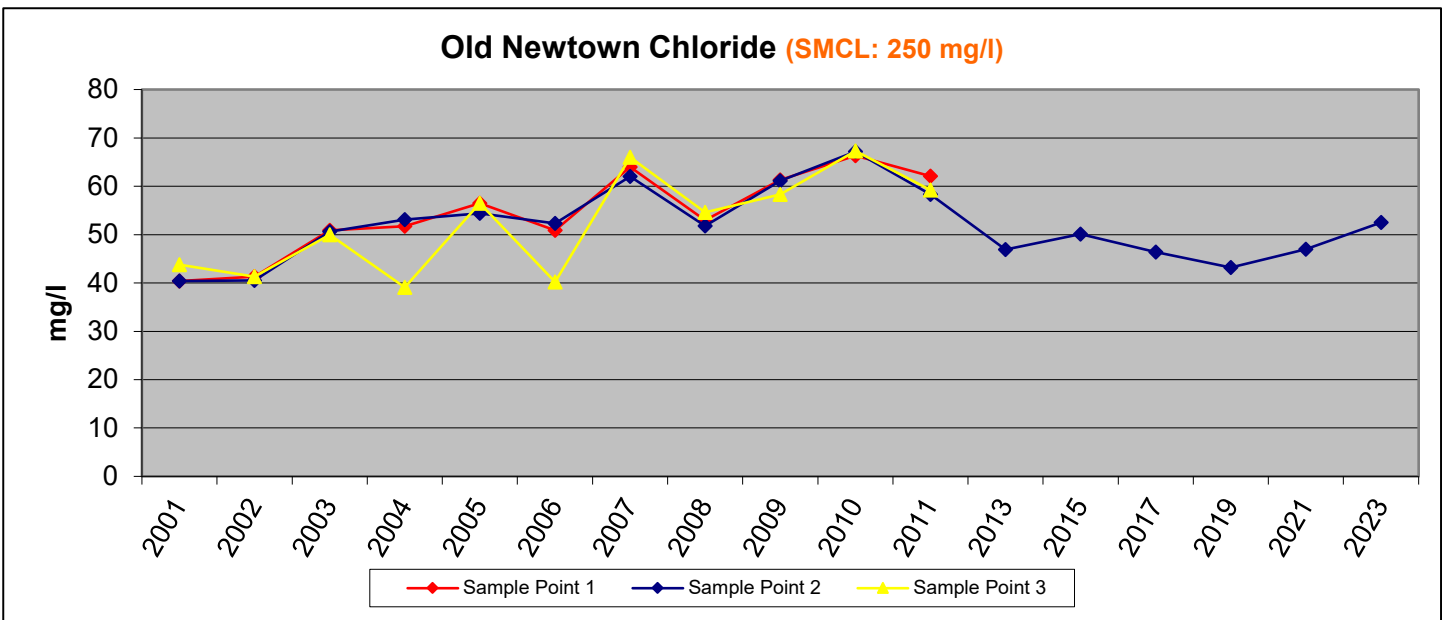
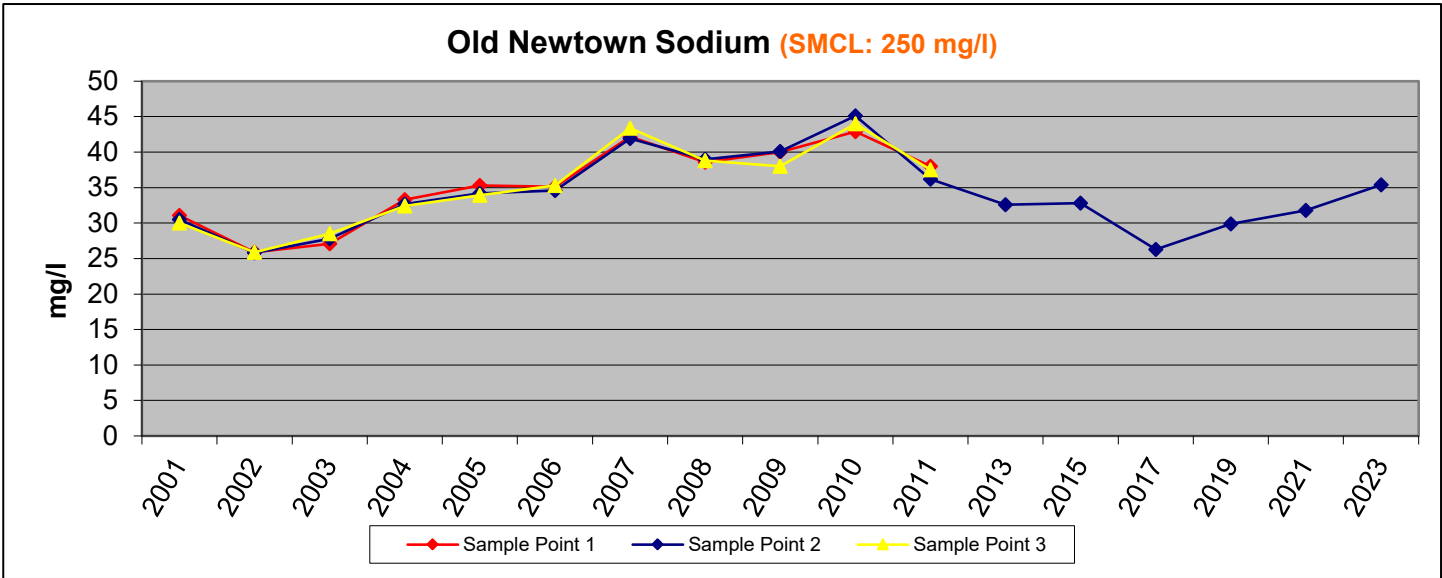
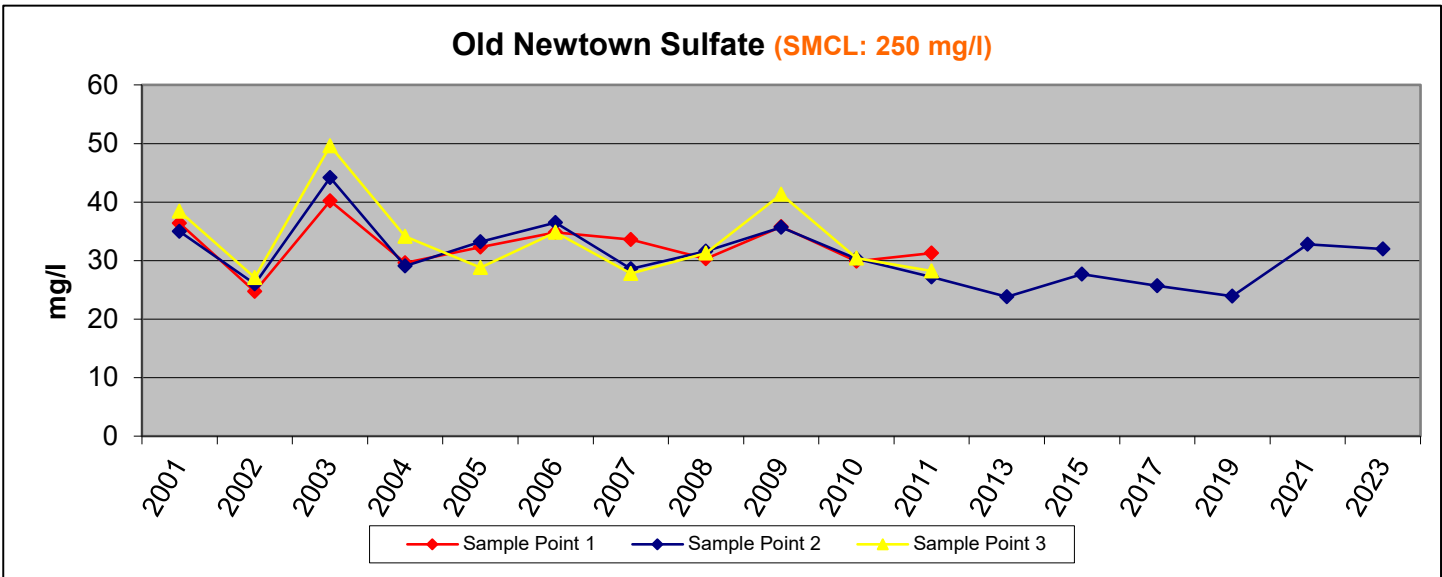
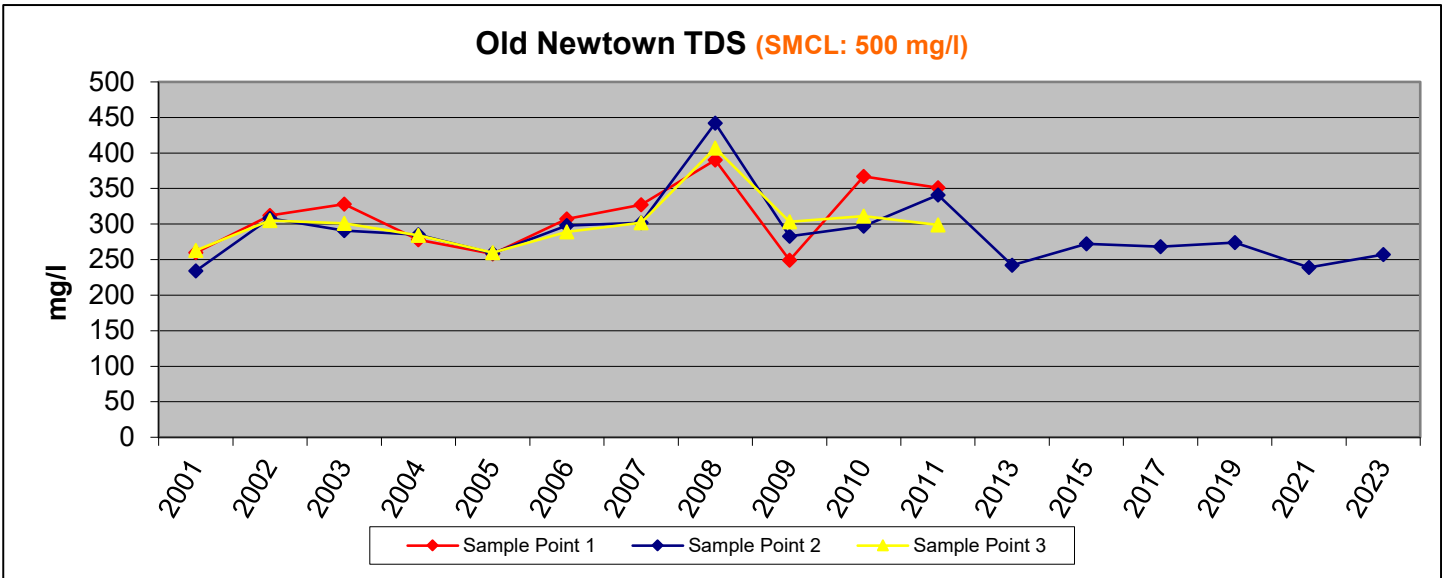
Results for all parameters (Appendix A) sampled in 2023 indicate acceptable water quality, where no MCLs, SMCL’s, or action levels were exceeded. Sodium has been trending upwards over the last 3 sampling events but remains well below the SMCL of 250 mg/L. Similarly, chloride has been on an increasing trend for the last two sampling events, but concentrations remain well below the SMCL of 250 mg/L. During 2015 sampling alkalinity results were the highest ever recorded at sampling point 2. Subsequent results have shown alkalinity returning within the range previously observed at the site. All other parameters were within the ranges previously observed at the site. Surface water chemical data is illustrated for Old Newtown Landfill in the graphs on the subsequent pages.

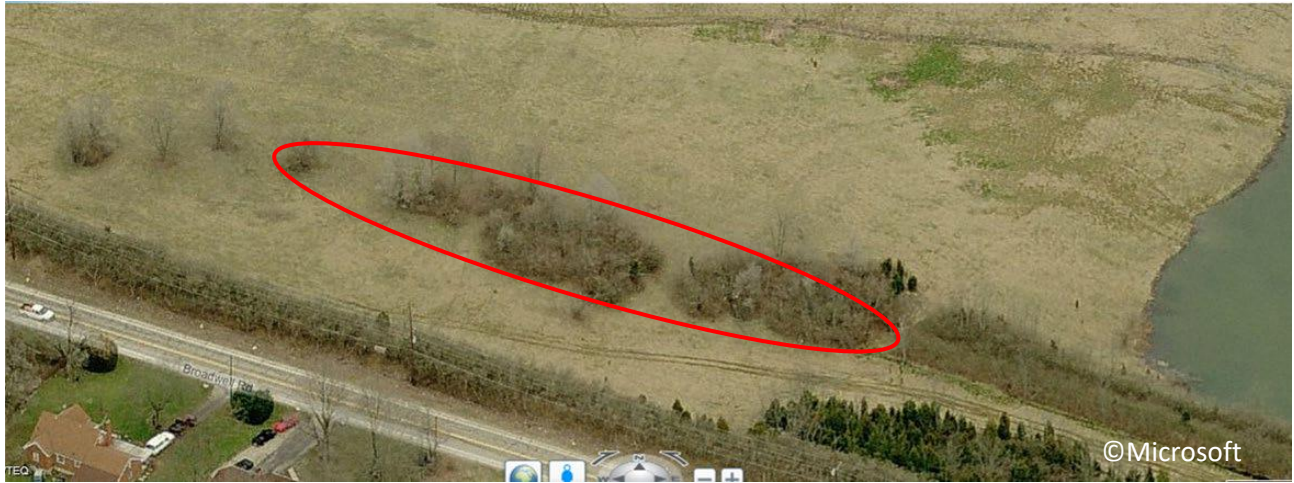
FIGURE 3.15.3-E

The site was inspected by HCPH on December 27, 2023. The south end of the property has become increasingly overgrown with honeysuckle, trees, and grass over the last 15 years making it more difficult to access and inspect. Areas of exposed waste which have been identified during previous inspections are still present. Some of the materials appear to be exposed from former landfill activities and other materials may be a result of past open dumping. The areas of exposed waste are completely covered with trees and Honeysuckle. Seeps have also been identified in the same general area during previous inspections but were not present at the time. Whether the seeps are naturally occurring or related to former landfill activities is unclear. The debris and seeps are located in the wooded areas on the Southern portion of the site as depicted in Figure 3.15.3-E.

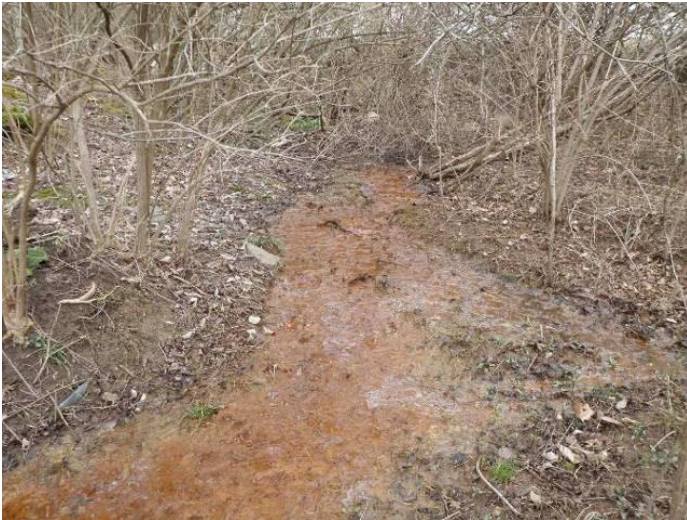
Seeps - 3/24/2010

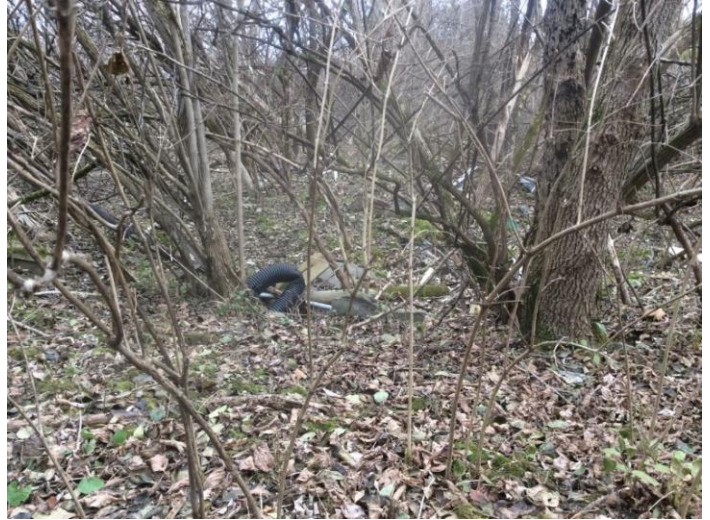
Exposed waste/open dumping – 12/14/2018

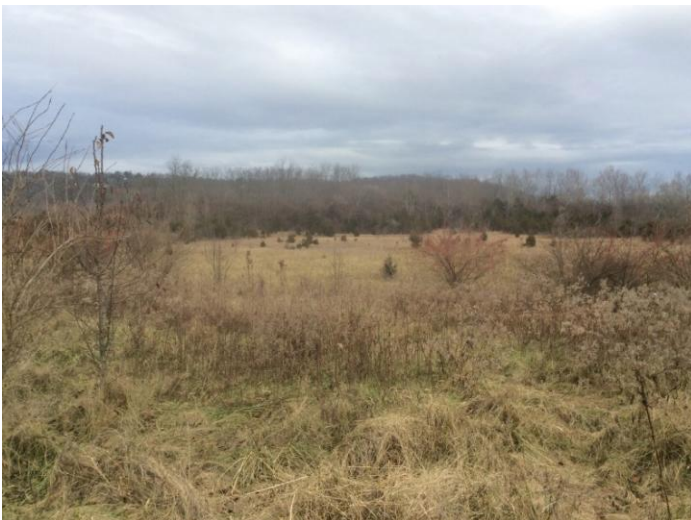
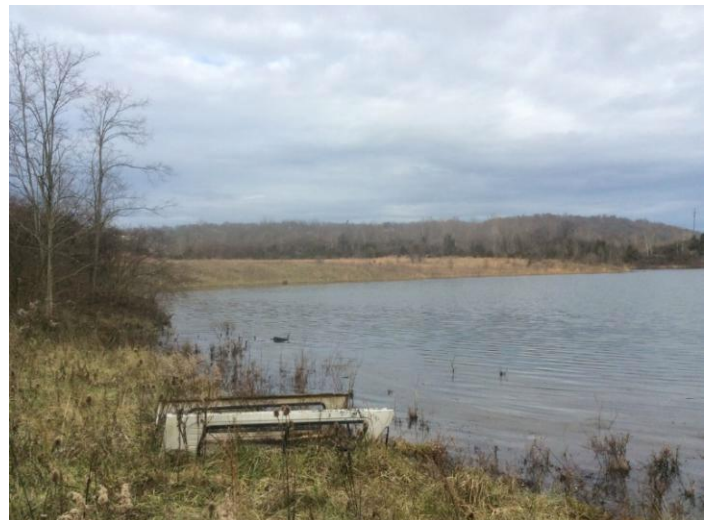
Today, the landfill area sits vacant with little to no activity at the site. The former landfill is covered with established grass, honeysuckle, and trees.

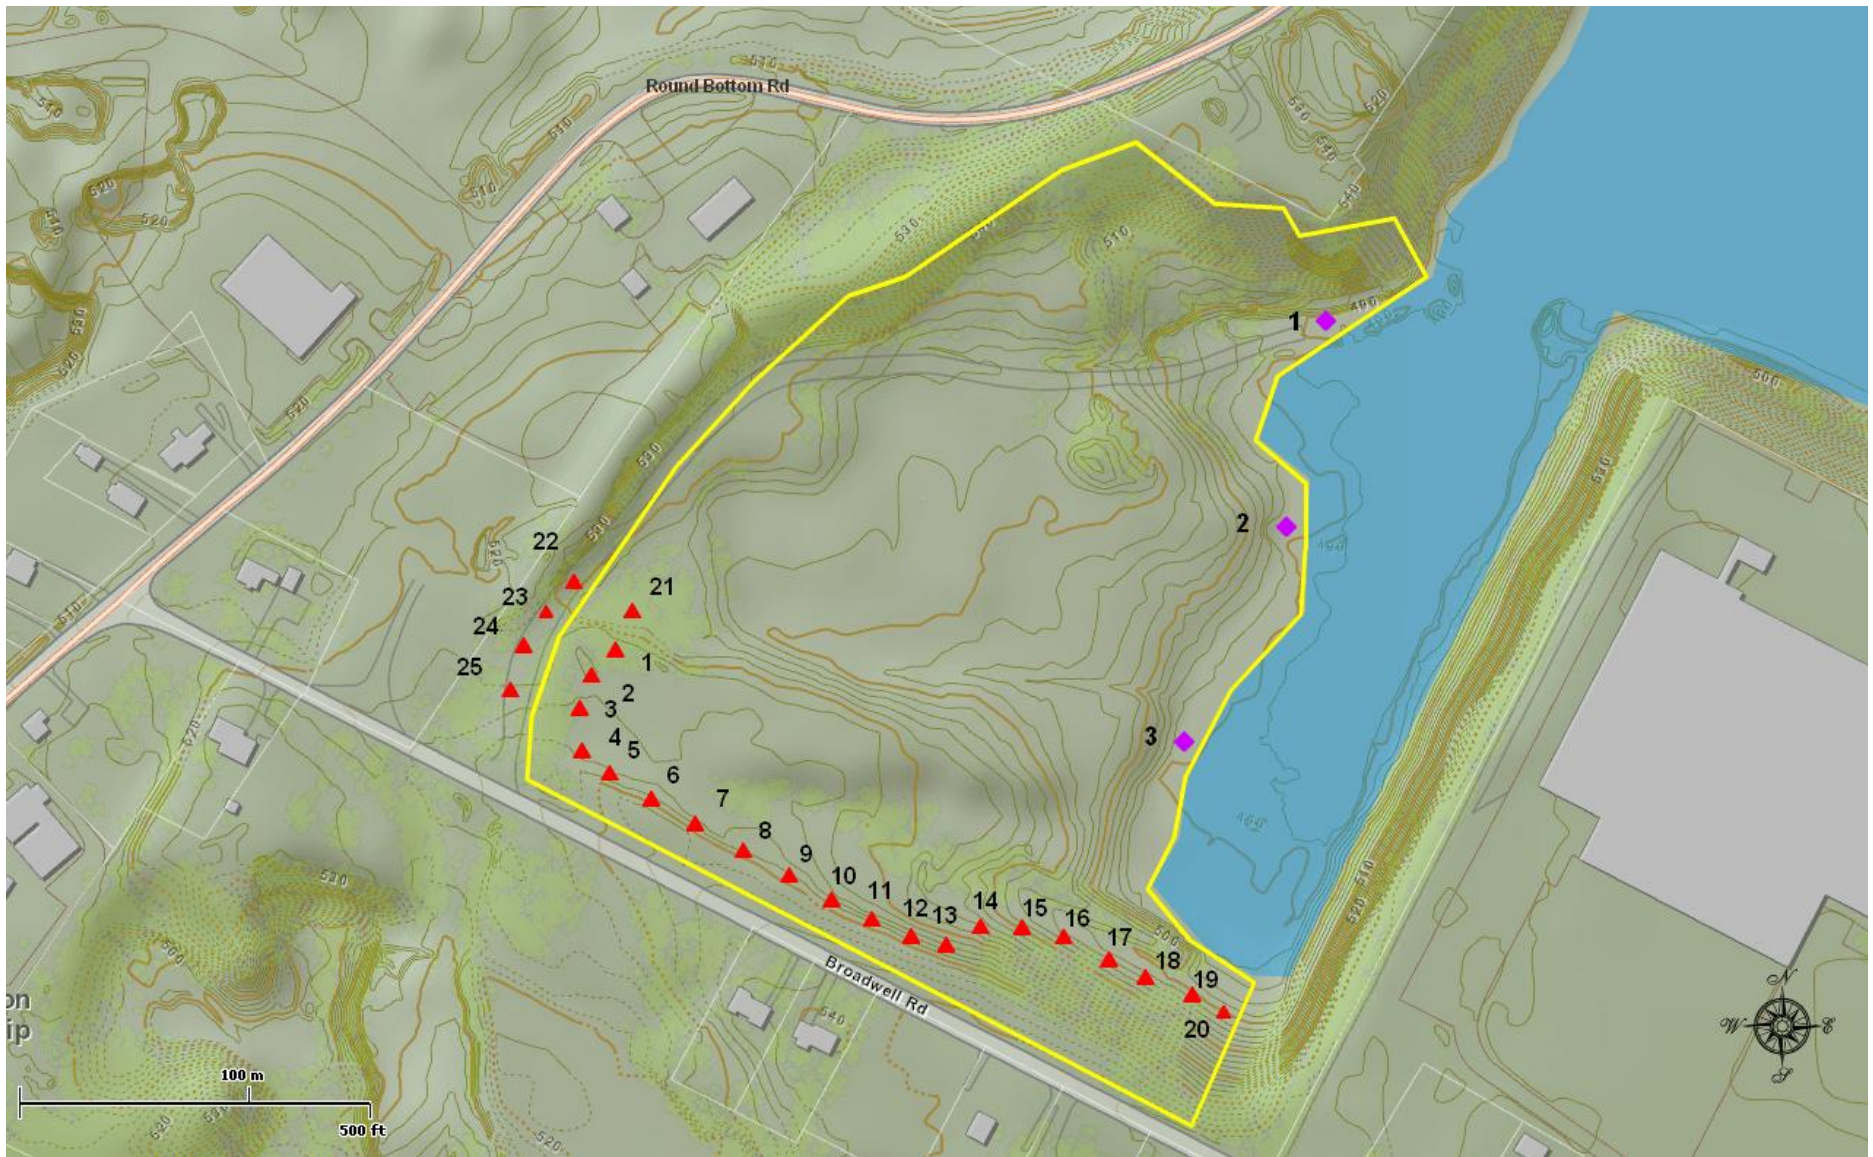
Figure 3.15.3-F
Old Newtown Closed Landfill
Broadwell Road

There is a large quarry pond located on the eastside of the Old Newtown Landfill. The pond was historically sampled in three locations. Given the steady findings at all three locations, sample sites S-1 and S-3 were removed from the sampling protocol in 2013. Samples around Old Newtown Landfill were collected on November 6, 2023. The samples were collected when pond levels were very low. The S-2 pond sample location has a rocky/gravelly bottom with aquatic vegetation. The samples were collected in shallow water less than one foot deep. The referenced locations are shown on Figure 3.15.3-F.

Gas monitoring was conducted on December 27, 2023 (Table 3.15.3-B) primarily along the southern perimeter of Old Newtown Landfill along Broadwell Road, where the closest (<200 feet) occupied structures are located. A low concentration of methane (2% LEL) was detected at sample point 1 during 2023 monitoring. During 2022 monitoring methane was detected at sample points 1 and 3 at 2% and 5% respectively. In 2021 methane was detected in one sample point (7) at 2% LEL. The last several sampling events have continued a trend of methane detections, in low concentrations, at sampling points 1, 2, 3, and 21 which are located on interior portions of the landfill (Figure 3.15.3-F).

- ◆ = Surface Water Sampling Location
- = Approximate Limits of Waste
- ▲ = Gas Monitoring Location
