3.19.1 SCHWEITZER LANDFILL

Facility Name: Schweitzer

Location: 325 Clark Street

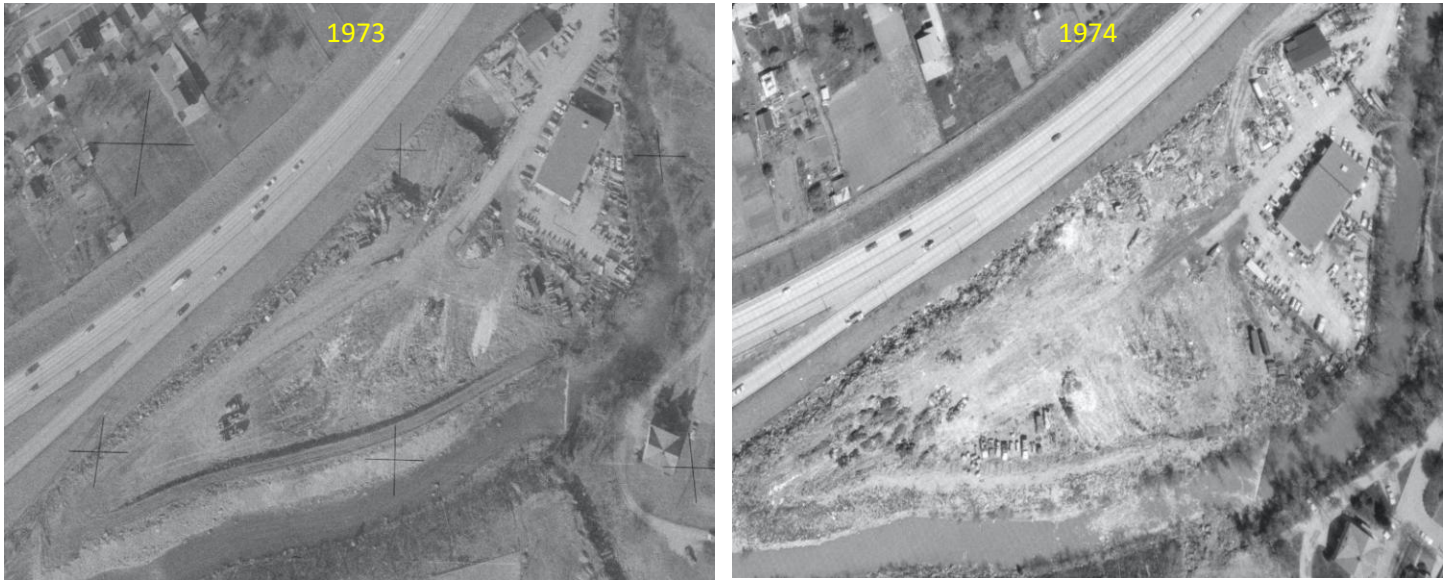
FIGURE 3.19.1-A

The fill was approved by Arlington Heights zoning in a letter dated June 11, 1970, by ODH in a July 15, 1970 letter, and in a letter dated July 24, 1970 Schweitzer Construction made application for a license with Hamilton County Board of Health. The fill was used for disposal of Philip Carey Corporation and later Celotex. Materials include asphalt, asphalt impregnated paper, roofing shingles, and asbestos-cement slurry. This material was then covered daily with onsite material and construction materials from Schweitzer Construction. Detail plans for proposed modifications to the landfill along with an application for permit to install was received by the OEPA December 20, 1974, and approved in a March 6, 1975, letter. Figure 3.19.1-A shows aerials from 1973 and 1974 when the landfill was in operation.

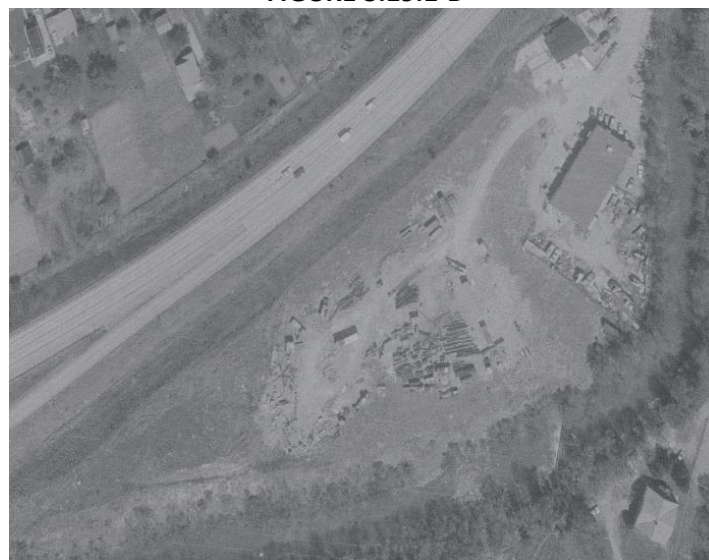
FIGURE 3.19.1-B

According to a September 14, 1984, letter from the OEPA the site had a record of "poor operational compliance". Review of inspections performed from 1971 through 1977 indicated inadequate cover, improper grading, and waste in the Mill Creek. In a letter dated December 21, 1977, the Village of Arlington Heights notified the landfill that they must cease acceptance of waste by the end of the year due to complaints and violations. During a January 10, 1978, meeting Schweitzer landfill, Arlington Heights, Hamilton County Board of Health, and the OEPA agreed that no waste would be disposed of after July 15, 1979 (*this is probably a typo and should be July 15, 1978*) and that no asbestos material could be accepted. In a January 12, 1978, letter to Mr. Schweitzer HCGHD indicated that asbestos material had been found in the landfill. Two additional inspections of the landfill were made in August and September of 1978 during which the operator was told to place additional cover and to grade certain areas of the landfill. Figure 3.19.1-B shows an aerial photo from 1980 after the facility had been closed. Figure 3.19.1-C shows the present-day topography of the site.

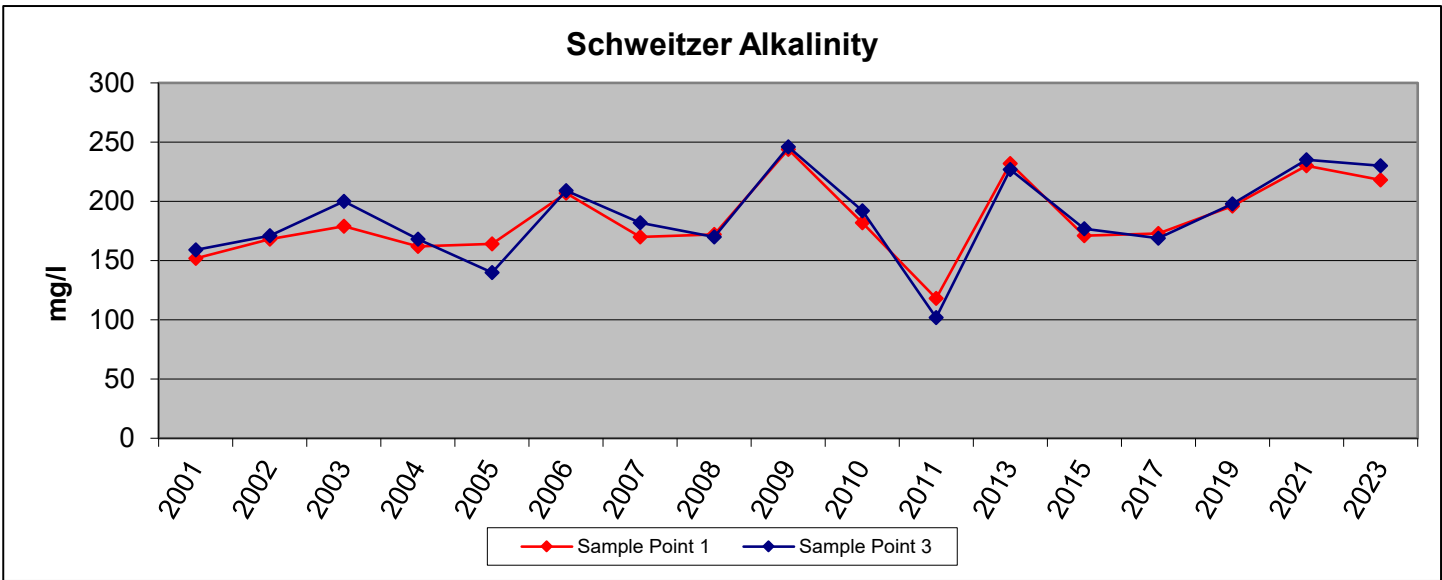
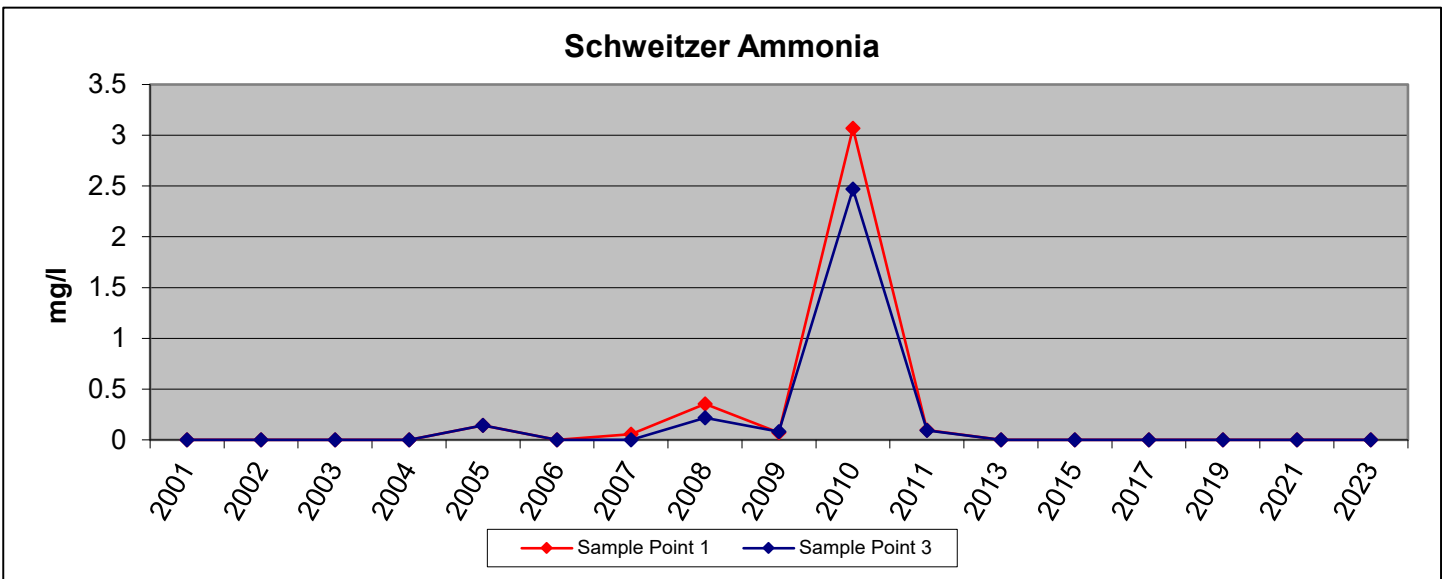
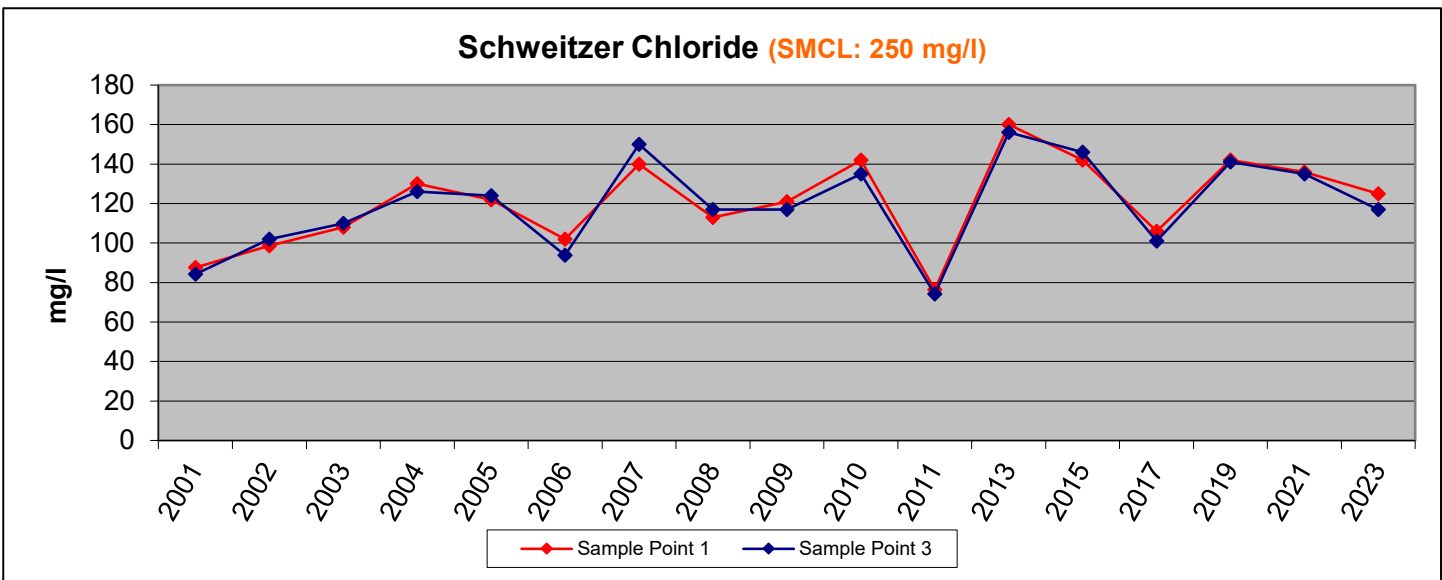
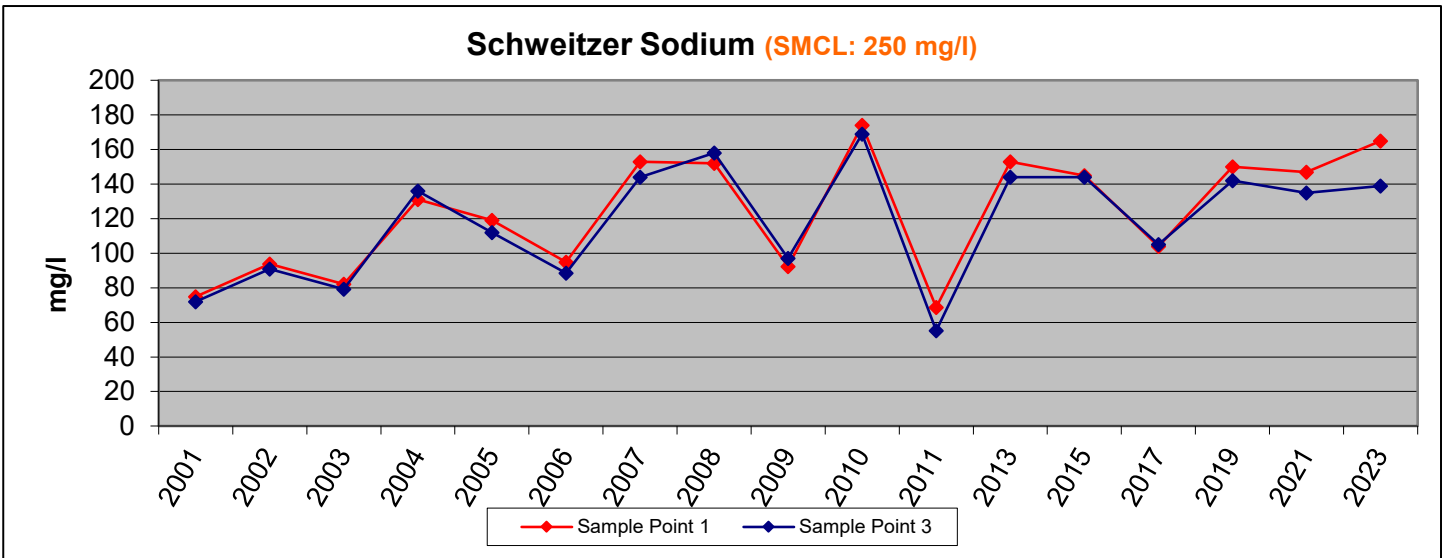
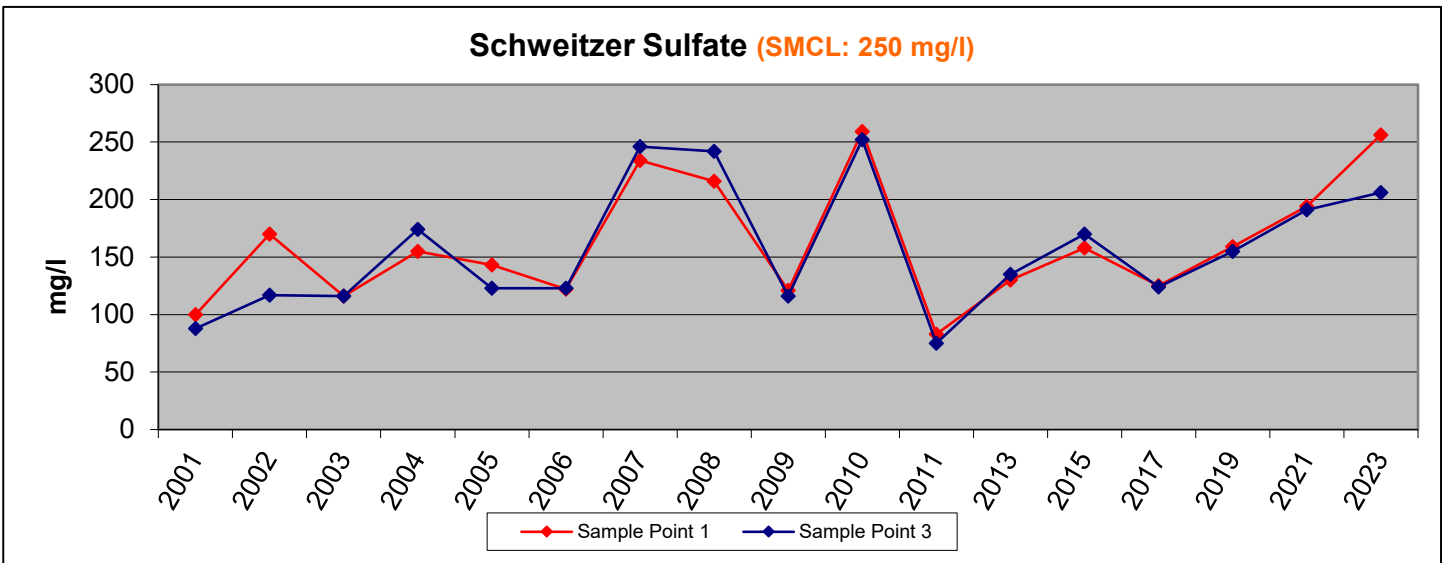
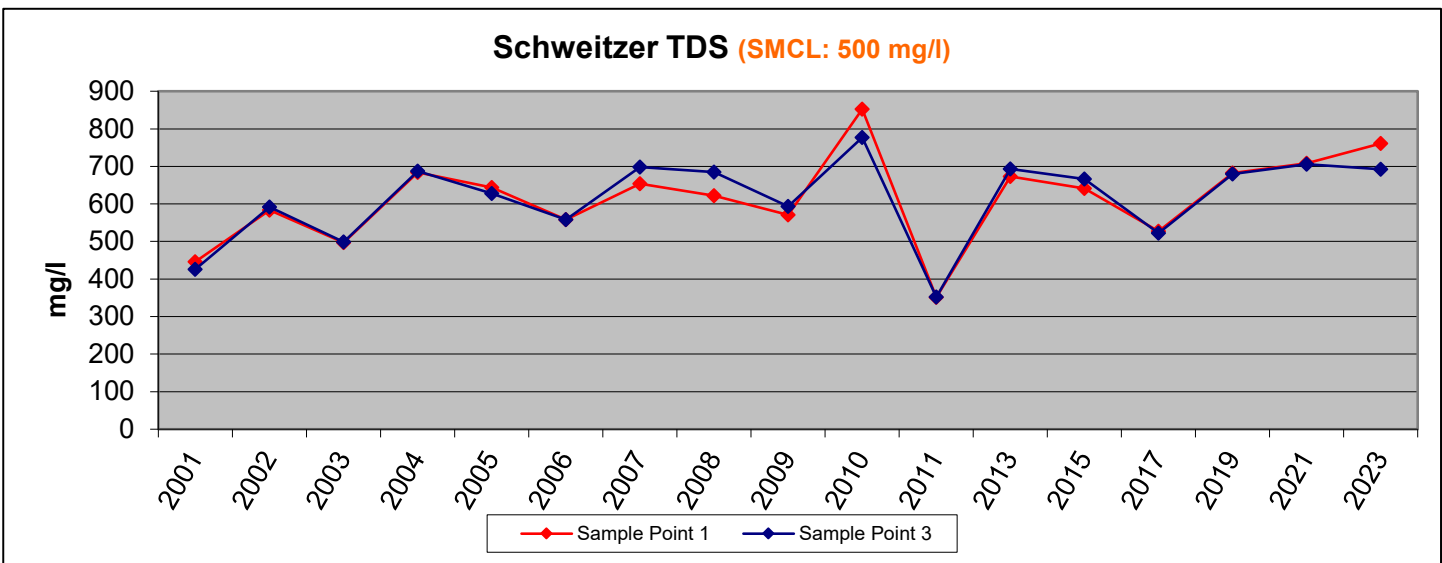
For 2023, TDS again exceeded the SMCL (500 mg/L) in both the upstream and downstream sample. TDS has exceeded the SMCL at both sample locations during the vast majority of sampling events. Manganese concentrations exceeded the SMCL of 0.05 mg/L at both sample locations during 2021 monitoring. In 2023, both sample locations decreased with location 1 (0.066 mg/L) remaining above the SMCL and location 3 (0.047 mg/L) dropping below the SMCL. Iron concentrations were below the SMCL of 0.3 mg/L at both sampling locations in 2023. Prior to this iron concentrations had exceeded the SMCL at both locations during the previous 3 sampling events (2017, 2019, 2021). Sulfate continued the recent 3 sampling event, trend upwards at both locations. The concentration of sulfate at sample point 1 was 256 mg/L which is above the SMCL of 250 mg/L while the concentration at sample point 3 was 206 mg/L. Sodium concentrations increased at both sampling locations and were near historical highs at sample point 1. Both locations remain well below the SMCL of 250 mg/L. Chloride concentrations continued a decreasing trend, at both sampling locations, which has been observed during the last two sampling events. All other parameters were below their respective MCL's, SMCL's, and Action Levels as well as within the ranges historically observed at the site. Surface water chemical data is illustrated for Schweitzer Landfill in the graphs on the subsequent pages.

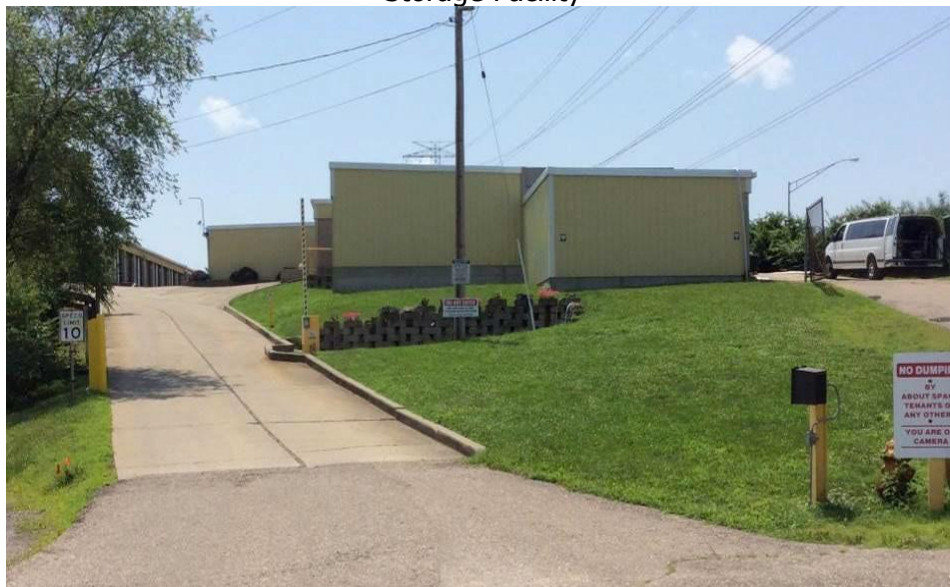
Storage Facility

Today the property has a storage facility on top of the former landfill. Commercial buildings and equipment/material storage areas occupy the eastern portions of the property.

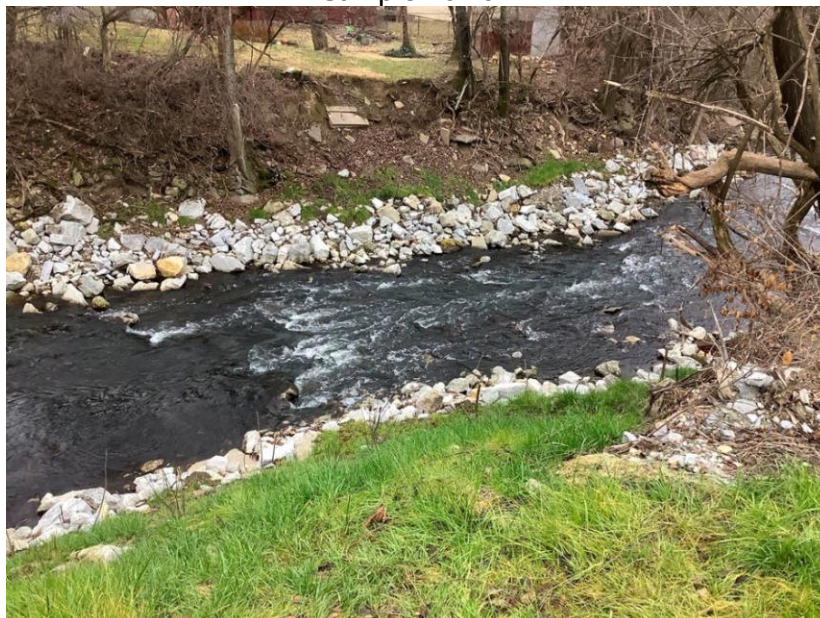
Sample Point 1

The Mill Creek flows along the east and south side of Schweitzer Landfill from north to south. Steep banks border each side of the creek in this area. The creek was sampled above and below the landfill. The sample location (S-1) upstream and north of the landfill is located near the Clark Road Bridge. The sample site is characterized by a rocky bottom. A deep pool is present under the bridge with a rapid/riffle area just to the south. The mid-landfill sample location (S-2) has not been sampled since 2001. S-3 is below the landfill, under and south of Galbraith Road. The southern sample site (S-3) is an area with both shallow, rocky riffle areas and 2-4-foot-deep pools. Access to the shallow riffle areas is occasionally not possible depending on stream conditions (flow volume, depth of pools, etc). Prior to 2023 three lowhead dams existed between sample points 1 and 3. In 2023 the northernmost lowhead dam, near sample point 1, was removed. The other two lowhead dams remain. Samples around Schweitzer Landfill were collected on October 24, 2023 (Appendix A). The samples were collected during average flow conditions. The referenced locations are shown on Figure 3.19.1-D.
