### **3.19.3 ST. BERNARD – Oak Street**

Location: Oak Street, I-75, and Ross Park in St. Bernard, Ohio.

Region: City of St. Bernard

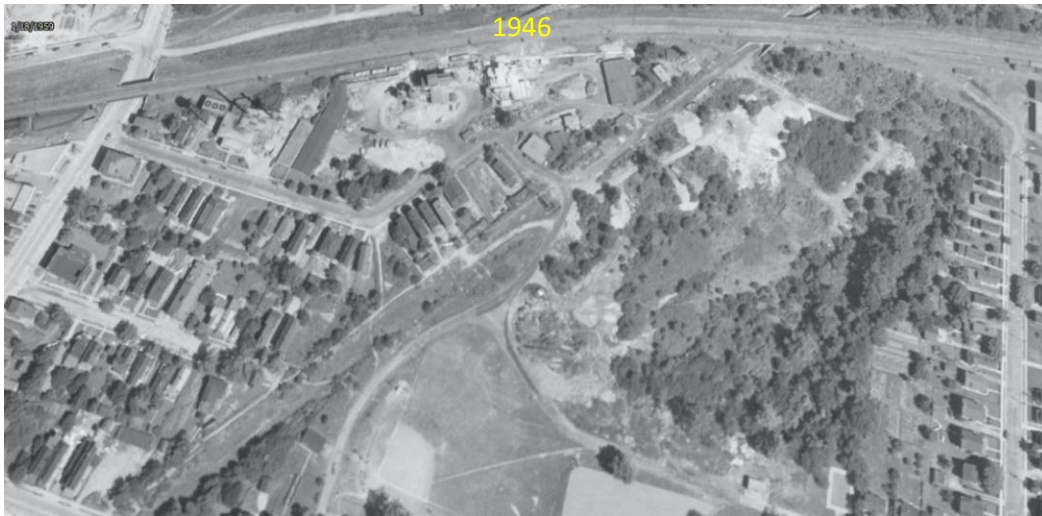
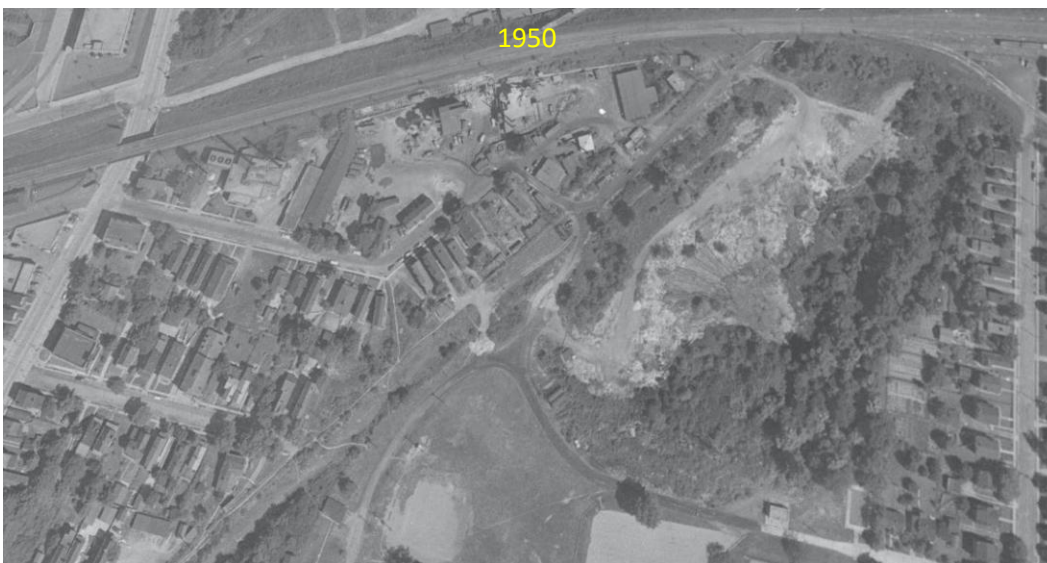
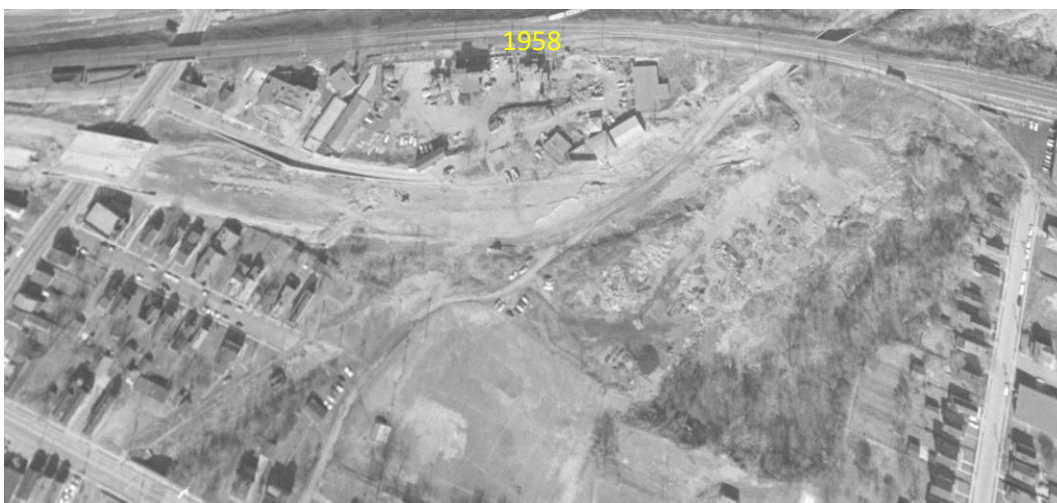
**FIGURE 3.19.3-A**

Review of aerials from the 1930's show buildings already present in areas south of the railroad and north of present day I-75. In aerials from 1946 and 1950 filling in areas that are now occupied by I-75 and the park is

evident. By 1958 filling of these areas continues and construction of I-75 is visible. See Figure 3.19.3-A for aerials from 1946, 1950, and 1958. Filling in these areas continues in 1962, however in 1963 filling in these areas appears to be complete, and the present-day walking path is under construction.

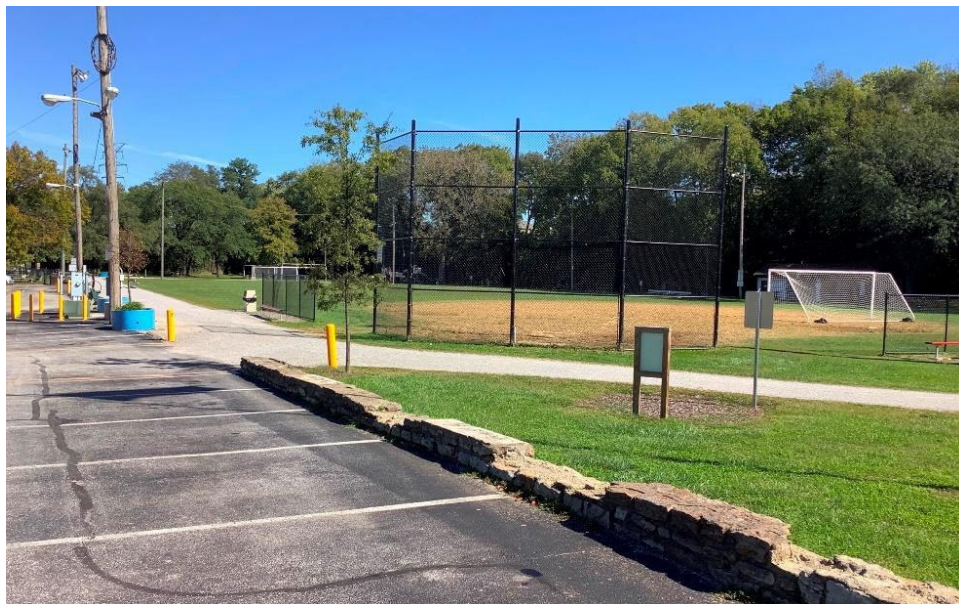
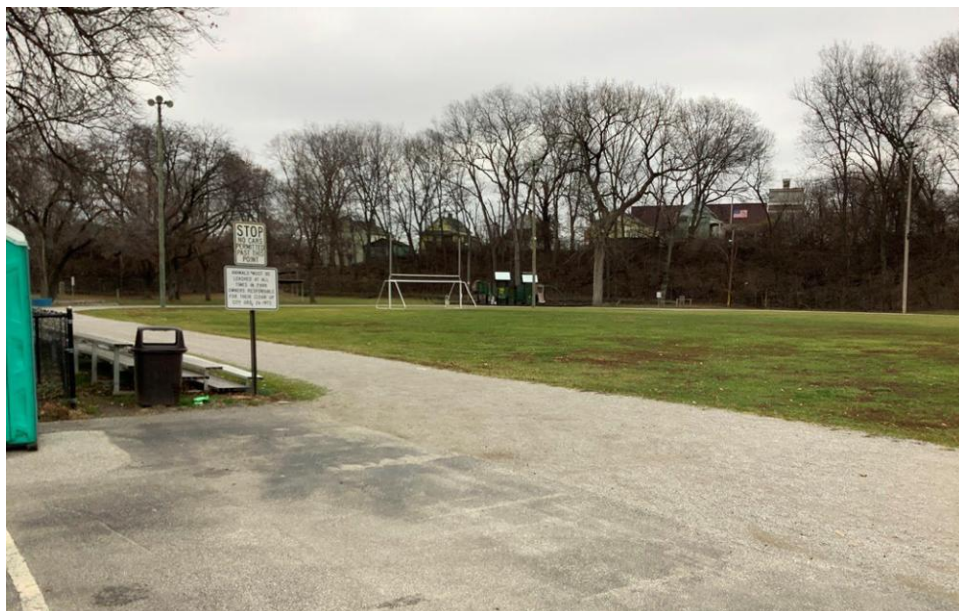
Part of the suspected location of historical filling is now occupied by I-75. The remainder of the suspected areas are now occupied by Ross Park. The park contains a paved parking lot, paved walking path, grass fields, dirt baseball field, and several small buildings.
