### 3.23.4 WYOMING LANDFILL

Facility Name: Wyoming Closed Landfill

Region: Wyoming, OH 45215

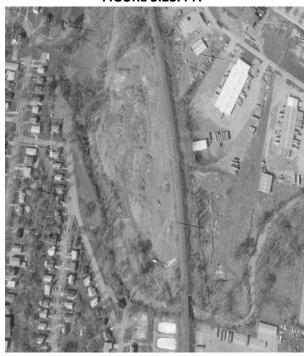
**FIGURE 3.23.4-A**

The City of Wyoming began operating the landfill sometime in the mid-1950's. Based on historic information and discussions with City personnel, the landfill was used to dispose of typical household waste (garbage), yard waste (grass cuttings, branches, leaves, etc.) and some hard fill type material (concrete, rubble, etc.). Lime from the public water treatment plant was also reportedly deposited in the northern portion of the landfill. Figure 3.23.4-A is an aerial from 1973 showing fill activities at the site. Figure 3.23.4-B is an aerial from 1986 after the area was developed as a park.

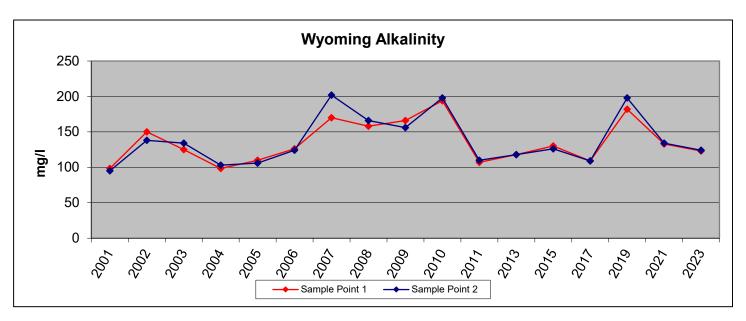
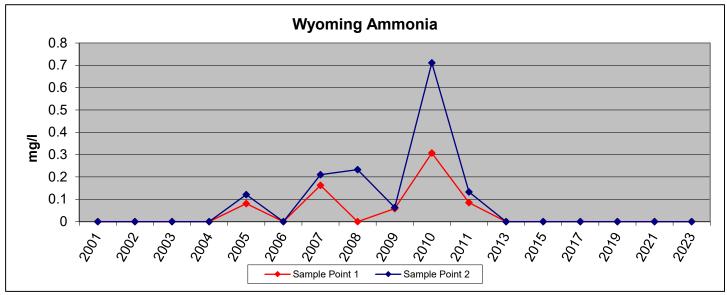
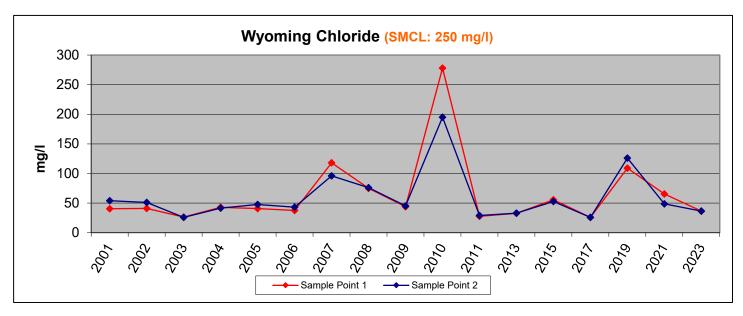
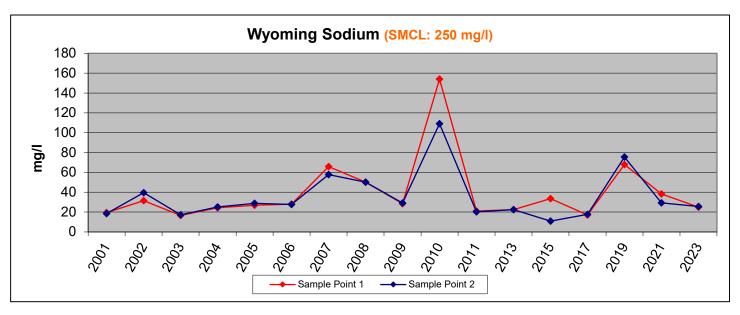
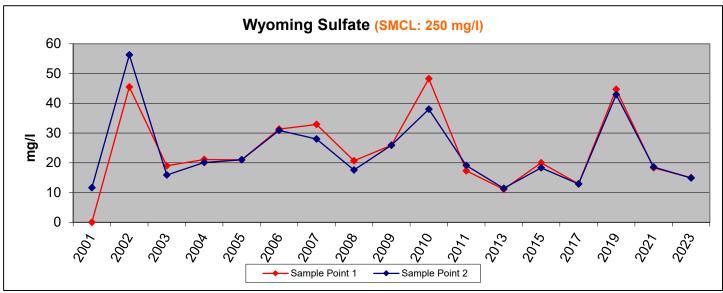
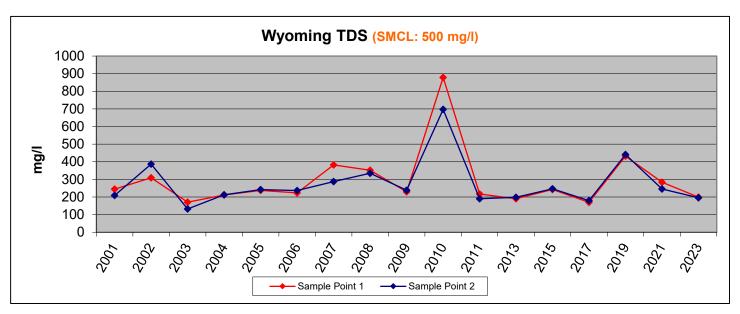
In 2010, alkalinity, chloride, sodium, sulfate, TDS, ammonia, conductivity, and barium all exhibited highest levels since sampling began for both upstream and downstream samples. During subsequent sampling events from 2011 through 2017 concentrations of all the above-mentioned compounds returned to previously observed levels. In 2019 sampling, results again increased to concentrations approaching those observed during 2010. During subsequent sampling events in 2021 and 2023. concentrations have trended downward and generally returned within ranges historically observed. Alkalinity, chloride, sodium, sulfate, sodium, and TDS all showed a decreasing trend when comparing 2019 data to 2021 and 2023 data. Additionally, all remained below their respective SMCL's. Iron exceeded the SMCL of 0.3 mg/L at sampling points 1 (0.326 mg/L) and 2 (0.325 mg/L). Iron has exceeded the SMCL at sample point 1 during each sampling event since it was added as a parameter in 2010. Both sample locations exceeded the SMCL for manganese (0.05 mg/L). Manganese has exceeded the SMCL at each sampling point since it was added as a parameter in 2010. The Health District staff will continue to monitor the water quality in this area for any changes. Surface water chemical data is illustrated for Wyoming Landfill in the graphs below.

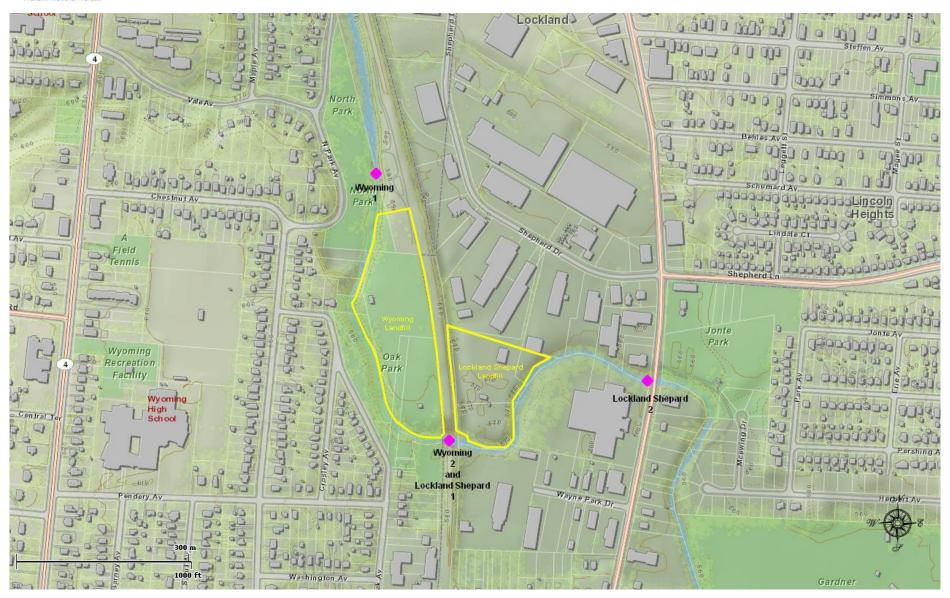
### **Figure 3.23.4-C**

The West Fork of the Mill Creek flows along the west and south side of the Wyoming Landfill. Samples are taken above (S-1) and below (S-2) the landfill. Samples around Wyoming Landfill were collected on November 6, 2023 (Appendix A). The samples were collected during above average flow. The S-1 sample location consisted of a series of pools and gravelly/rocky riffles located adjacent to the landfill. The Wyoming S-2 sample location is the same as the Lockland Shepherd Lane (S-1) sample location consisting of pools with a gravel/rocky bottom. The referenced locations are shown on Figure 3.23.4-C.

# **Wyoming Closed Landfill**

= Surface Water Sampling Location

= Approximate Limits of Waste

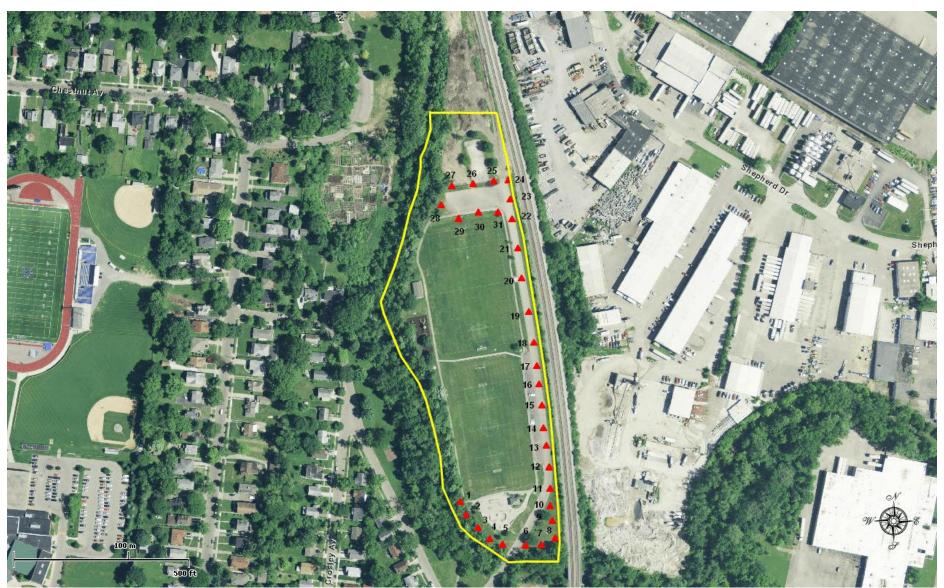
# **Figure 3.23.4-D**

The Wyoming Closed Landfill was monitored by HCPH for explosive gas on December 22, 2023 (Table 3.23.4-B). Monitoring took place along the southern and eastern perimeter of the property (Figure 3.23.4-D). Methane has been detected along the eastern boundary and around the northern parking area every year since 2007. However, in 2022 there was a significant decrease in both the number of detections and the concentrations observed when compared to previous monitoring events. In fact, 2022 monitoring was the first time in 10+ years that no detections of 100% LEL were observed at the site. Monitoring completed in 2023 resulted in 9 locations with methane detected. All locations where methane was detected were low concentrations of <25% LEL except for sample point 28 which had a concentration of 100% LEL. Sampling further out away the suspected location of waste (sample point 28B) resulted in no methane detected. During 2023 monitoring carbon monoxide (CO) was detected at 20 of the sampling locations with concentrations between 2 and 81 ppm. This is similar to CO results for past monitoring events.

Wyoming Fall Gas Sampling

= Approximate Gas Monitoring Location

= Approximate Limits of Waste

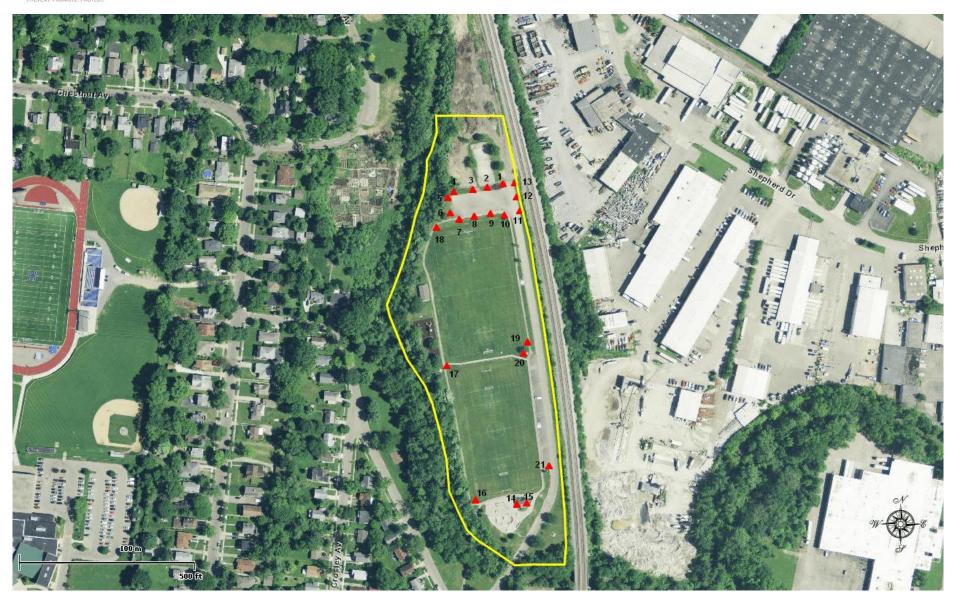
# **Figure 3.23.4-E**

The parking area at the north end of the park is likely located over waste. Punch bar sampling in this area has consistently indicated methane production and detection of carbon monoxide gas subsurface during sampling. Since 2006, WM staff have conducted additional sampling around the parking area at the north end of the park prior to the City of Wyoming using this area for fireworks launching in July. Samples denoted with an "S" were taken using a 1 liter bottle placed over an area of ground (7 sq.in.). Pressure is applied to the bottle to form a semi-tight seal. A hole in the bottle allowed the sampling probe to draw from inside the bottle for 1 minute, and the measurement is recorded. The results of the sampling are provided to the City of Wyoming prior to the event. The 2023 fireworks sampling locations are shown in Figure 3.23.4-E. The results of the June 2023 sampling are in Table 3.23.4-C. (Sampling data for this landfill is in the files at Hamilton County Public Health).

# **Wyoming Fireworks Gas Sampling**

= Approximate Gas **Monitoring Location**

= Approximate Limits of Waste
