3.3.2 CARMICAL LANDFILL

Facility Name: Carmical Landfill

Location: 5451 East Miami River Road.
Situated north of East Miami River Road, approximately 0.5-mile west of the Gum Run Road intersection.

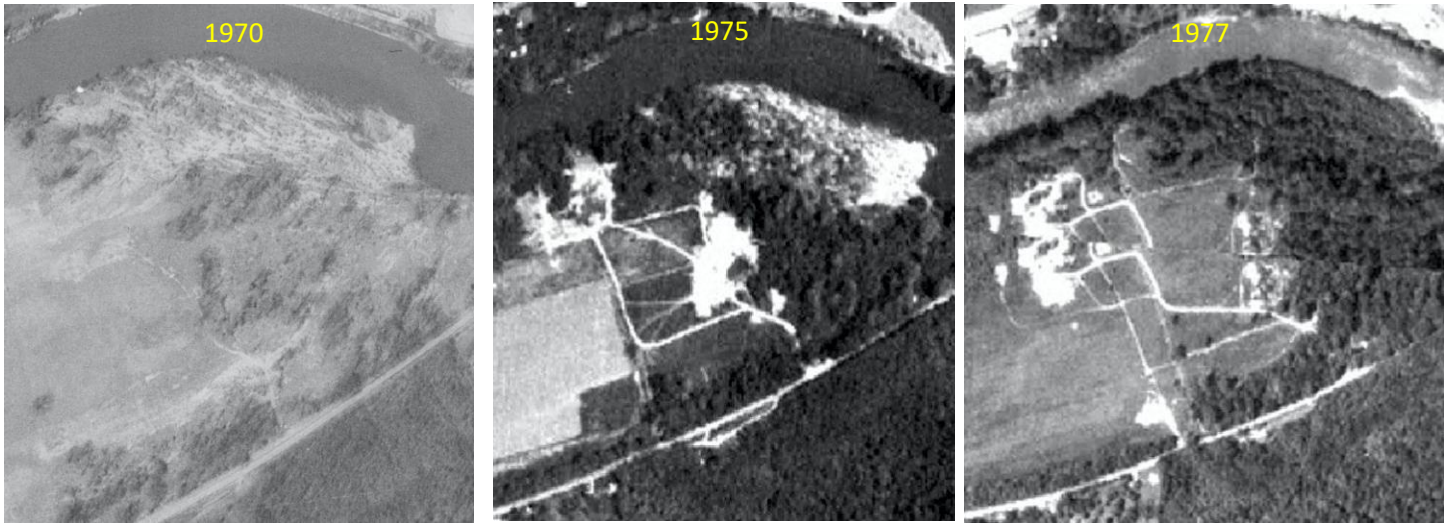
FIGURE 3.3.2-A

Based on records obtained from the Hamilton County Auditor website, the property was purchased by a sand and gravel company in 1975. Mining of the property likely occurred after the property changed hands and the aerials in figure 3.3.2-A support this. The figure shows aerial photographs from 1970 to 1977. It does not appear as though filling or mining activities are occurring in the 1970 photograph. Activities are occurring on the central and northwest portions of the property in the 1975 and 1977 photographs. This suggests that filling began

sometime between 1970 and 1975. Based on records, filling of the gravel pit likely occurred both during the operation of the gravel pit and after.

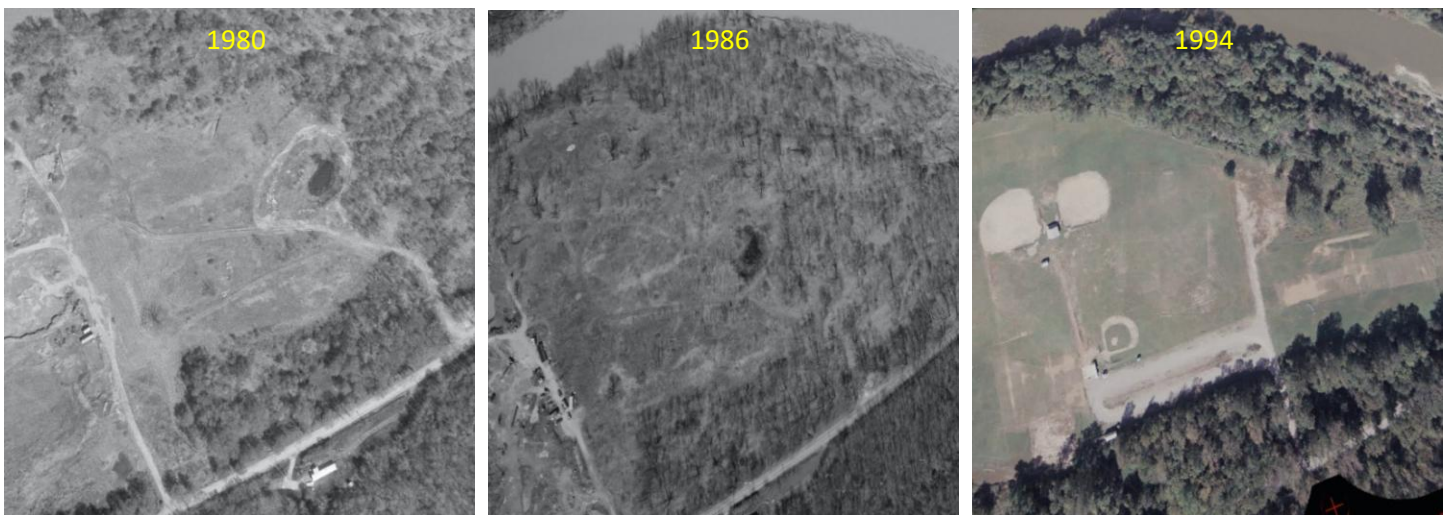
FIGURE 3.3.2-B

Two additional letters indicating guidelines that the landfill could only accept construction and demolition debris were sent by Hamilton County on February 12, 1992 and May 19, 1992. No closure records of the landfill are available. Figure 3.3.2-B shows aerials from 1980, 1986, and 1994. It appears as though filling is occurring on the property in both 1980 and 1986.

In the 1994 aerial it appears as though filling has ceased and the property has been converted to athletic fields. Until 2011, the property had been used by the Monfort Heights Athletic Association as recreational baseball and soccer fields with gravel parking areas and a gazebo. In 2011, the recreational ball fields and gravel parking areas were removed, and the property is now vacant green space owned by the Hamilton County Park District.

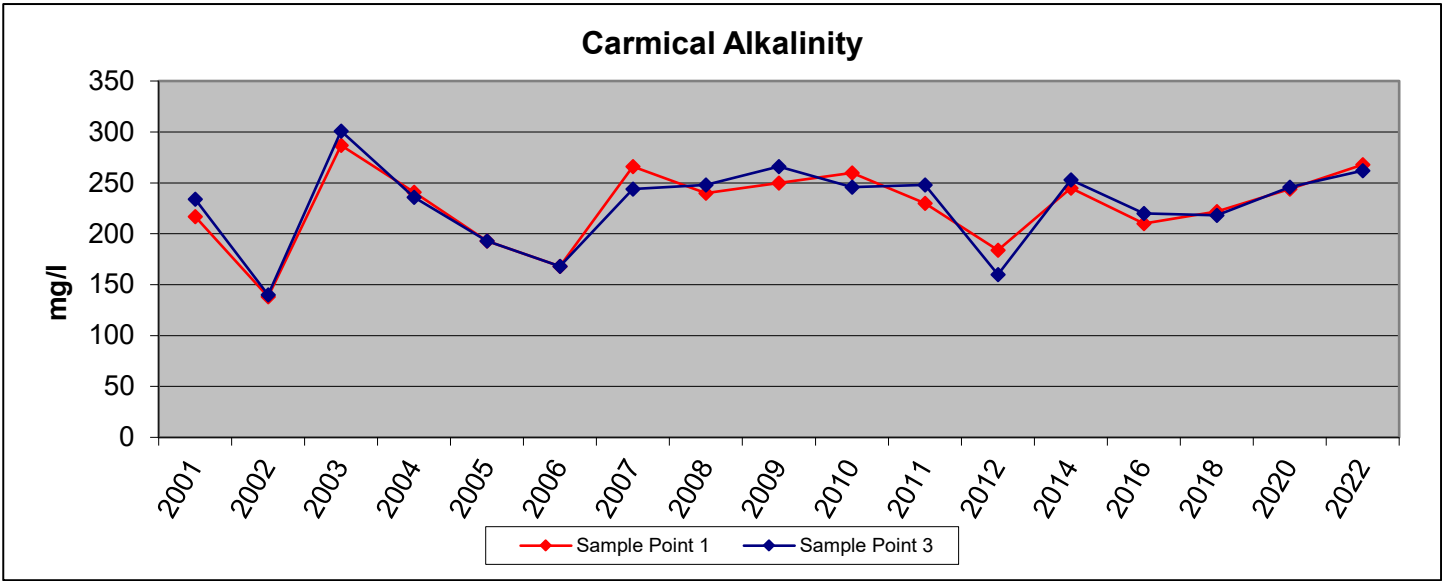
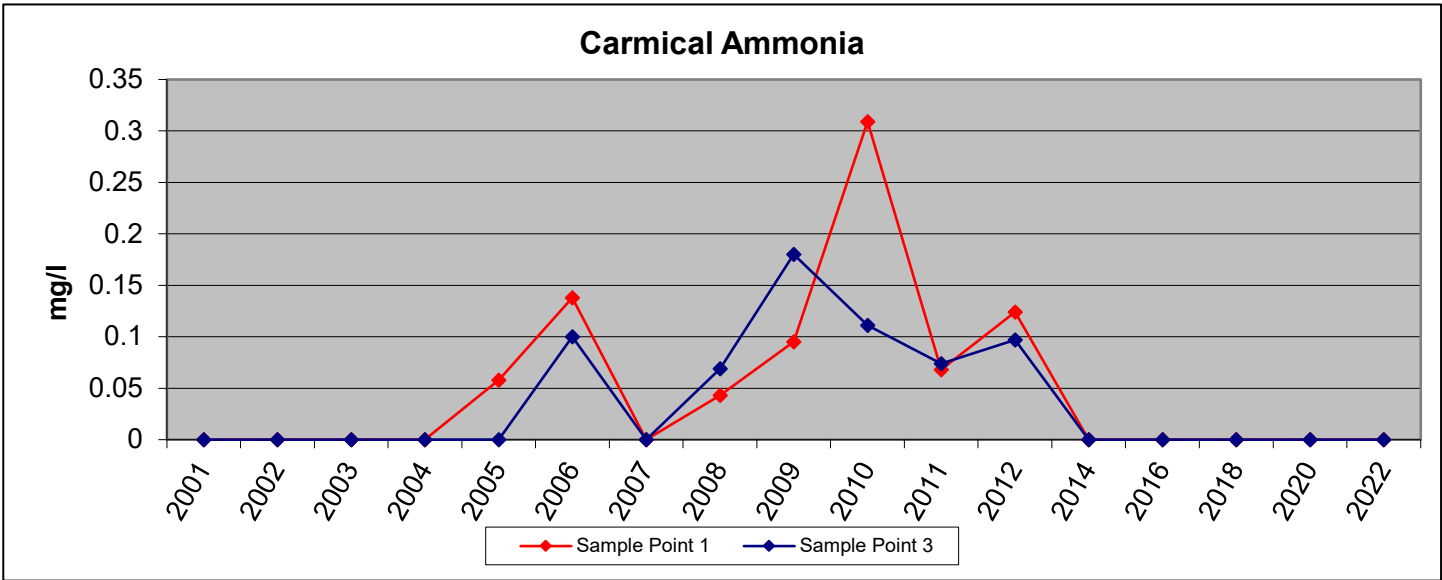
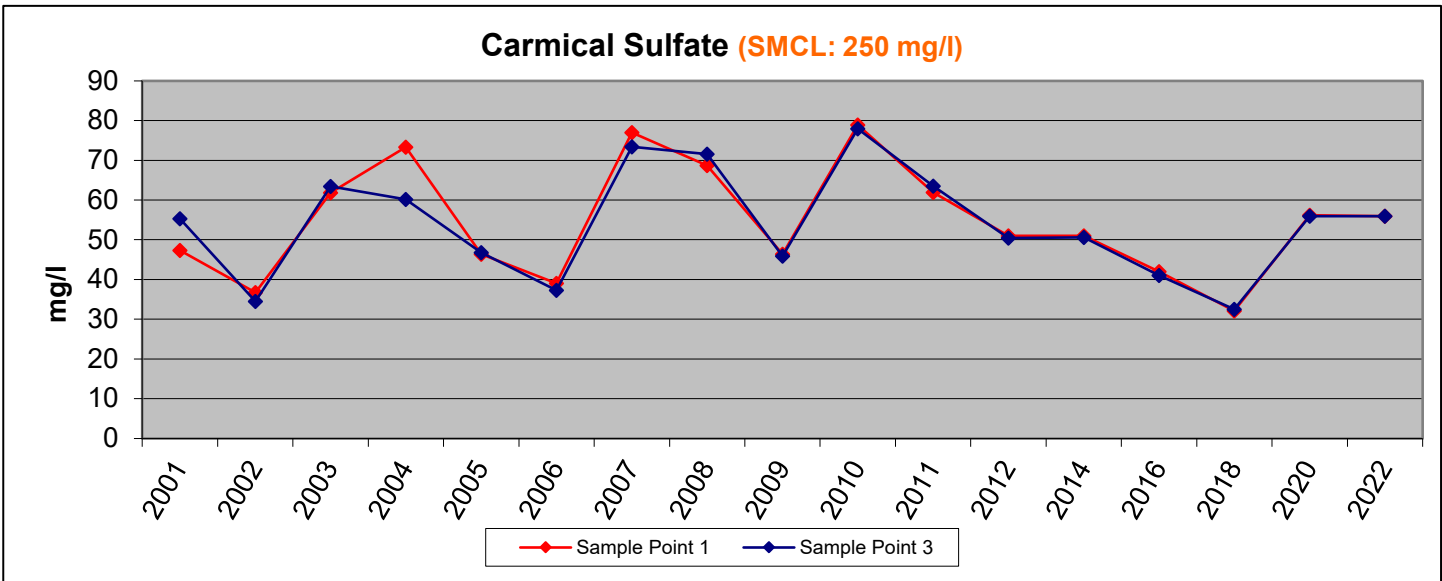
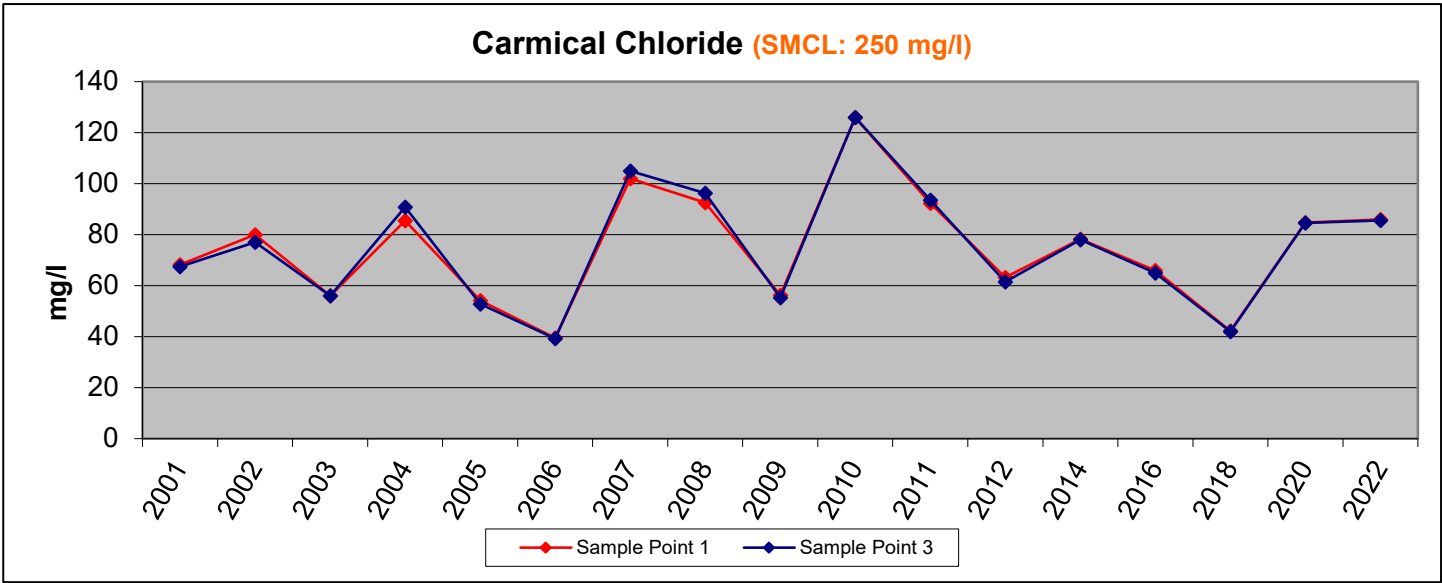
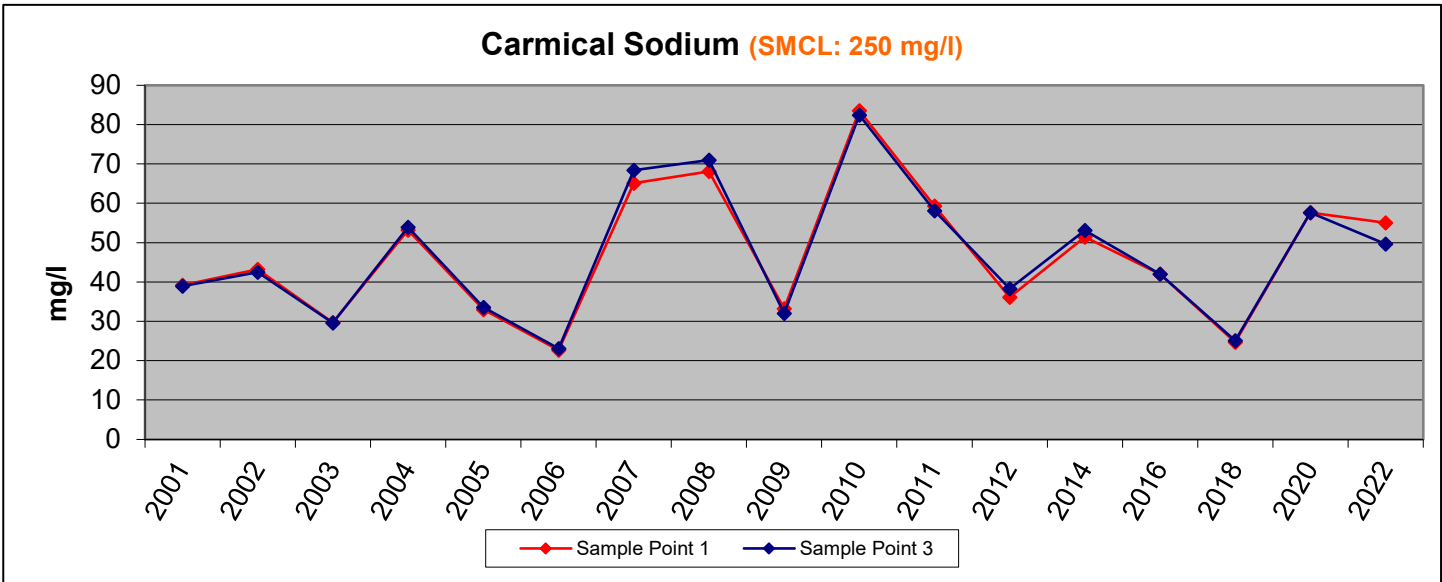
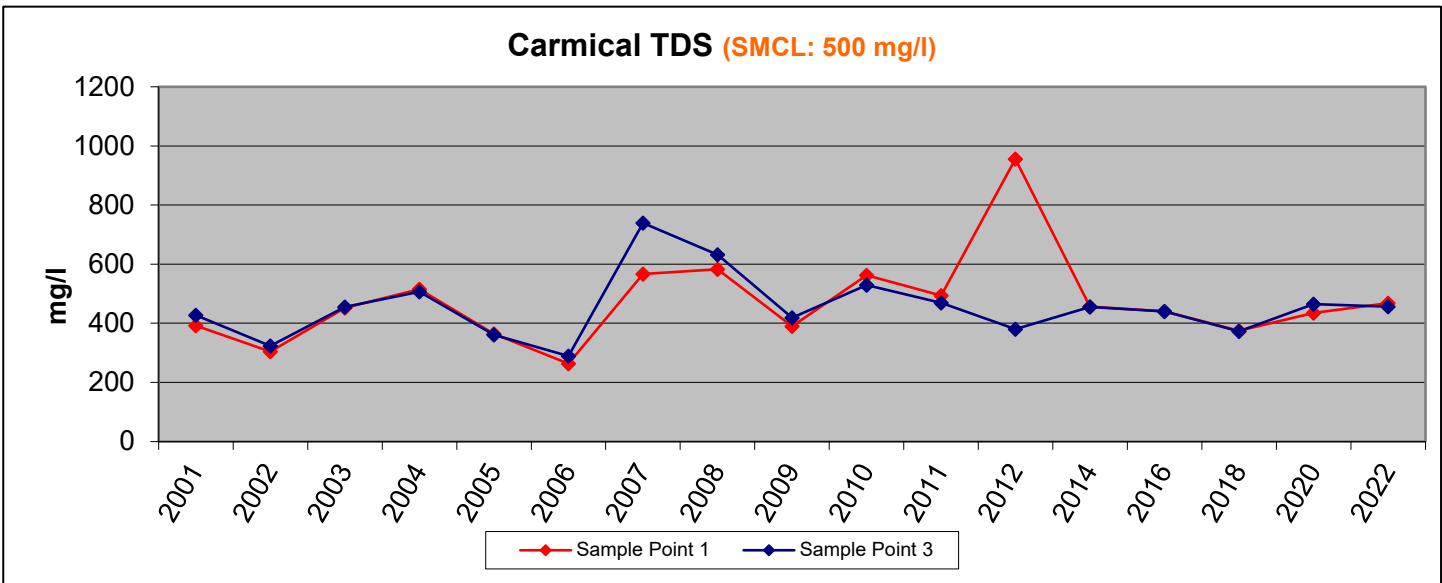
Except for a decrease observed at both sampling locations during 2012, alkalinity has been consistent during sampling events over the last 15 years at both the upstream and downstream sample points. However, a slight increasing trend is evident over the last 3 sampling events. Similarly, TDS has been relatively consistent since 2009 outside of an elevated result at the upstream location in 2012. From 2010 to 2018 sulfate, sodium, and chloride had been on a downward trend. During 2020 sampling however, all three increased in concentration and 2022 results were similar. The recent results (2020 & 2022) remain within the historical ranges seen during past sampling events and remain well below the respective SMCLs for sulfate, sodium, and chloride. After historical high concentrations for iron were observed at both sampling locations during 2018 sampling, 2020 concentrations of iron decreased significantly at both sampling locations. This trend continued during 2022 when iron concentrations were below the SMCL of 0.3 mg/L at both sampling points for the first time since monitoring for this parameter began in 2010. The SMCL pH range has occasionally exceeded the upper limit (8.5) during previous sampling events with both S-1 and S-2 consistently near or above the high end of the pH range for SMCL. Recently however, the SMCL pH range has been below the upper limit during the last 4 sampling events. Manganese has been below the SMCL (0.05 mg/L) at both sample locations during the last 4 sampling events including in 2022. All other parameters were below their respective SMCL or MCL in both the upstream and downstream samples. Surface water chemical data is illustrated for Carmical Landfill in the graphs on the subsequent pages.

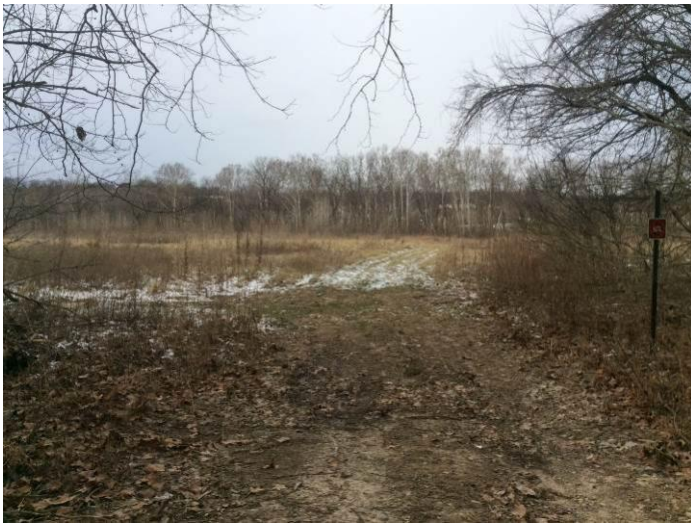
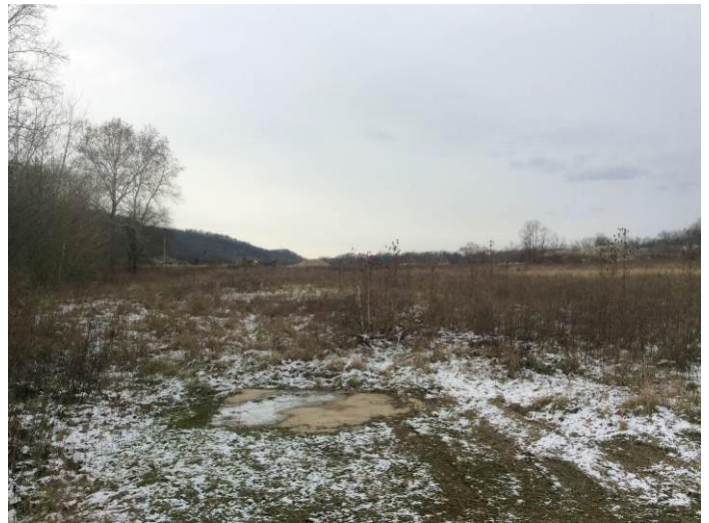
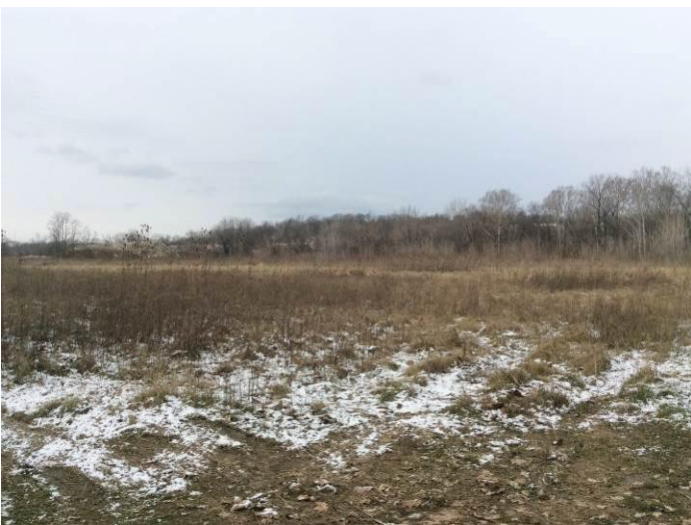
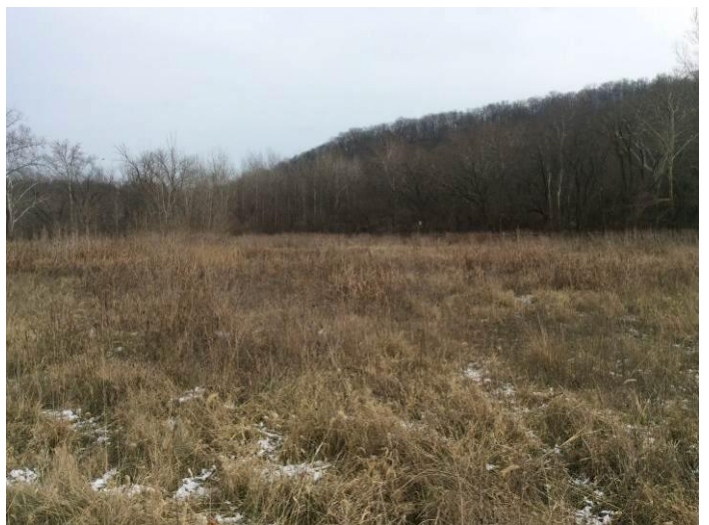
Figure 3.3.2-C
Carmical Closed Landfill
East Miami River Road

The Great Miami River runs along the north side of the Carmical Landfill. Samples are taken above and below the landfill. Historically, stream samples have been taken above (S-1), next to (S-2), and below (S-3) the landfill (Appendix A). Given the steady findings of S-2 and that both upstream and downstream samples are collected around Carmical landfill, sample site S-2 was removed from the sampling protocol in 2007. Samples around Carmical Landfill were collected on October 19, 2022. The upstream sample was in shallow (1'), gravelly, rocky riffle area of the river. The shallow area had rapid flow across the rocks. The downstream sample was taken in a pool about 2 to 3 feet deep with a rocky, silty bottom. Both locations had low flow at the time of sampling. It was noted during the 2010 and 2011 sampling that the riverbank had been significantly reshaped by the owner for recreational use since the 2009 sampling. The referenced locations are shown on Figure 3.3.2-C.

The Great Miami River borders the Carmical Closed Landfill (Figure 3.3.2-C) to the north and east. The adjacent property to the west has a gravel pit pond along much of the west boundary of the landfill. A drainage ditch runs along the southern edge of the landfill. No gas monitoring is conducted at this location.

Today the site is open space owned by the Hamilton County Park District. The topography of the former landfill is primarily flat, with gentle south/southwest to north/northeast slope. The site is completely covered by grass and weeds with trees around the perimeter of the former landfill. A locked gate blocks vehicle entry to the area. The property is bordered to the north and east by the Great Miami River. The property is bordered to the south by East Miami River Road. A former gravel pit (currently being filled) is located west of the landfill. The former Miamitown C&DD landfill (3.13.2) is located west on the north bank of the Great Miami River as shown in Figure 3.3.2-C.

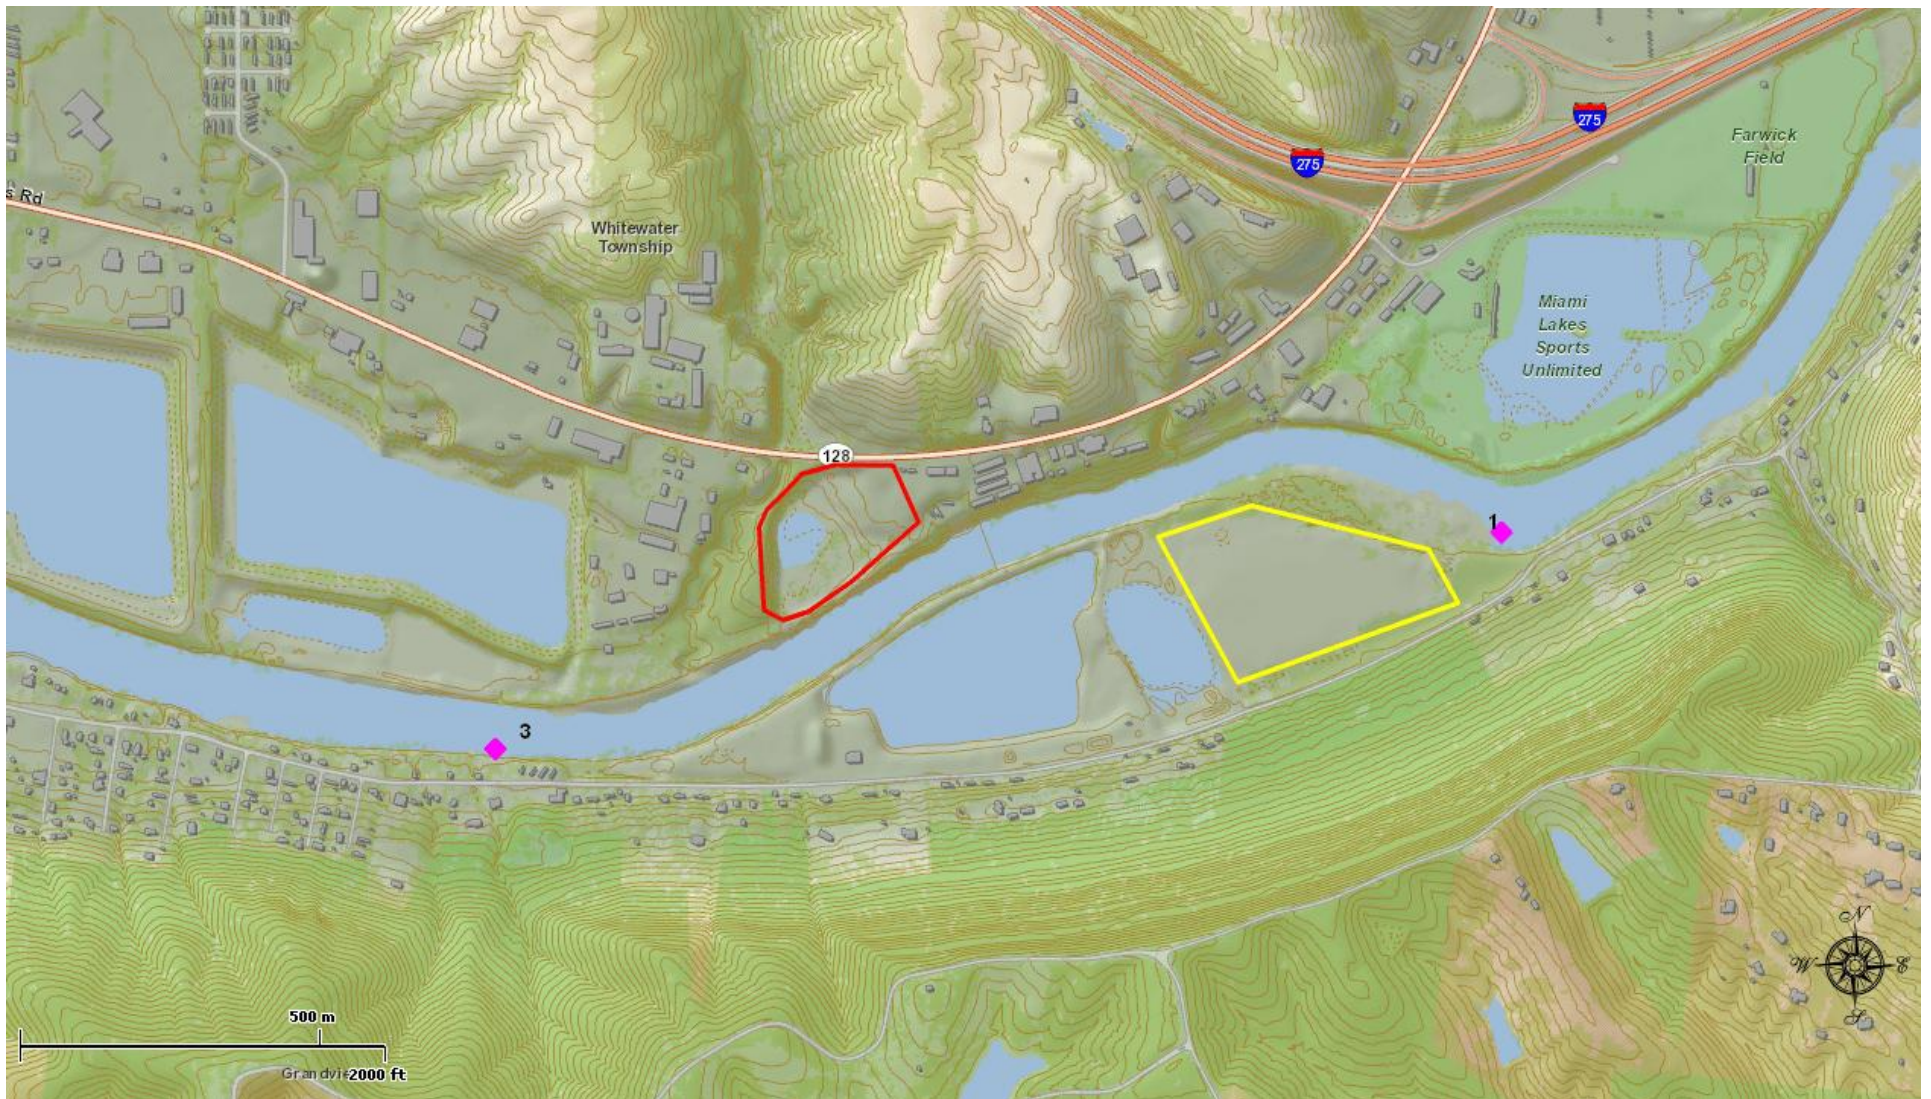
- ◆ = Surface Water Sampling Location
- = Approximate Limits of waste (Carmical)
- = Approximate Limits of waste (Miamitown)
