### **3.3.5 CINCINNATI MILACRON LANDFILL**

Facility Name: Cincinnati Milicron  
A.K.A.: N/A  
Location: Northwest of the intersection between Highland Avenue and Ridge Road  
Parcel(s): 52002700011, 52002700089, 52002700076, 52002700054  
Lat/Long: 39.169625 -84.428920  
Region: Columbia Township  
Owner: Ridgewater Commerce LLC, Cole Lo Cincinnati [Ridge] OH LLC, Wesley Community Services Organization  
Operation (yrs): Pre 1956 – 1970's

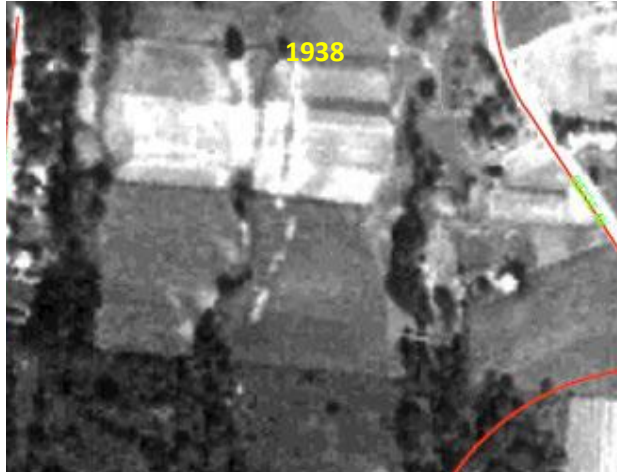
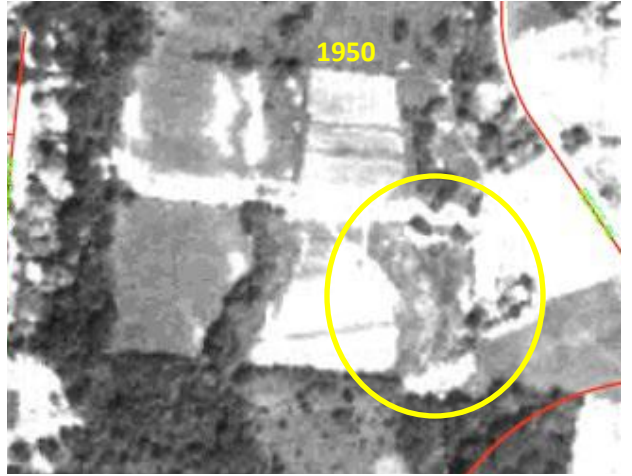
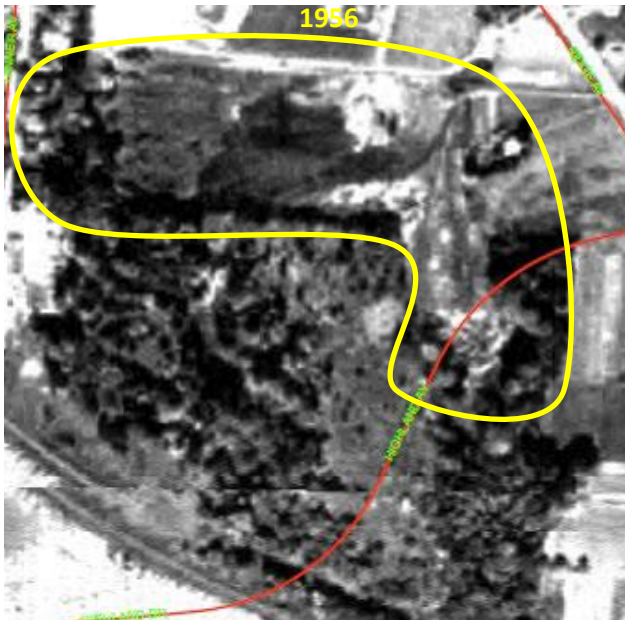
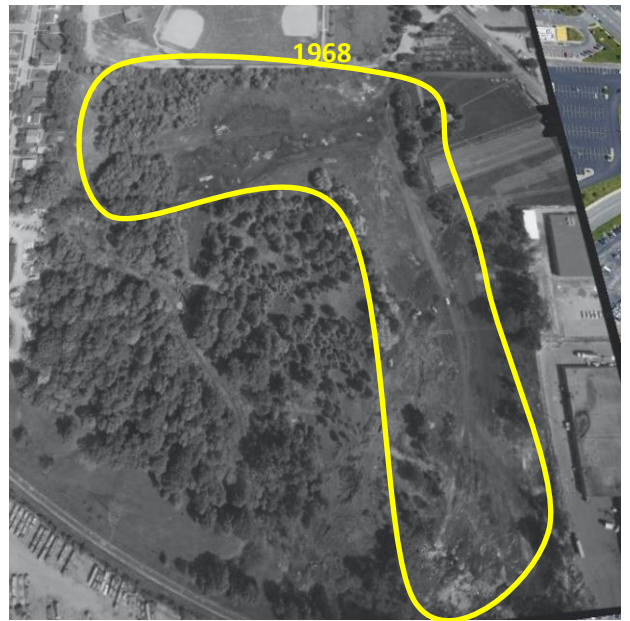
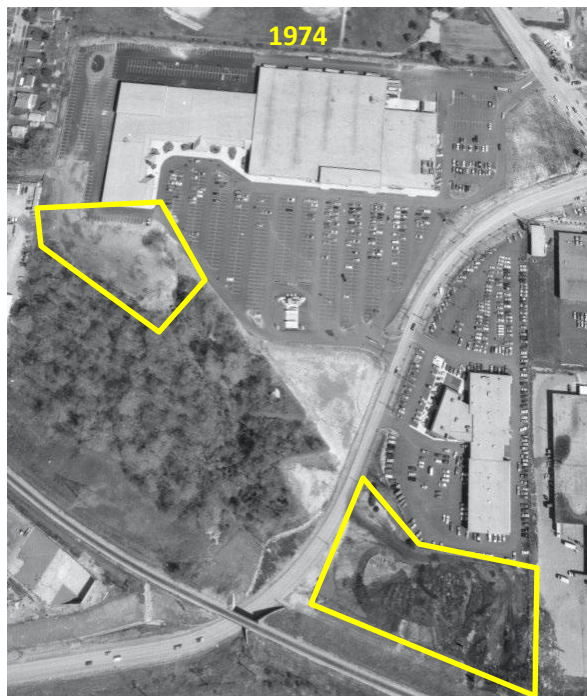
FIGURE 3.3.5-A

There is no documentation as to when the landfill began operation. However, you can see in the following aerials (Figure 3.3.5-A) that the area was undisturbed in 1938 and a small area is disturbed in the eastern ravine by 1950. Unfortunately, the picture is not clear enough to see if filling is occurring. By 1956 you can clearly see the dark fill being placed on the property south of the baseball fields. In 1968 filling continues south of the baseball fields and filling is also occurring along the eastern edge of the area. By 1974 buildings have been constructed in the former fill areas, Highland Ave has been constructed in its present-day location, and filling is confined to two smaller areas.

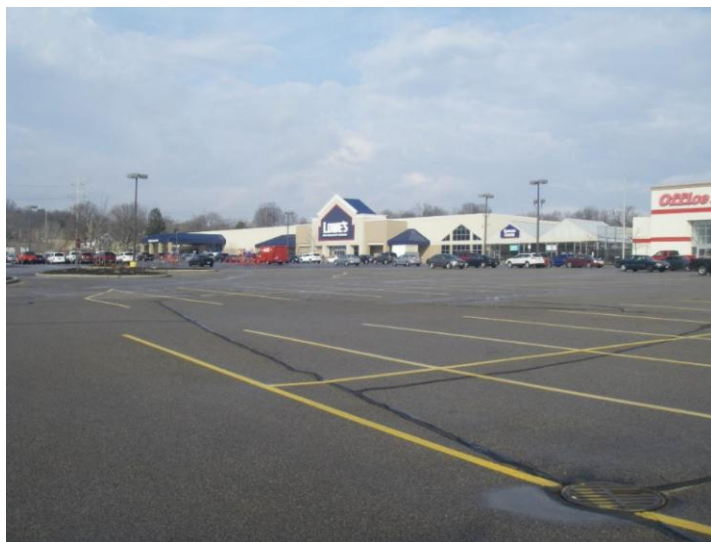
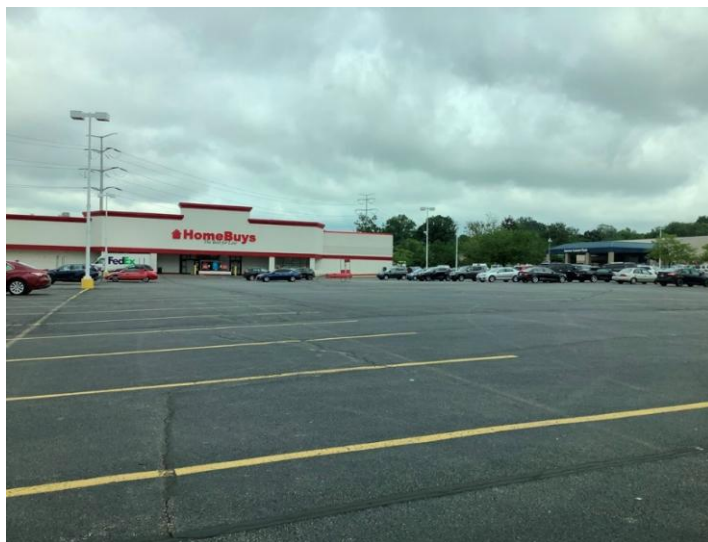
The site was inspected by HCPH on December 28, 2022. The inspector noted that the site is completely developed and no violations or nuisance conditions were observed on the site.

The site is mostly paved to provide parking for a strip mall, Lowes, and other stores/businesses.
