3.5.3 EVANS LANDFILL

Facility Name: Evans
A.K.A.: N/A
Location: 4229 Round Bottom Road
Parcel(s): 50001700016
Lat, Long: 39.144653 -84.331813
Region: Anderson Township, OH
Owner: BEE Holdings Limited Partnership
Operation (yrs): unknown

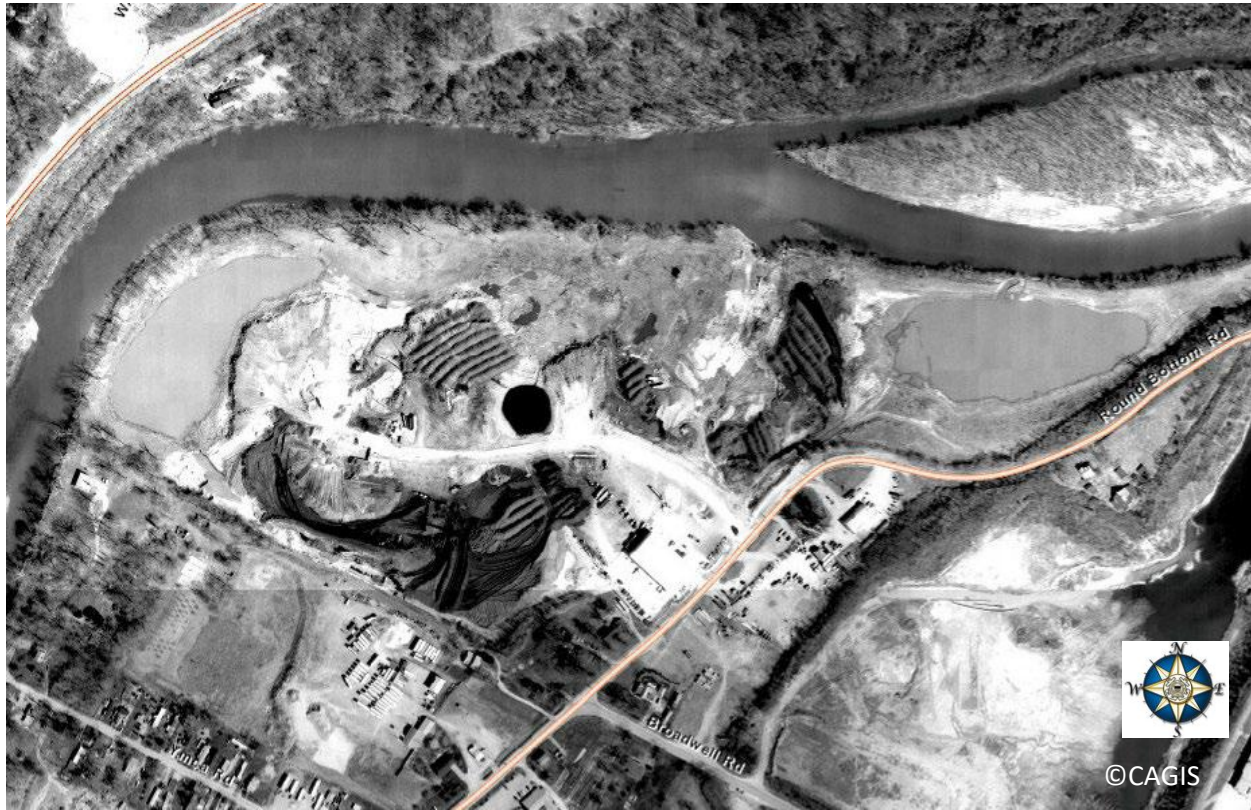
FIGURE 3.5.3-A

Holdings Limited Partnership, which Mr. Evans is a partner of. This location is currently used for the operation of Evans Landscaping and includes a class IV composting facility registered with the Ohio EPA. The 1996 aerial below (Figure 3.5.3-A) shows the suspected landfill area while in operation as a gravel pit and landscaping business:

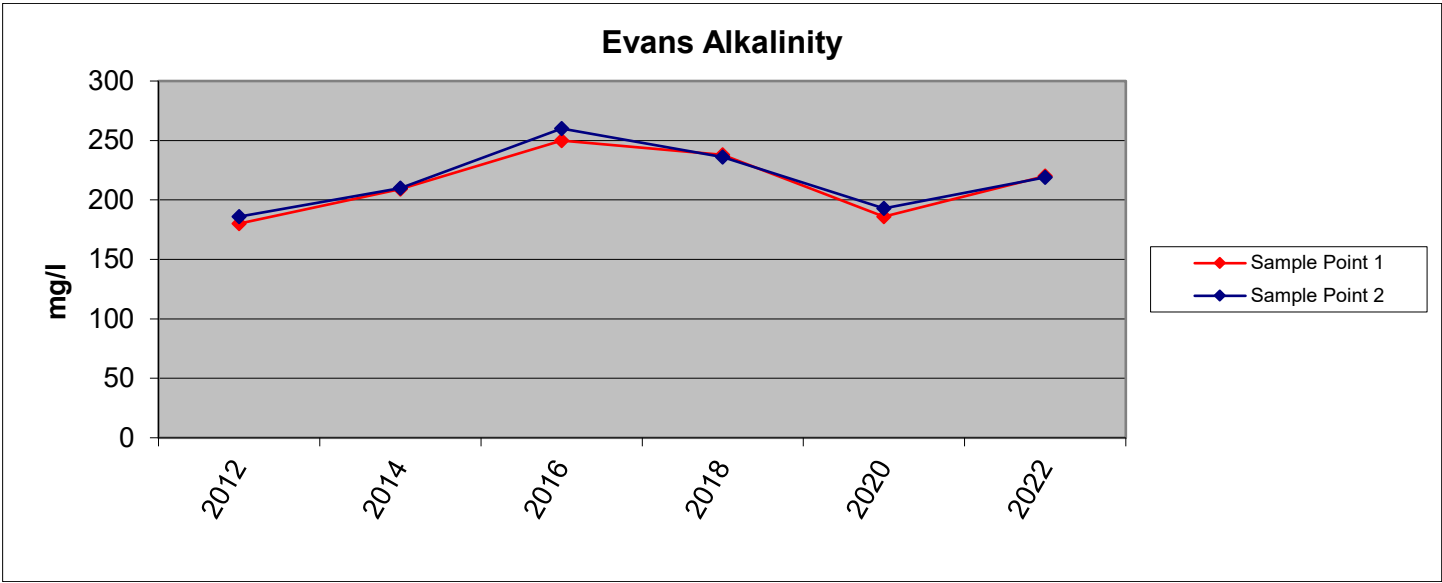
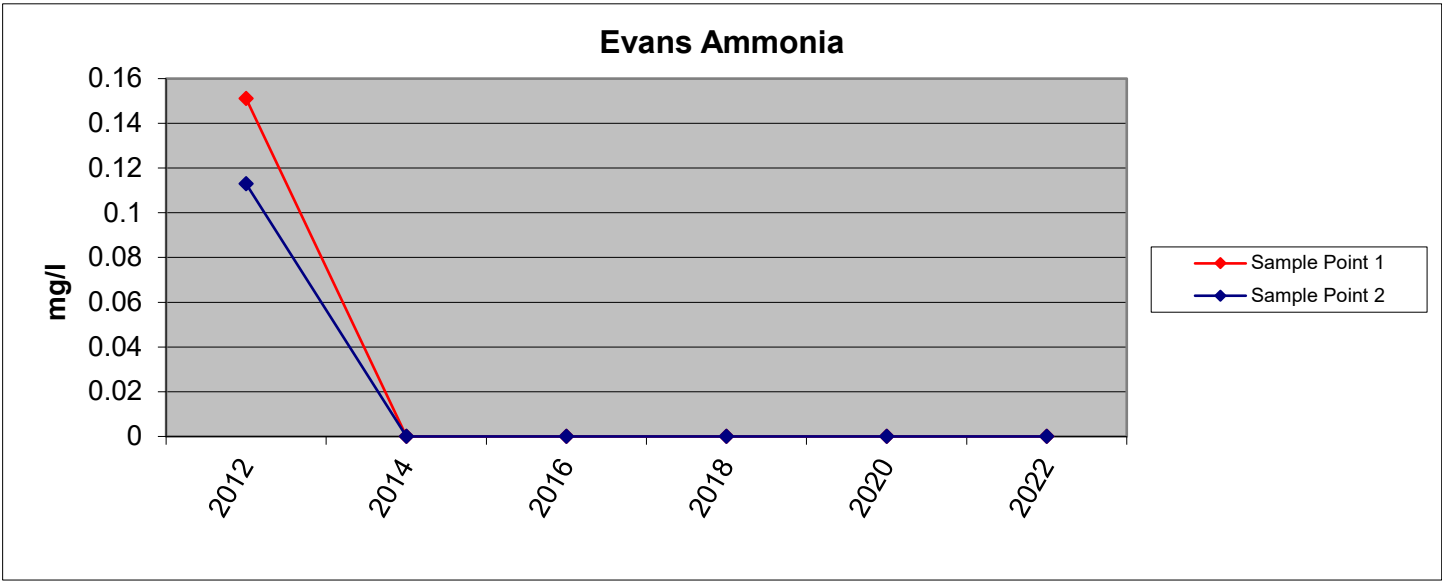
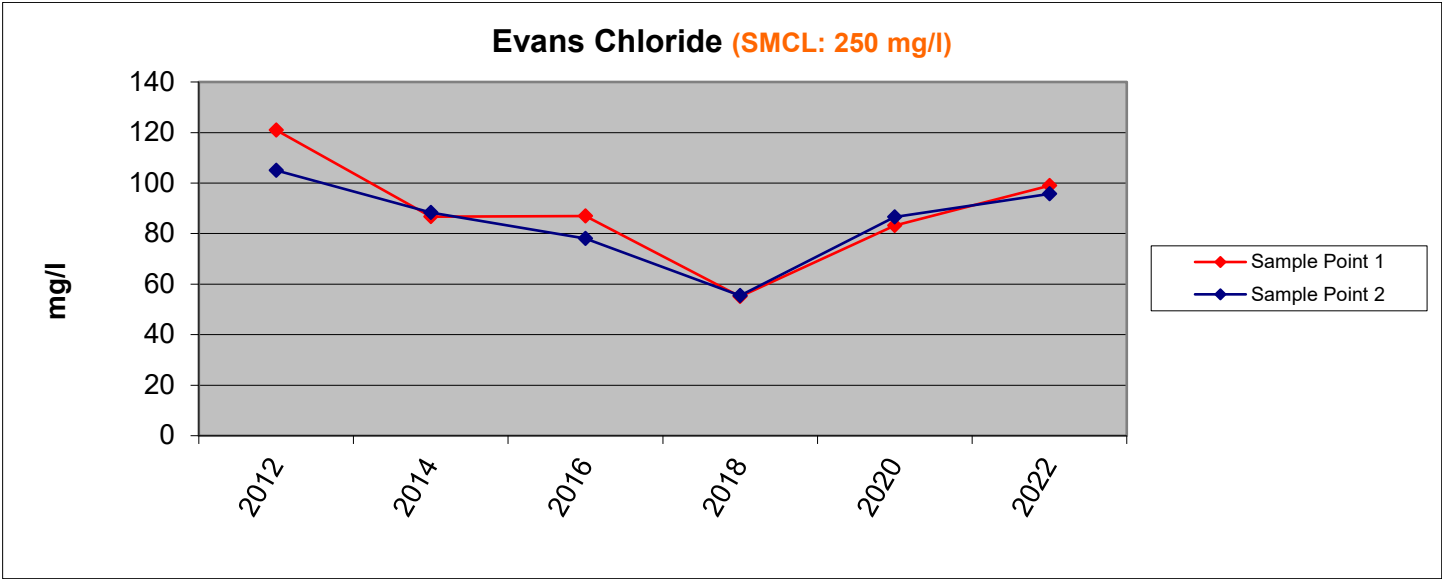
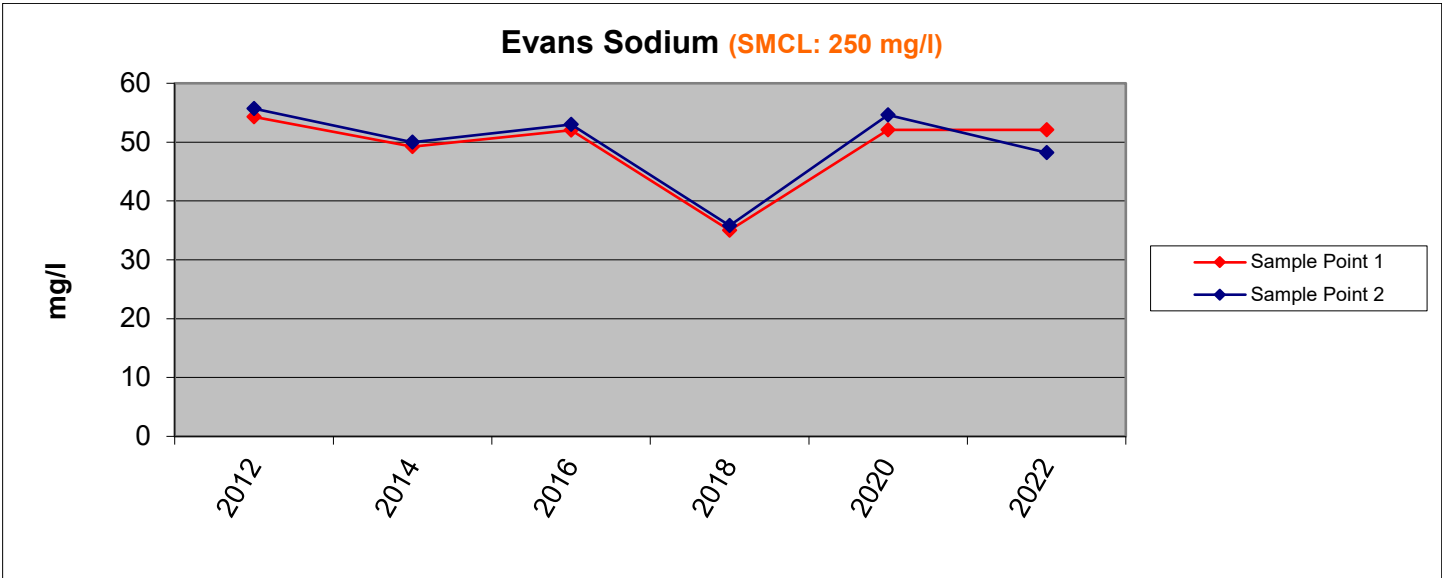
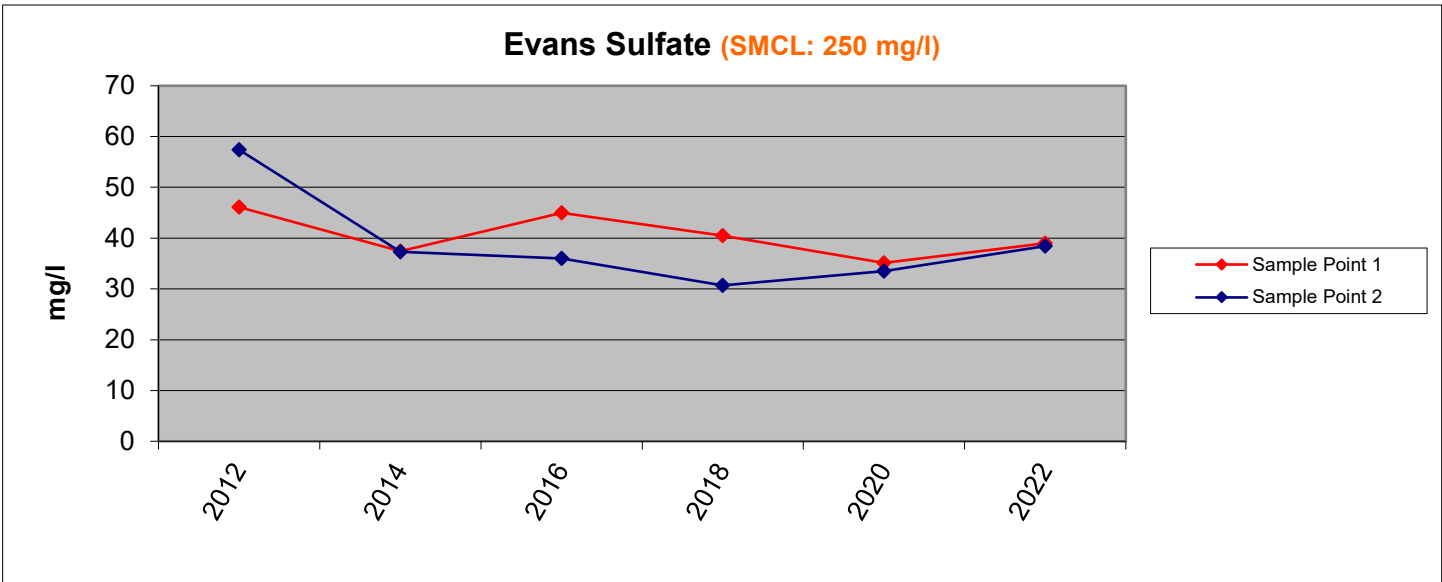
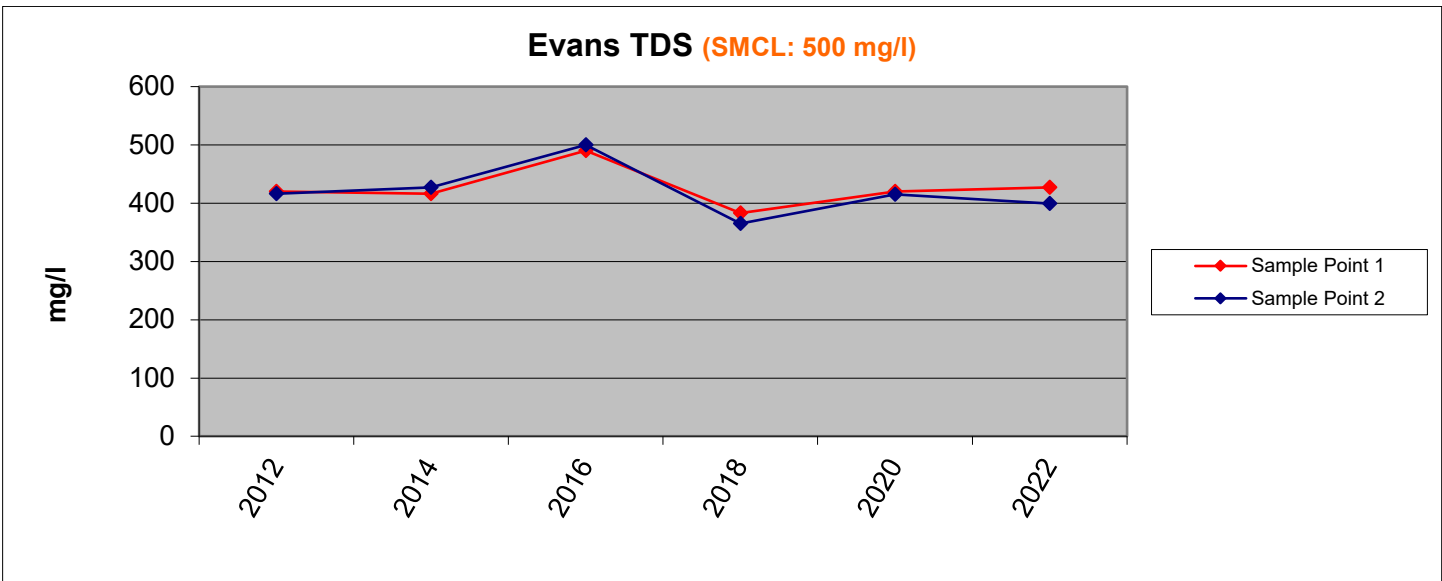
The two sampling locations have been monitored six times since initial sampling was completed in 2012. Alkalinity has been relatively consistent with upstream and downstream concentrations between 180 and 260 mg/L during all sampling events. Similarly, ammonia has been less than 0.2 mg/L at both sample points during each sampling. Chloride, sodium, and sulfate have been well below their respective SMCL's consistently over the six sampling events. TDS equaled the SMCL of 500 mg/L at sample point 2 during sampling in 2016. Concentrations during the three subsequent sampling events have been between 365 and 427 mg/L at both sampling locations. 2022 Iron concentrations were below the SMCL of 0.3 mg/L at both sampling locations after exceeding the SMCL at both locations during 2020 sampling. Manganese concentrations dropped back below the SMCL of 0.05 mg/L at both S-1 (0.0325 mg/L) and S-2 (0.0436 mg/L) after exceeding the SMCL at both locations in 2020. All other parameters sampled for in 2022 were below their respective Maximum Contaminant level (MCL) or Secondary Maximum Contaminant Level (SMCL). No significant differences were observed between the upstream and downstream water quality. Data is illustrated for Evans Landfill in the graphs on the subsequent pages.

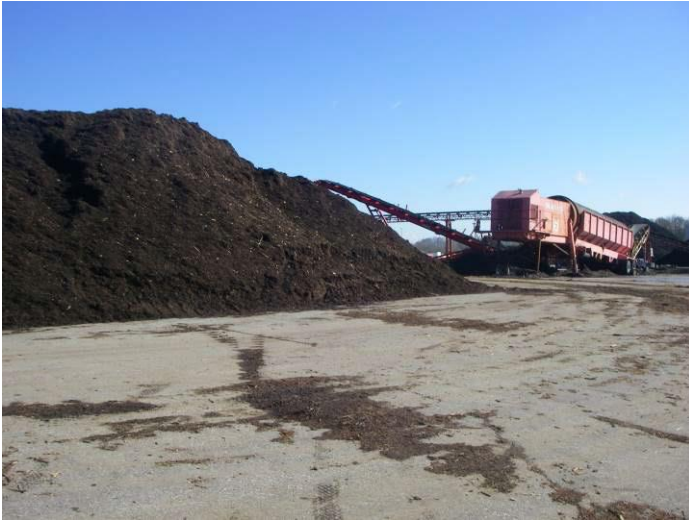
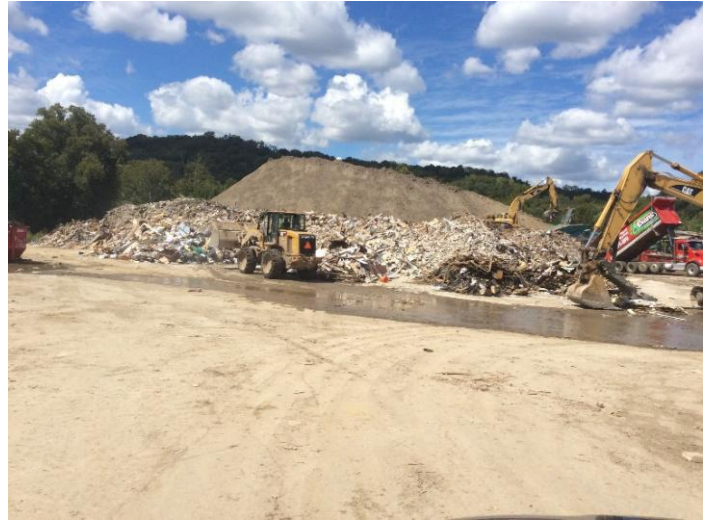
The site is currently used by Evans landscaping to store bulk materials. The former landfill area is now paved and used for storage and processing of the facility's mulch, compost, and recycling operations. The site is regularly inspected by HCPH.

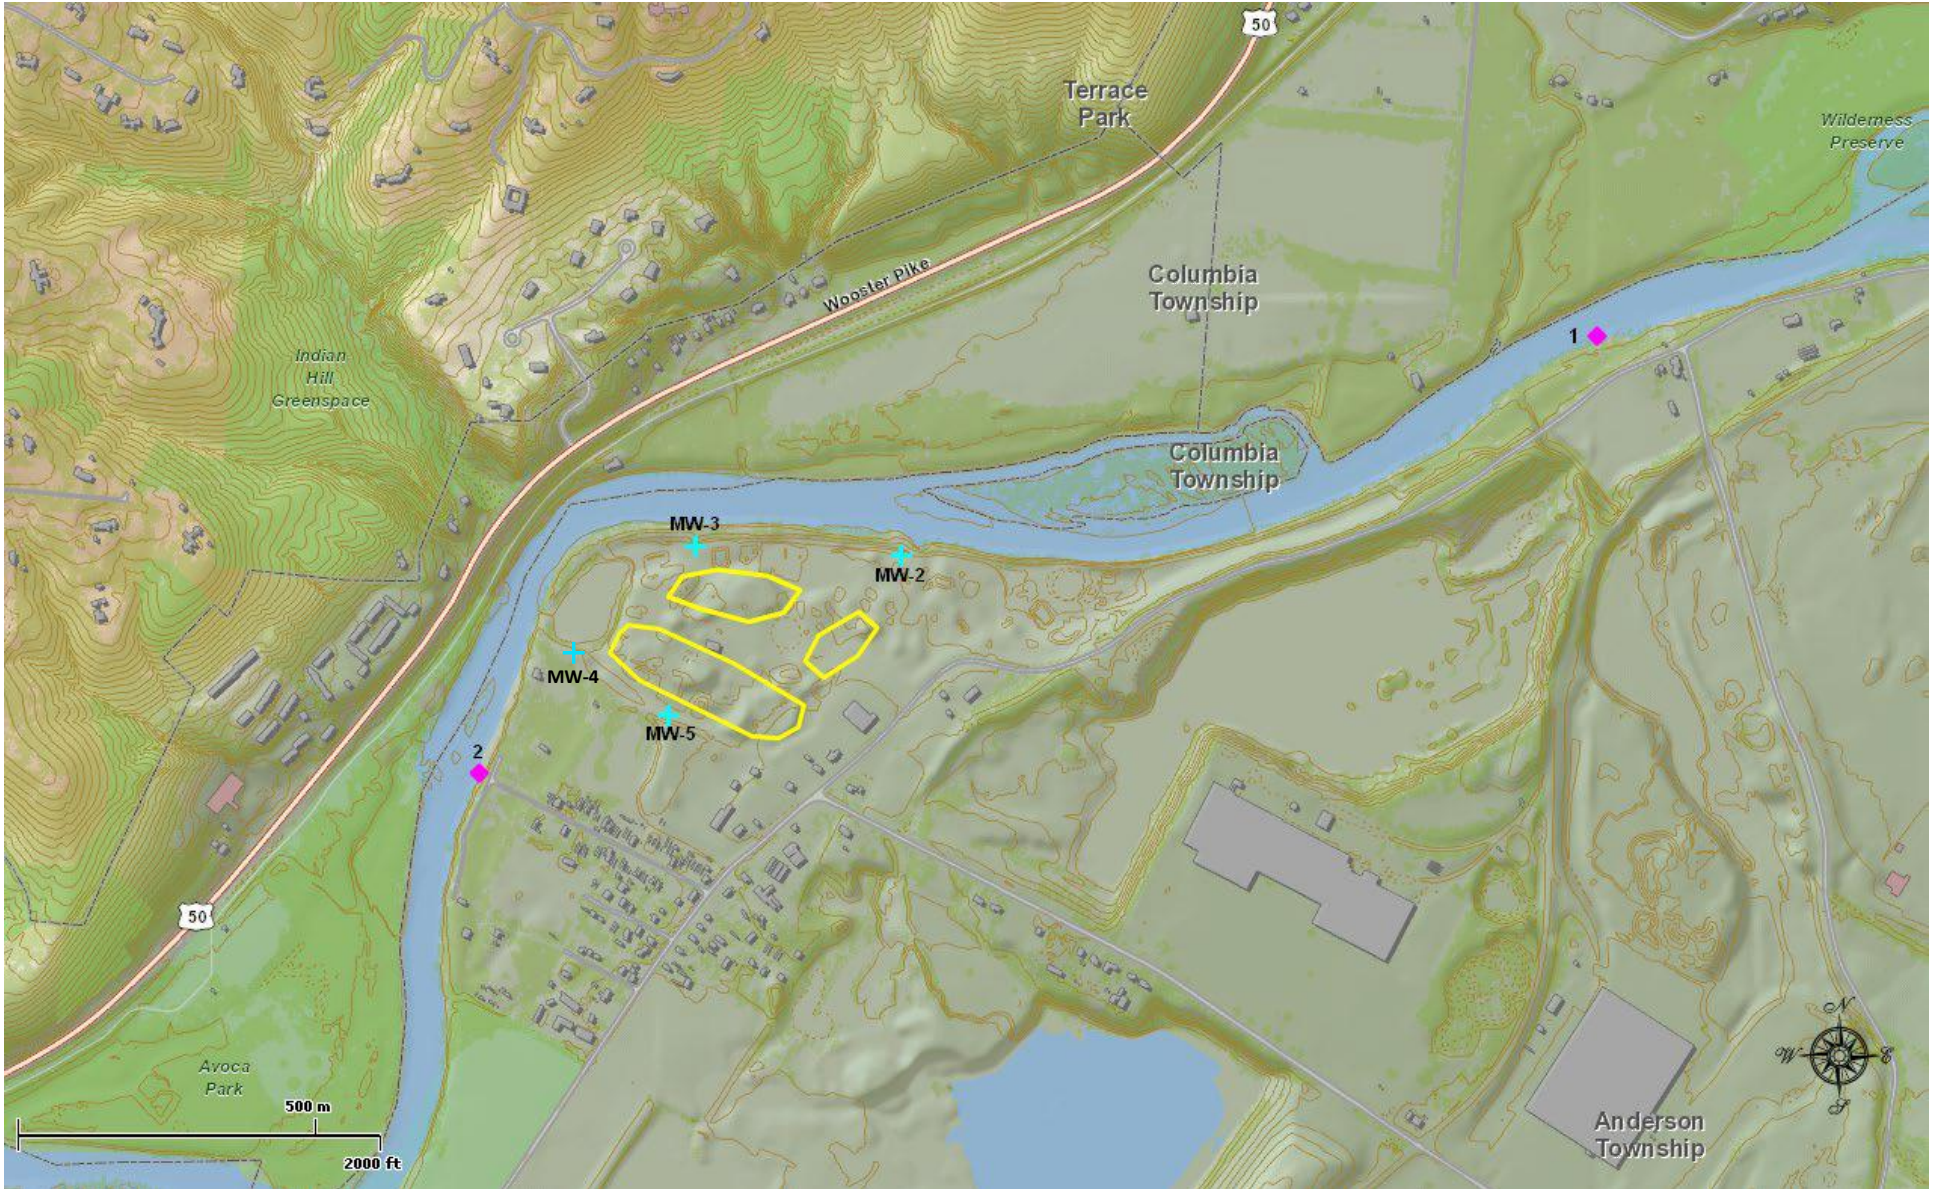
Figure 3.5.3-B
Evans Landscaping
4229 Round Bottom Road

The Little Miami River runs along the north and west sides of the Evans Landfill. Sampling was completed on October 11, 2022 (Appendix A). Samples were taken above and below the landfill. The upstream sample was in a shallow (1'), gravelly, rocky riffle area of the river. The shallow area had rapid flow across the rocks. The downstream sample was taken in slightly deeper water about 1 to 2 feet deep with a rocky bottom. The referenced locations are shown on Figure 3.5.3-B.

- ◆ = Surface Water Sampling Location
- = Approximate Limits of Waste
- + = Ground Water Sampling Location
