3.5.4 EVENDALE LANDFILL

Facility Name: Evendale Landfill

Location: 9941 Reading Road and areas immediately south

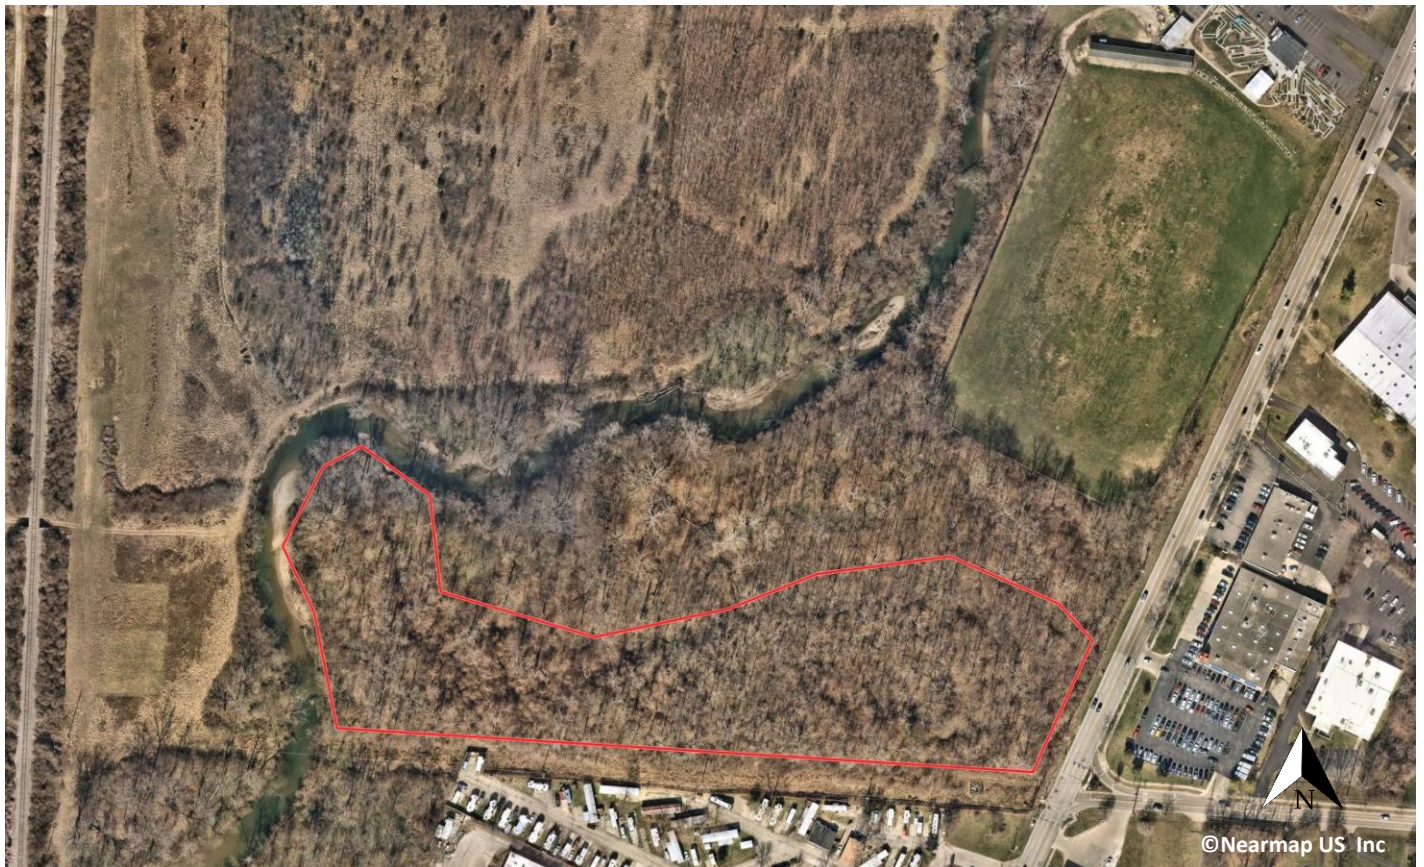
FIGURE 3.5.4-A

The exact location of the former landfill is unknown. At one time it was thought that the driving range may be the location of the former fill. However, after reviewing historical aerials it appears that property to the south of the driving range may be the actual location. Aerials from 1932, 1938, 1950, 1956, 1962, 1968, 1975, 1977, and 1990 were reviewed. In all these photographs the driving range appeared to be an open field. As you can see in Figure 3.5.4-A there was some evidence of possible filling to the south of the driving range in 1962 and 1968. Note that in the 1956 aerial there is no disturbance on the property to the south of the driving range, however

in the aerial from 1962, there is a small area of disturbance circled in yellow. By 1968 there is a larger area of disturbance that is circled in yellow. In the aerial from 1975 the area appears very similar to the way the properties are today. Additionally, an ODOT aerial from 1970 clearly shows filling occurring on the property.

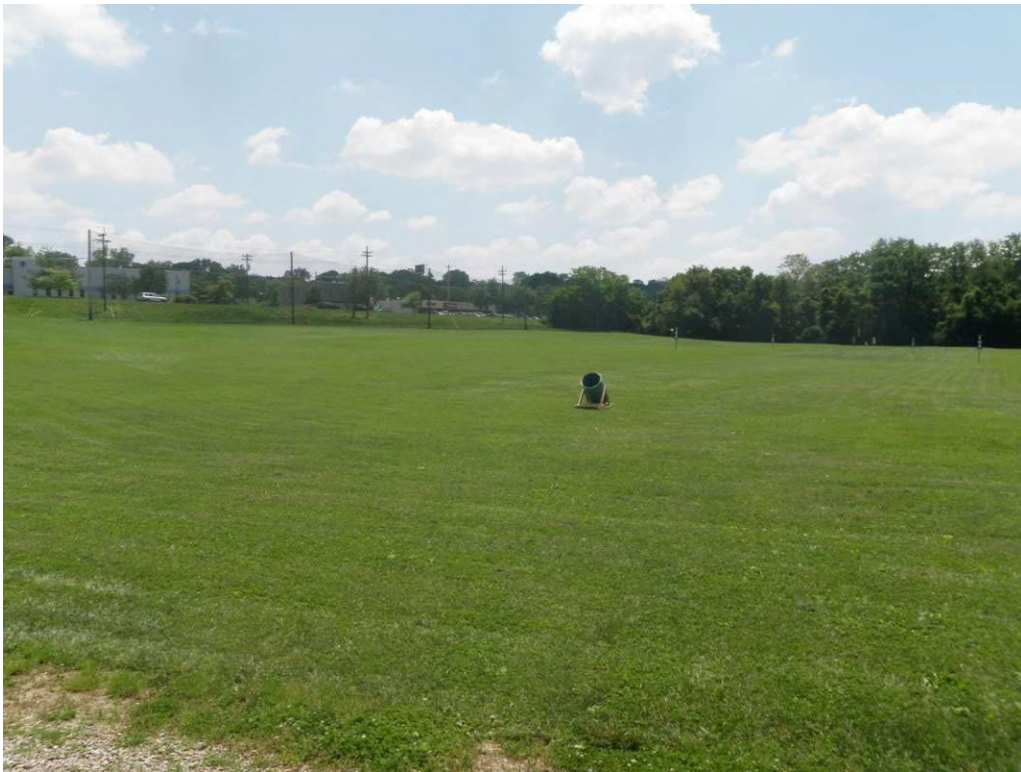
3.11.4 SITE PRESENT DAY

The driving range remains open while the area to the south is wooded vacant land fenced in to restrict access. Below is a photograph taken from the driving range looking southeast toward the shopping center that was a concern in 1987. The wooded area can be seen in the distance on the right half of the photo as well.
