3.7.5 GREENHILLS LANDFILL

Facility Name: Greenhills Landfill
A.K.A.: N/A
Location: 1300 West Sharon Road
Parcel #: 59100170006
Lat, Long: 39.276987 -84.529820
Region: Forest Park, OH 45240
Owner: Village of Greenhills
Operation (yrs): 1938 – 1981 (based on records)

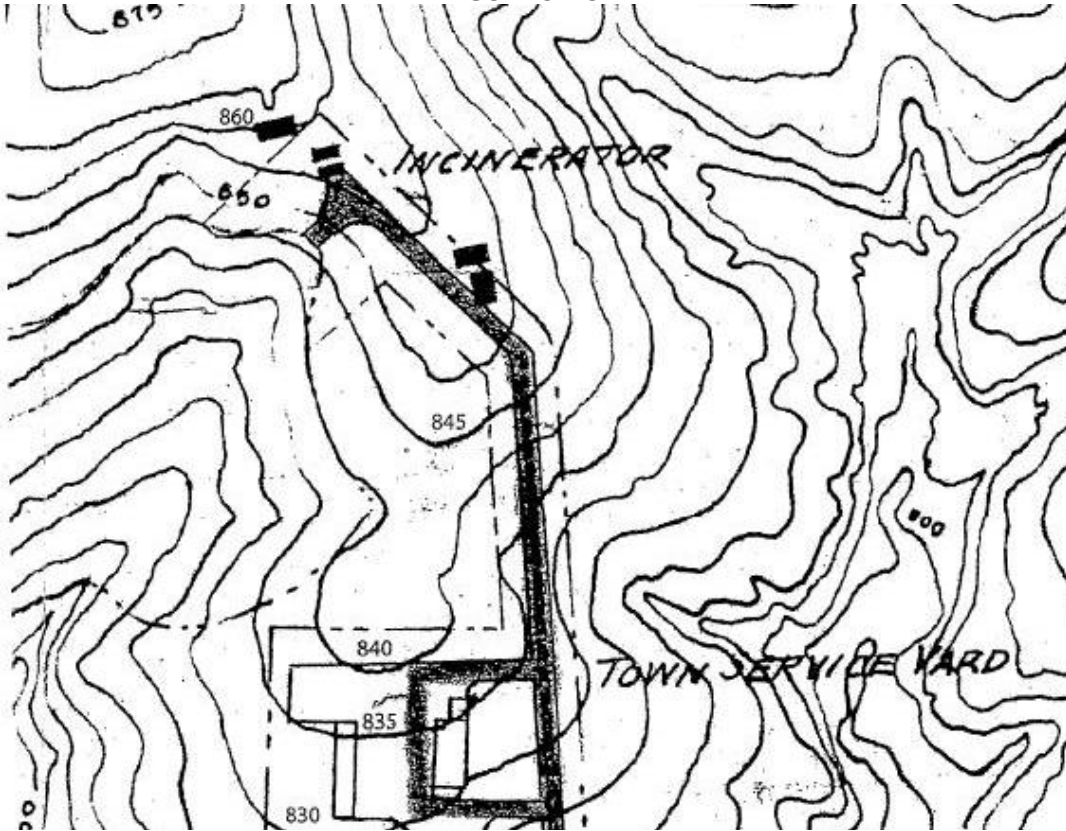
FIGURE 3.7.5-A

3.7.5-B illustrates today's topography of the site. The red line represents areas that appear to have been filled based on comparison of topographic maps from 1937 (Figure 3.7.5-A) and today. The yellow line delineates areas of waste placement as reported in the facility's explosive gas monitoring plan or EGMP.

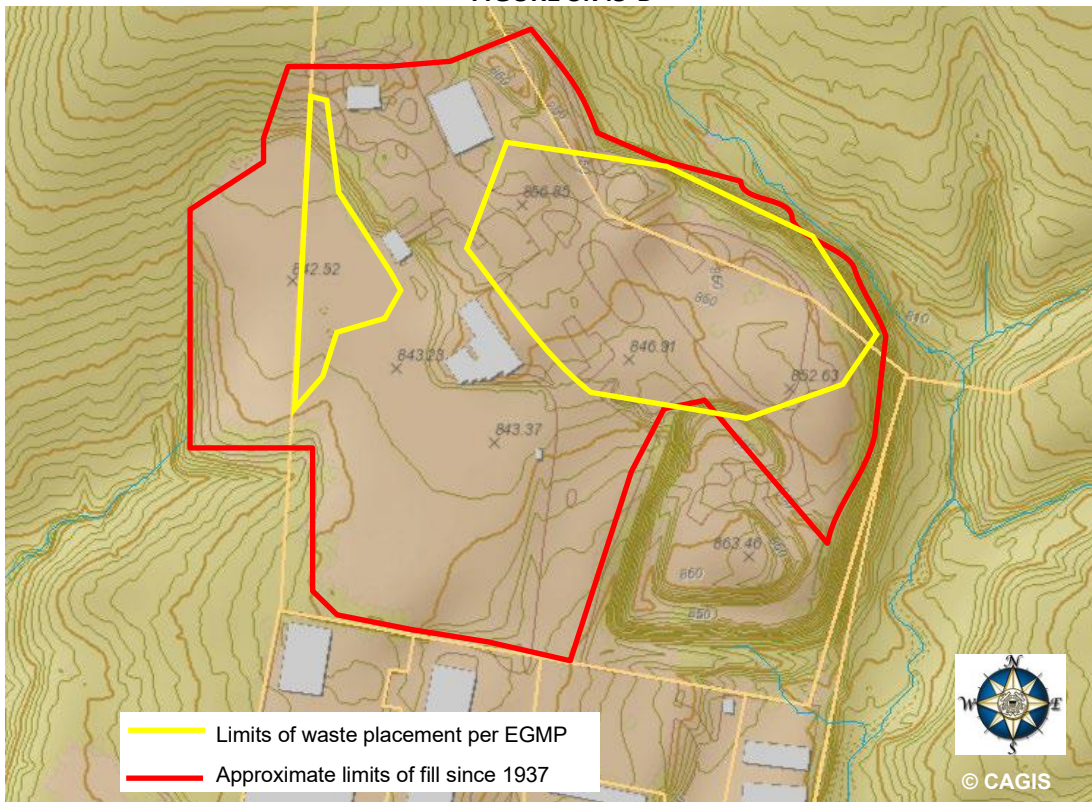
FIGURE 3.7.5-B

Topography of the former landfill was created as the site was developed as a hillside fill where waste material was pushed from the ridgeline over the slope from west to east. Filling also occurred south and west of the ridgeline however documentation has indicated this was likely hard fill materials (may include C&DD). Figure

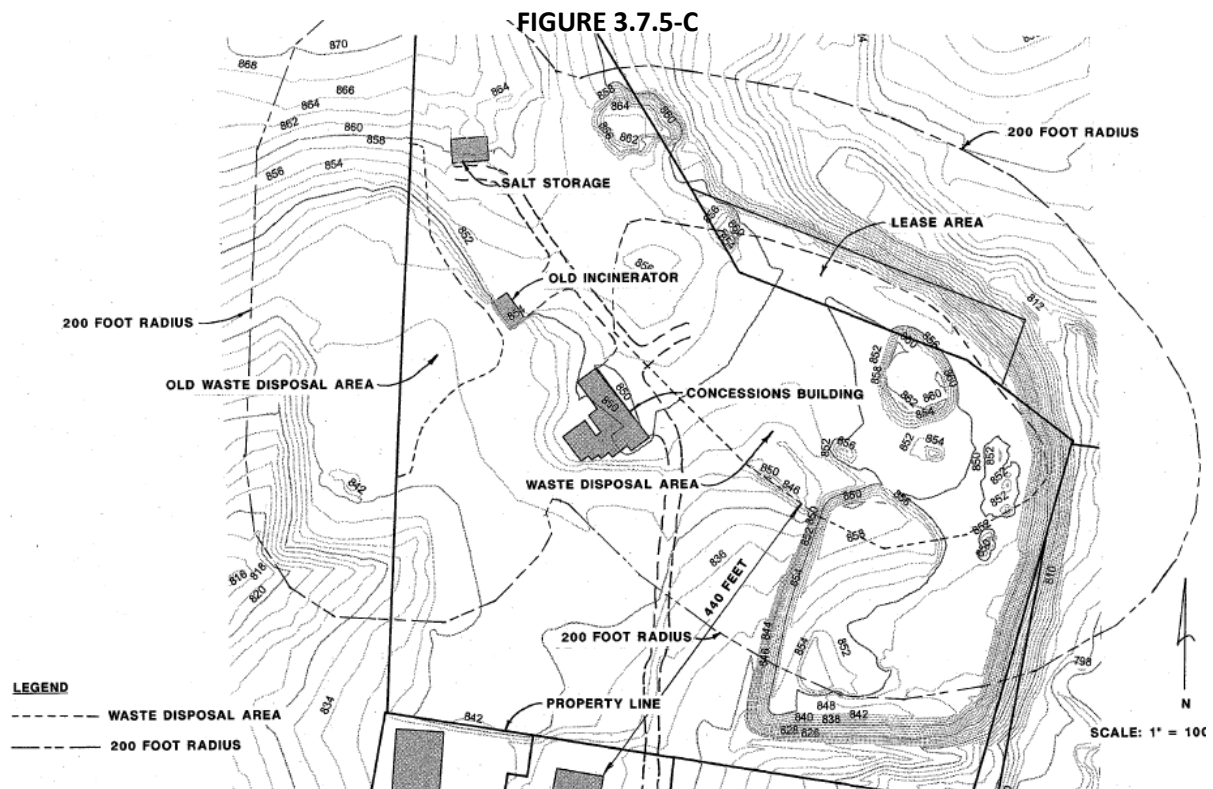
Based on records, operation of the landfill for the disposal of putrescible waste and incinerator ash dates to 1938. The site served primarily as disposal for incinerator ash for an onsite incinerator operated by the Federal Government until 1951, and by The Village until 1968, when it was closed. From 1968, the landfill disposed of mostly debris from the Village of Greenhills until sometime in the early 1970's. The majority of waste disposed at the landfill from 1968 until 1981 consisted of yard waste and an occasional load of putrescible waste. The facility maintained an operating license issued by the Hamilton County General Health District until 1981. All putrescible waste and incinerator ash was disposed on the northern side of the landfill property. A letter from HCPH to the village, dated 2/8/1989, indicates the landfill is operating a "demolition fill site" but is accepting some prohibited solid waste items such as furniture, appliances, and tires. A HCPH report from 1991 indicates that the site has been operating as a C&DD facility for approximately 3 yrs. Acceptance of C&DD ceased sometime prior to 1997 when licensing of C&DD landfills was established. The incinerator was torn down and removed in 2018. Presently the Village accepts clean hard fill; organic material is also accepted at an Ohio EPA registered class IV compost facility operated by the village. Figure 3.7.5-C illustrating prior waste disposal for the site follows:

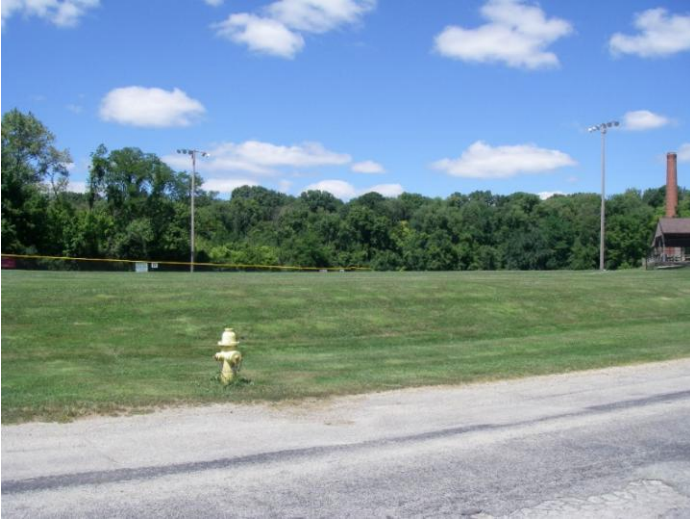
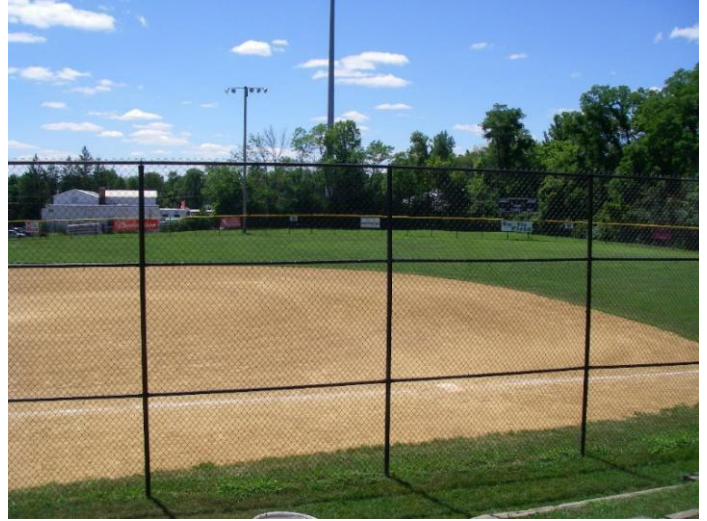
The site was inspected by HCPH on December 28, 2023. No violations or nuisance conditions were observed on the site. During past inspections, minimal amounts of exposed waste have been observed on the east slopes of the former landfill. However, these slopes are completely covered with established trees and removal/re-covering would not be practical at this time.

The property is currently used by the Village of Greenhills as a recreational area with baseball fields, a concessions structure, and associated gravel parking lots. Other uses of the property include equipment and material storage. Additionally, the village operates an Ohio EPA registered Class IV Composting Facility and a clean hard fill disposal area on the property.

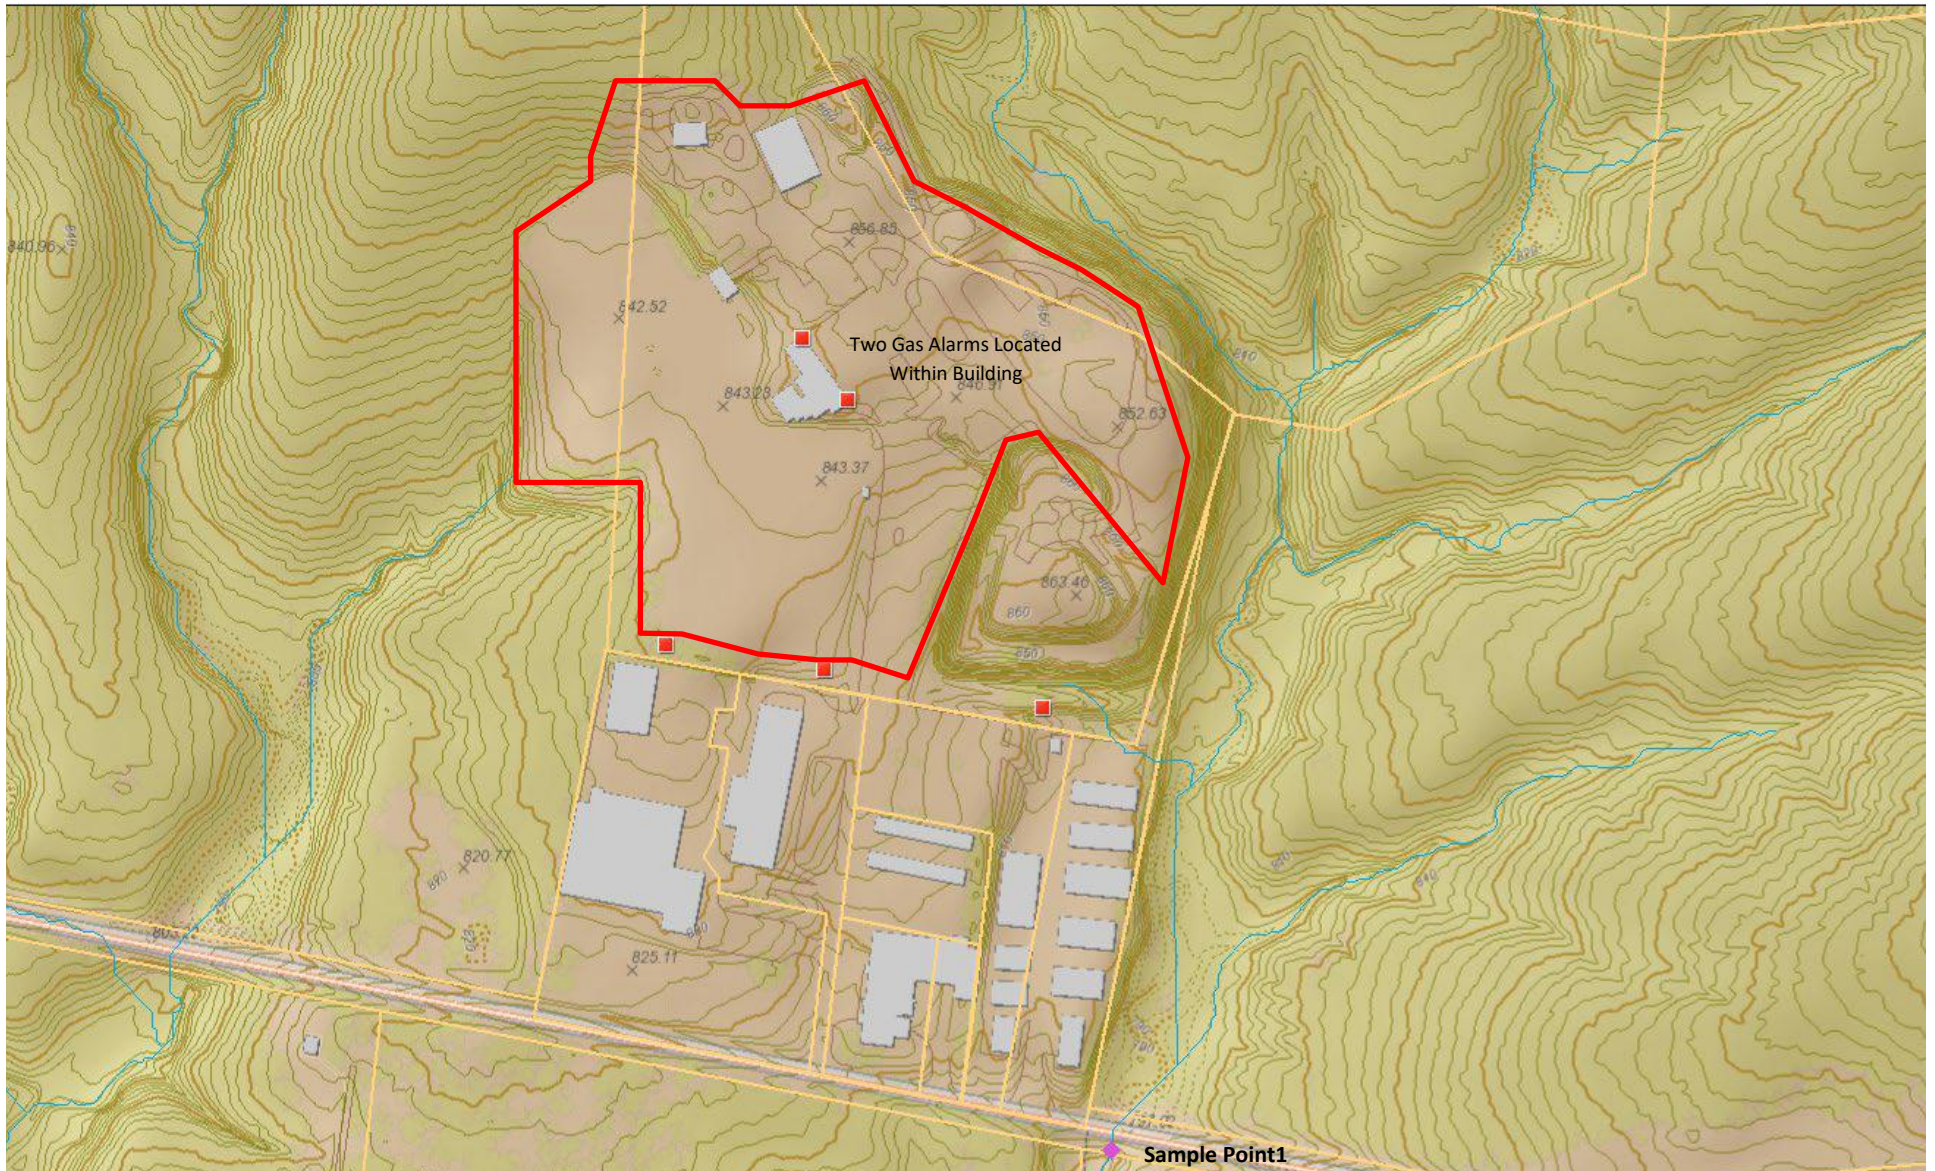
Figure 3.7.5-C
Greenhills Closed Landfill
1260 West Sharon Road

The Village of Greenhills Landfill Explosive Gas Monitoring Plan (EGMP) was approved by Ohio EPA on November 5, 2008. On December 8, 2008, three permanent monitors, one permanent punch bar station, and two gas alarms were installed at the Village of Greenhills Landfill (Figure 3.7.5-C).

= Surface Water Sampling Location
-

= Approximate Limits of Fill Since 1937
