BIANNUAL SURFACE WATER AND BIOLOGICAL STREAM SAMPLING AROUND RUMPKE AND BOND ROAD LANDFILLS

April 2024

HAMILTON COUNTY
PUBLIC HEALTH

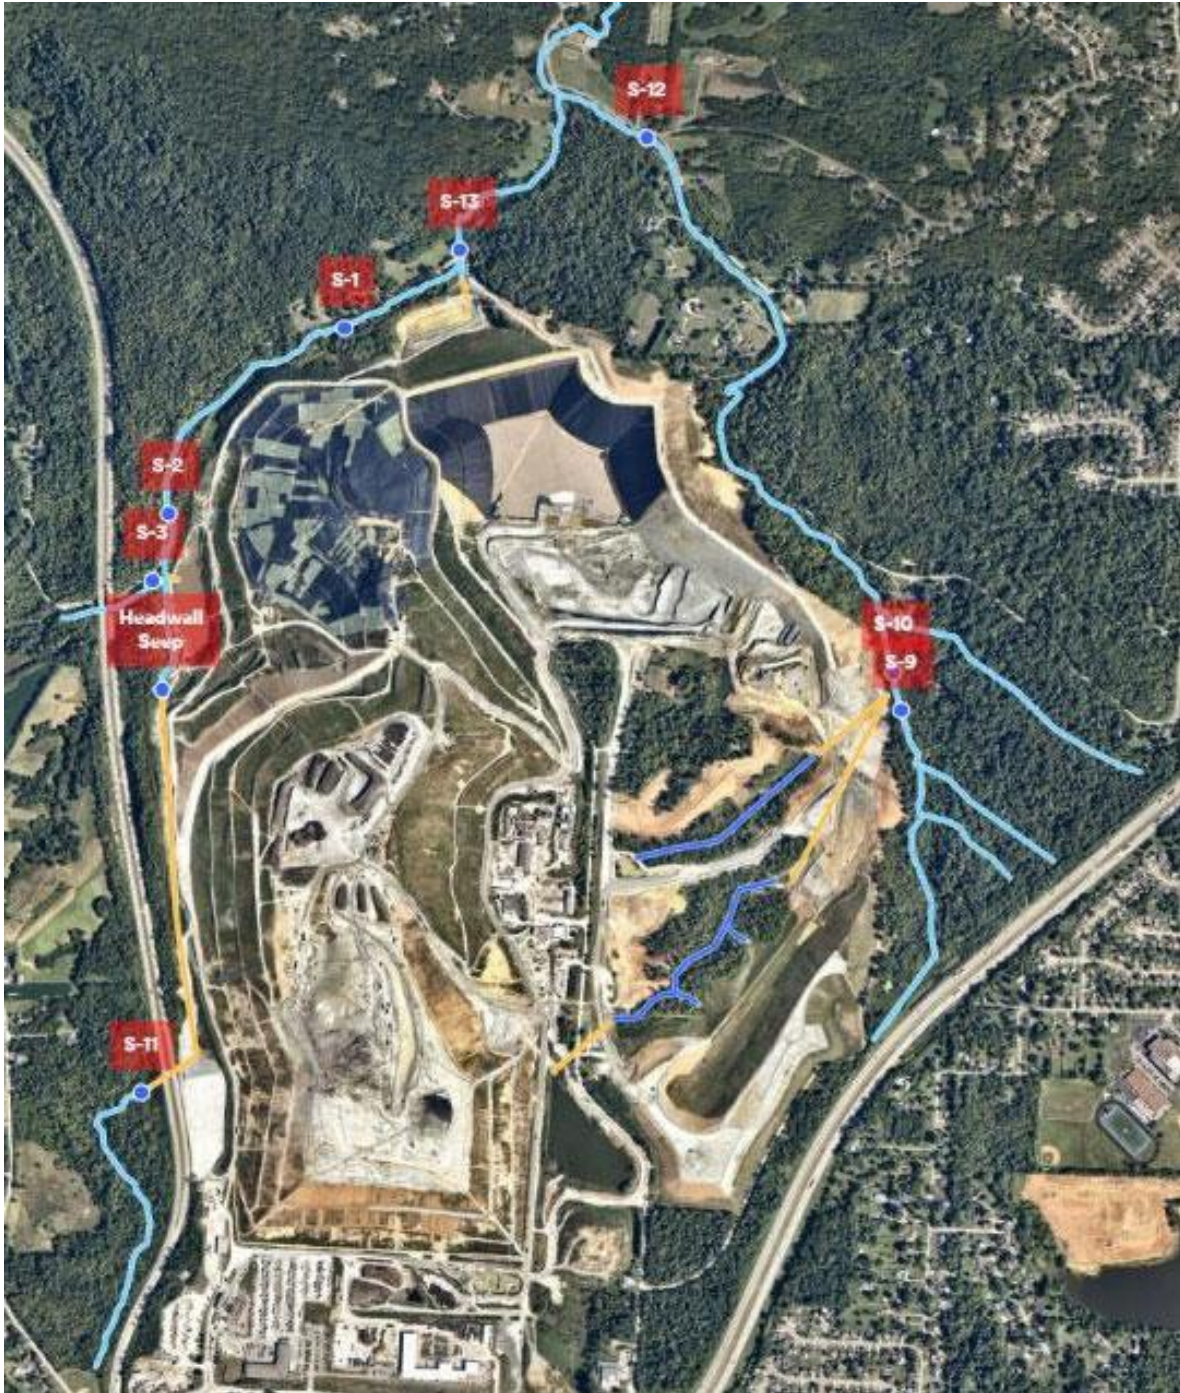
Figure 1
Rumpke Sanitary Landfill

The sampling locations around the landfill consists of the NW Pond and SE Pond outfalls, and their respective upstream and downstream locations (Figure 1).

Stream Sampling Locations

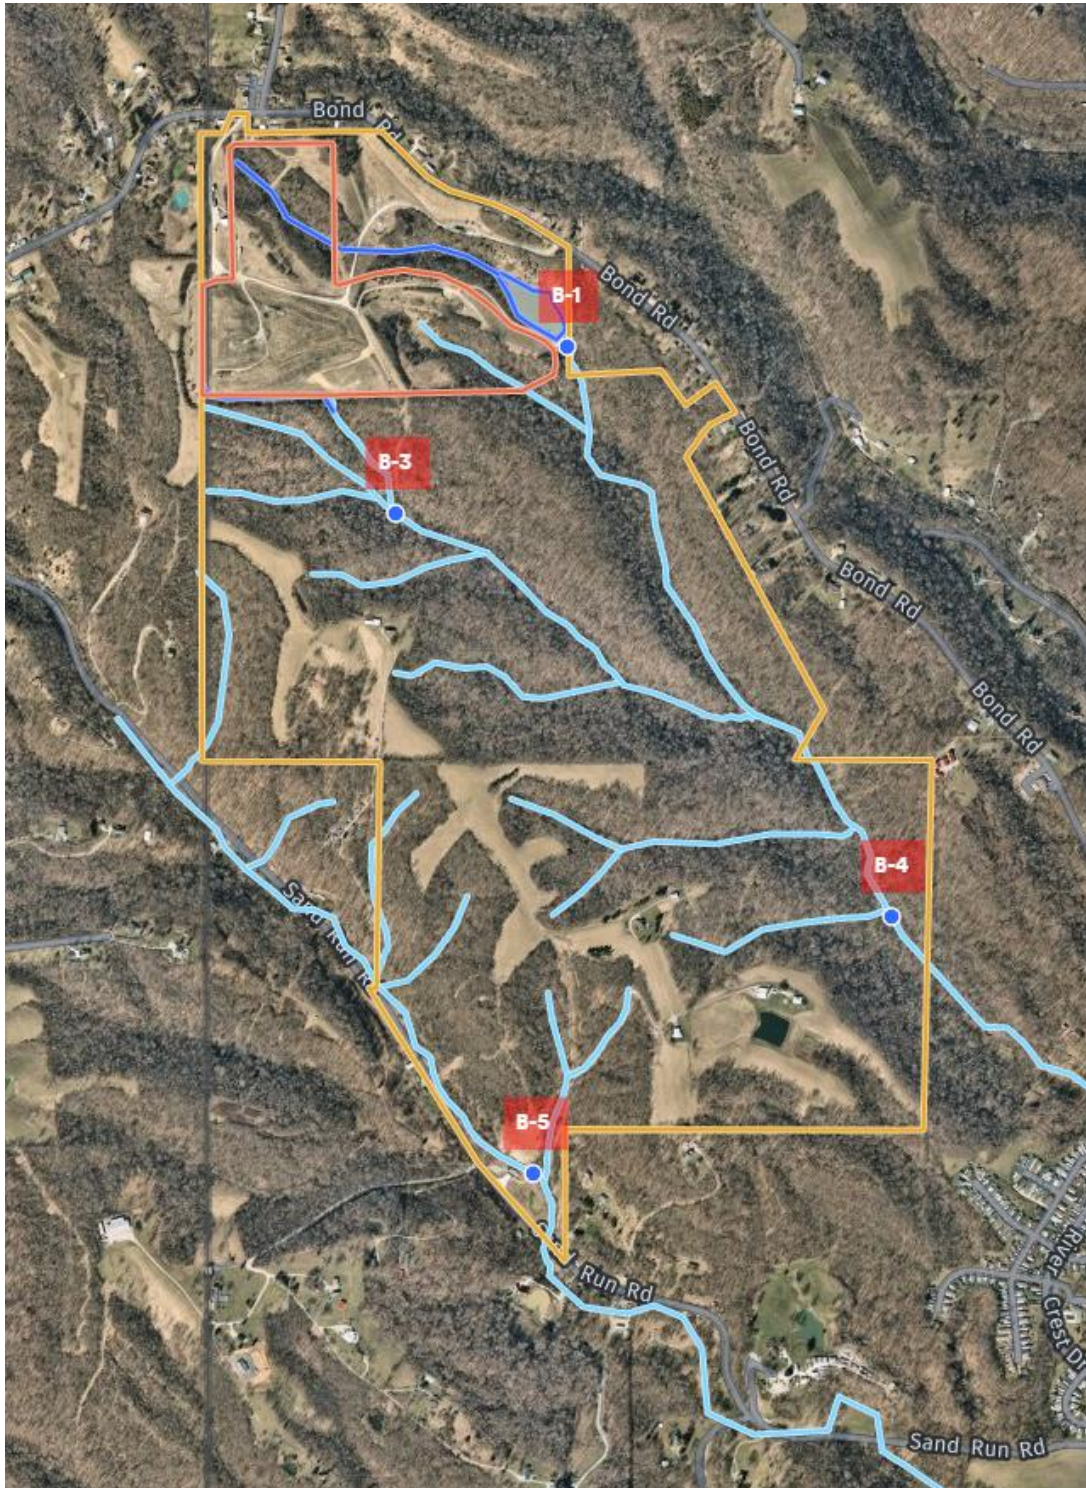
Figure 2

Bond Road Sanitary Landfill, located in Whitewater Township, is situated in western Hamilton County, Ohio. The landfill borders the State of Indiana to the west and Bond Road to the north. In 2021, Rumpke purchased 466 acres of land south of the existing landfill for purposes of future development and improvements, extending the southern landfill border to Sand Run Road. Improvements to the site will include the relocation of the facility entrance to Sand Run Road, accompanied by an access road to the existing limits of waste placement. Sampling locations around the Bond Road Sanitary Landfill consists of the following five sites (Figure 2):

Bond Road Landfill

Sampling Locations

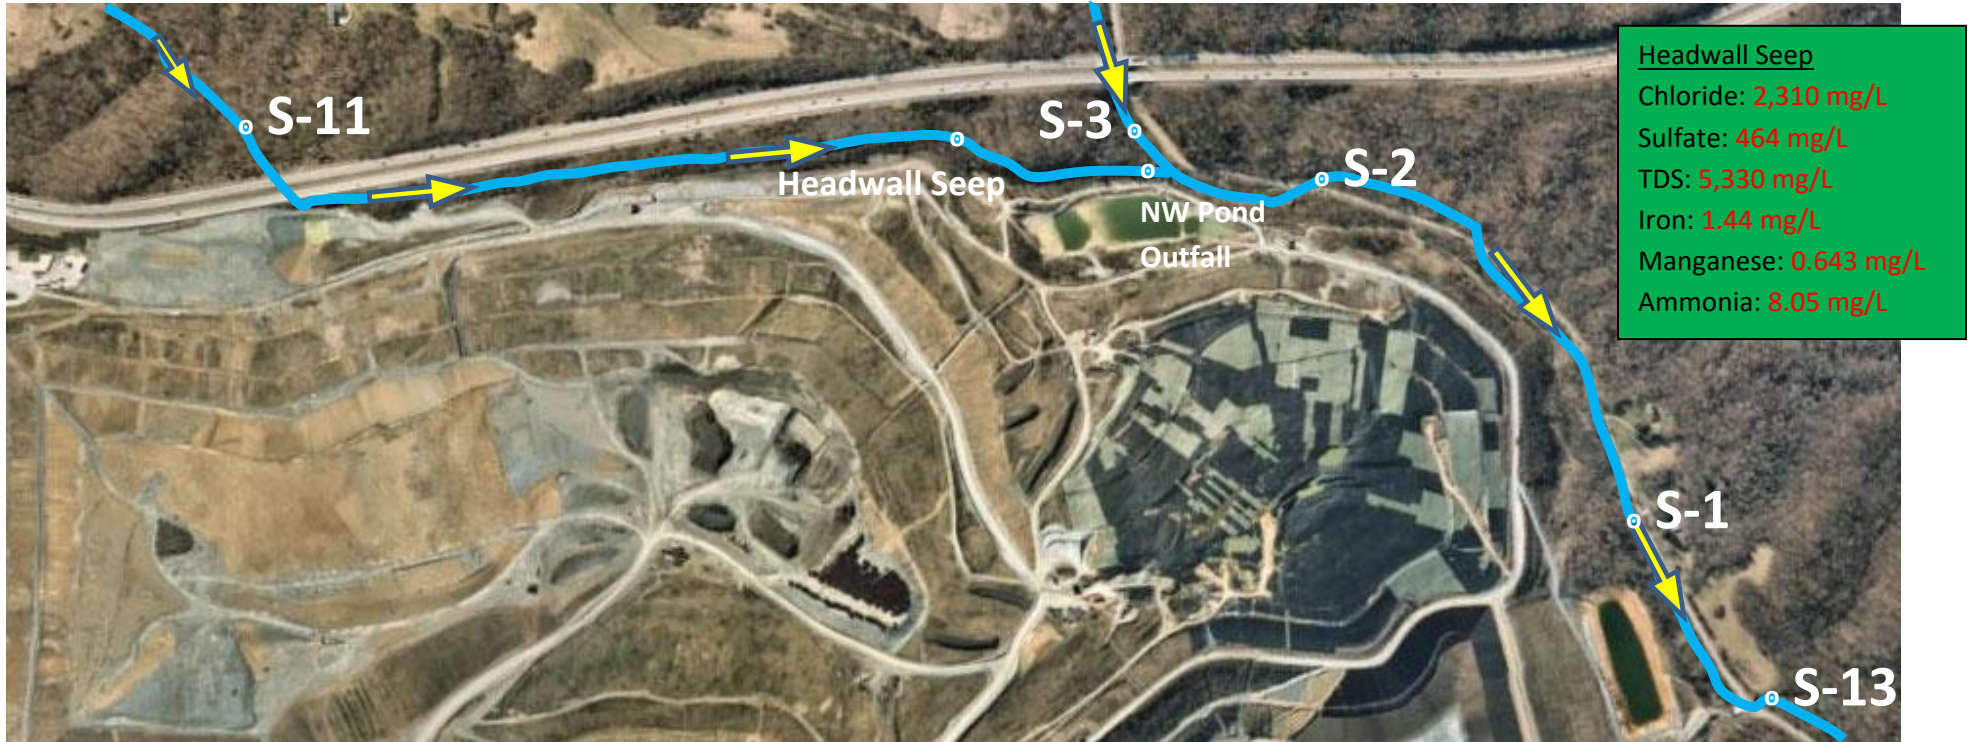
Figure 3

Comparison of Western Watershed Sampling Locations June 6, 2023

➡ Surface water flow direction
Red indicates above the MCL/SMCL/Action Level

<p><u>S-11</u> Chloride: 172 mg/L Sulfate: 282 mg/L TDS: 950 mg/L Iron: 0.381 mg/L Manganese: 0.0213 mg/L Ammonia: Non-detect</p>	<p><u>S-3</u> Chloride: 218 mg/L Sulfate: 88.4 mg/L TDS: 826 mg/L Iron: 0.412 mg/L Manganese: 0.0681 mg/L Ammonia: Non-detect</p>
---	---

<p><u>S-2</u> Chloride: 1,919 mg/L Sulfate: 1,030 mg/L TDS: 4,630 mg/L Iron: Non-detect Manganese: Non-detect Ammonia: Non-detect</p>	<p><u>S-1</u> Chloride: 1,430 mg/L Sulfate: 769 mg/L TDS: 3,580 mg/L Iron: 0.349 mg/L Manganese: 0.249 mg/L Ammonia: Non-detect</p>	<p><u>S-13</u> Chloride: 1,280 mg/L Sulfate: 729 mg/L TDS: 3,180 mg/L Iron: 0.132 mg/L Manganese: 0.29 mg/L Ammonia: Non-detect</p>
---	---	---

Sampling results comparing the NW Pond outfall with upstream sample locations (S-3 & S-11) and downstream sample locations (S-1, S-2 & S-13) are illustrated on Figures 3 & 4 and narrated below:

- Chloride was detected above the secondary maximum contaminant level (SMCL) of 250 mg/l in upstream sample location S-11 (301 mg/l) during the November sampling event. Chloride was not detected above the SCML in upstream sample S-3 during 2023 or the NW Pond in November 2023 when it was able to be sampled.

- Chloride was detected above the SCML in all downstream sample locations (S-1, S-2 & S-13) during the 2023 sampling events.
- Sulfate was detected above the SMCL of 250 mg/l in upstream sample S-11 (271 mg/L) during the June sampling event (282 mg/L) as well as the November sampling event (250 mg/L). Sulfate was not detected above the SCML in upstream sample S-3 during 2023 or the NW Pond in November 2023 when it was sampled.

- Similarly to chloride, sulfate was detected above the SCML in all downstream sample locations (S-1, S-2 & S-13) during the 2023 sampling events.
- All sample locations were above the SMCL of 500 mg/L for total dissolved solids (TDS) during the 2023 sampling events, including the NW Pond in November 2023.

- In June 2023, iron was detected above the SMCL of 0.3 mg/l in upstream sample locations S-11 (0.381 mg/L) and S-3 (0.412 mg/L), but below the SMCL during the

- Iron was detected above the SMCL in downstream sample location S-1 in June 2023 (0.349 mg/L) and November 2023 (0.353 mg/L). All other downstream locations were below the SMCL for iron in 2023.

- Manganese was detected above the SMCL of 0.05 mg/l in upstream sample locations S-3 in June 2023 (0.0681 mg/L) and S-11 in November 2023 (0.152 mg/L).

- Manganese was detected above the SMCL in downstream samples S-1 and S-13 during both 2023 sampling events. Downstream sample location S-2 was below the SMCL for manganese during both 2023 sampling events.

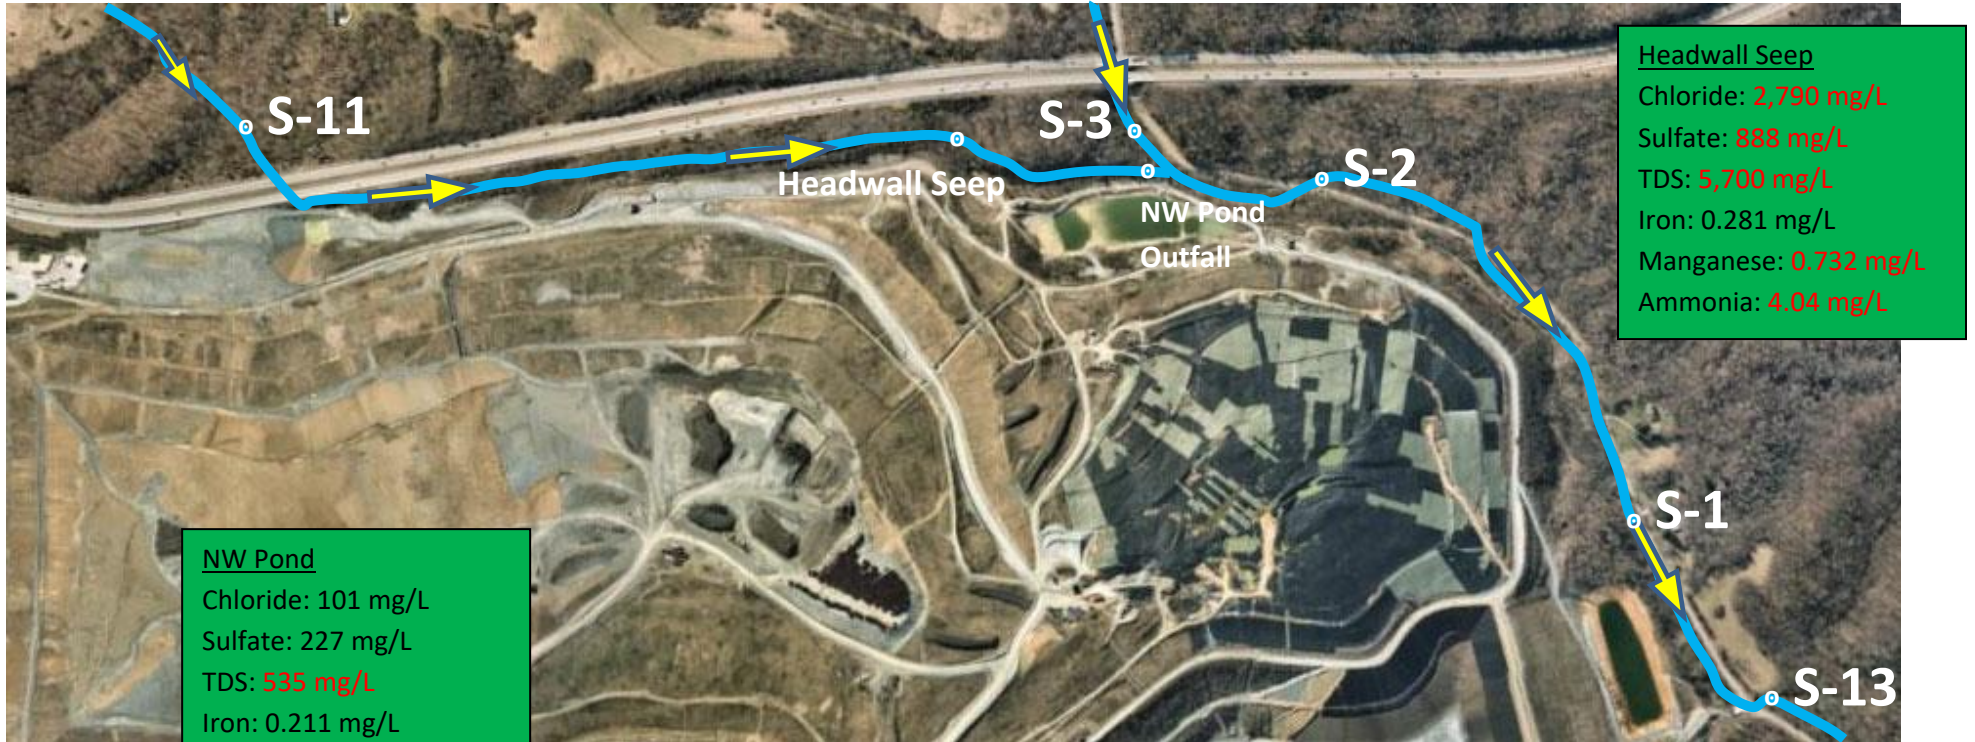
Figure 4

Comparison of Western Watershed Sampling Locations November 16, 2023

NW Pond
 Chloride: 101 mg/L
 Sulfate: 227 mg/L
 TDS: 535 mg/L
 Iron: 0.211 mg/L
 Manganese: 0.0142 mg/L
 Ammonia: Non-detect

Headwall Seep
 Chloride: 2,790 mg/L
 Sulfate: 888 mg/L
 TDS: 5,700 mg/L
 Iron: 0.281 mg/L
 Manganese: 0.732 mg/L
 Ammonia: 4.04 mg/L

➡ Surface water flow direction
 Red indicates above the MCL/SMCL/Action Level

S-11
 Chloride: 301 mg/L
 Sulfate: 259 mg/L
 TDS: 956 mg/L
 Iron: 0.114 mg/L
 Manganese: 0.152 mg/L
 Ammonia: Non-detect

S-3
 Chloride: 206 mg/L
 Sulfate: 137 mg/L
 TDS: 813 mg/L
 Iron: 0.143 mg/L
 Manganese: 0.0404 mg/L
 Ammonia: Non-detect

S-2
 Chloride: 708 mg/L
 Sulfate: 506 mg/L
 TDS: 1,770 mg/L
 Iron: 0.129 mg/L
 Manganese: 0.0161 mg/L
 Ammonia: Non-detect

S-1
 Chloride: 723 mg/L
 Sulfate: 513 mg/L
 TDS: 1,680 mg/L
 Iron: 0.353 mg/L
 Manganese: 0.253 mg/L
 Ammonia: Non-detect

S-13
 Chloride: 753 mg/L
 Sulfate: 494 mg/L
 TDS: 1,740 mg/L
 Iron: 0.264 mg/L
 Manganese: 0.389 mg/L
 Ammonia: 0.212 mg/L

- Ammonia was detected above the 0.20 mg/l laboratory limits in downstream sample location S-13 (0.212 mg/l) during the November 2023 sampling event. Less than 1.0 mg/L ammonia is considered usual for natural waters.

- Comparing sampling analytical results with years' past, concentrations of TDS, chloride and sulfate at the downstream samples S-1, S-2 and S-13 continue to be elevated as they were during the 2021 and 2022 sampling events. The higher concentrations of the analytes in the downstream samples in June 2023 compared to November 2023 is likely the result of the NW Pond outfall not being open, diluting the waters during sample collection.

In 2021, in determining a potential source of the elevated concentrations, Hamilton County Public Health surveyed areas upstream from S-2 to an existing headwall where the stream continues along the western landfill through an underground culvert. At the base of the headwall, a seep was identified coming from the weep holes installed to keep moisture from accumulating behind it. The seep was clear, but areas of discoloration were noted where it had been continuously flowing; the seep also smelled of sulfur.

The headwall seep was sampled during the 2022 and 2023 sampling events, and the results identified similarly increased concentrations of TDS, chloride and sulfate compared to downstream sample locations S-1, S-2, and S-13.

Hamilton County Public Health will continue to communicate with the Ohio EPA and Rumpke to further evaluate the headwall seep and determine its origin, whether it be groundwater, surface water or possibly landfill derived. The Ohio EPA, Hamilton County Public Health, and third-party consultants have determined that the headwall seep is not an imminent threat to public health or the environment as further sampling and investigation continues.

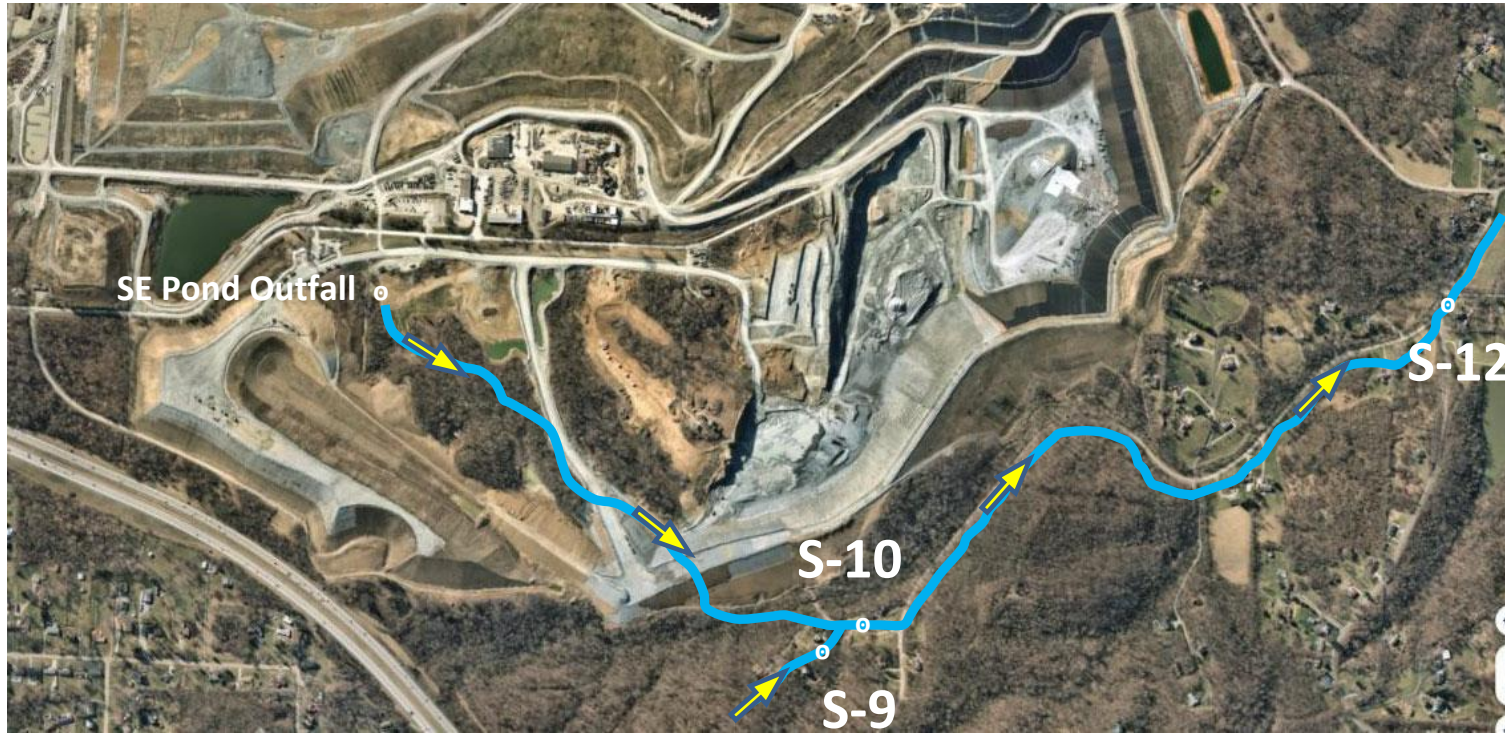
Figure 5

Comparison of Eastern Watershed Sampling Locations
June 6, 2023

Surface water flow direction
 Red indicates above the MCL/SMCL/Action Level

S-9
No longer able to sample due to the construction of Eastern Expansion of landfill.

SE Pond
Chloride: 149 mg/L
Sulfate: 178 mg/L
TDS: 616 mg/L
Iron: 0.165 mg/L
Manganese: 0.0859 mg/L
Ammonia: 0.271 mg/L

S-10
Chloride: 944 mg/L
Sulfate: 594 mg/L
TDS: 2,350 mg/L
Iron: 0.399 mg/L
Manganese: 0.306 mg/L
Ammonia: 0.226 mg/L

S-12
Chloride: 299 mg/L
Sulfate: 184 mg/L
TDS: 890 mg/L
Iron: 0.871 mg/L
Manganese: 0.112 mg/L
Ammonia: Non-detect

sampling events and sampled. Sampling results comparing the SE Pond and downstream sample locations (S-10 & S-12) are illustrated on Figures 5 & 6 and narrated below:

- Chloride was detected below the secondary maximum contaminant level (SMCL) of 250 mg/l in the SE Pond outfall sample during both 2023 sampling events.

- Chloride was detected above the SMCL for chloride in downstream sample locations S-10 and S-12 in June 2023 (944 mg/L & 299 mg/L, respectively) and below the SMCL in November 2023.

- Total dissolved solids (TDS) was above the SMCL of 500 mg/L in the SE Pond outfall sample in June 2023 (616 mg/L) and below the SMCL in November 2023.

- In June 2023, ammonia was detected above the 0.2 mg/l laboratory limits in the SE Pond outfall sample (0.271 mg/L) and downstream sample S-10 (0.226 mg/L). Less than 1.0 mg/L ammonia is considered usual for natural waters.

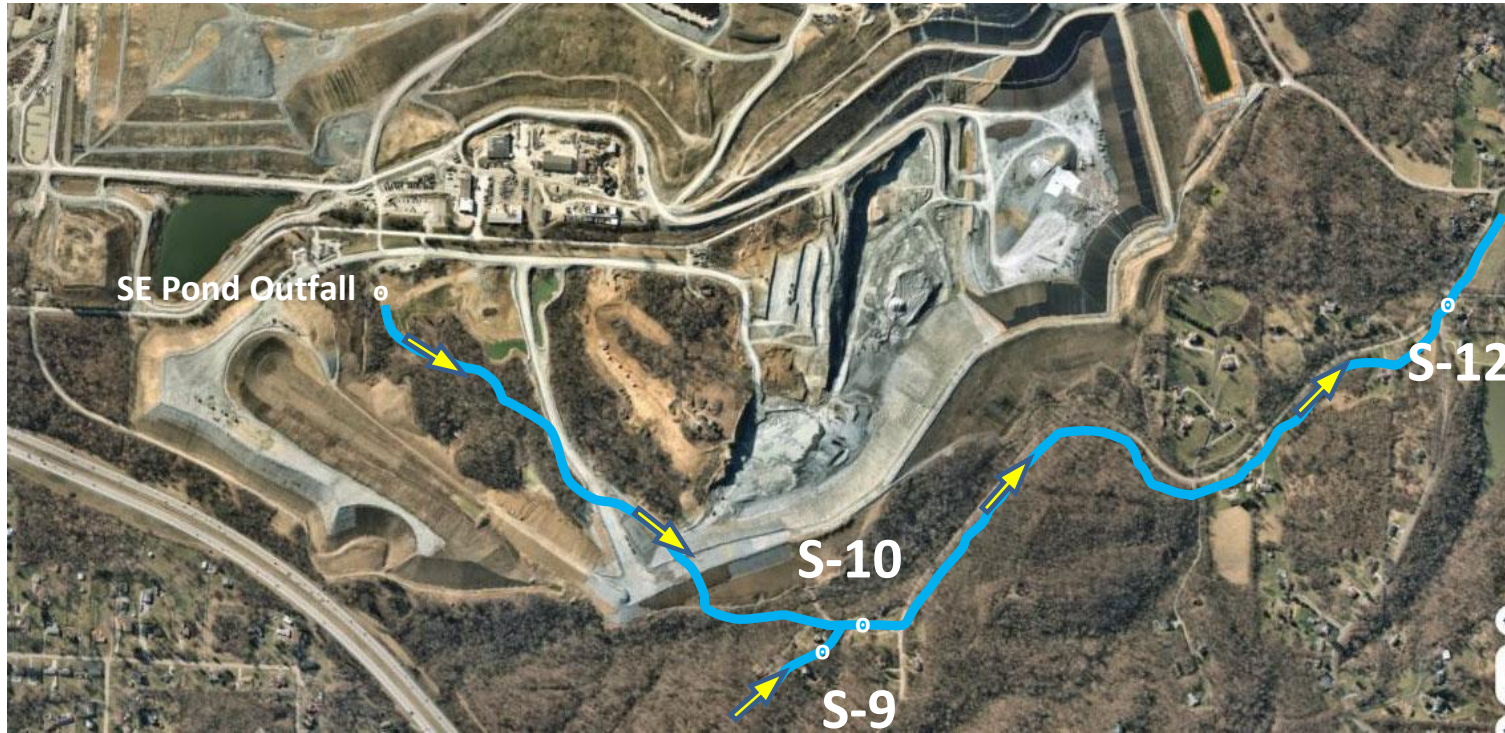
Figure 6

Comparison of Eastern Watershed Sampling Locations November 16, 2023

Surface water flow direction
 Red indicates above the MCL/SMCL/Action Level

S-9
No longer able to sample due to the construction of Eastern Expansion of landfill.

SE Pond
Chloride: 93.6 mg/L
Sulfate: 136 mg/L
TDS: 490 mg/L
Iron: 6.35 mg/L
Manganese: **0.191 mg/L**
Ammonia: Non-detect

S-10
Chloride: 119 mg/L
Sulfate: 152 mg/L
TDS: **544 mg/L**
Iron: **1.13 mg/L**
Manganese: **0.0884 mg/L**
Ammonia: Non-detect

S-12
Chloride: 121 mg/L
Sulfate: 147 mg/L
TDS: **535 mg/L**
Iron: **0.447 mg/L**
Manganese: **0.0923 mg/L**
Ammonia: Non-detect

- Downstream sample locations S-10 and S-12 were above the SMCL for TDS during both 2023 sampling events.
- Iron was detected below the secondary maximum contaminant level (SMCL) of 0.3 mg/l in the SE Pond outfall sample in June and November 2023.

- Downstream sample locations S-10 and S-12 were above the SMCL of 0.3 mg/L for iron during both 2023 sampling events.
- Manganese was detected above the SMCL of 0.05 mg/l in all sample locations during both 2023 sampling events.
