BIANNUAL SURFACE WATER AND BIOLOGICAL STREAM SAMPLING AROUND RUMPKE AND BOND ROAD LANDFILLS

July 2025

Introduction

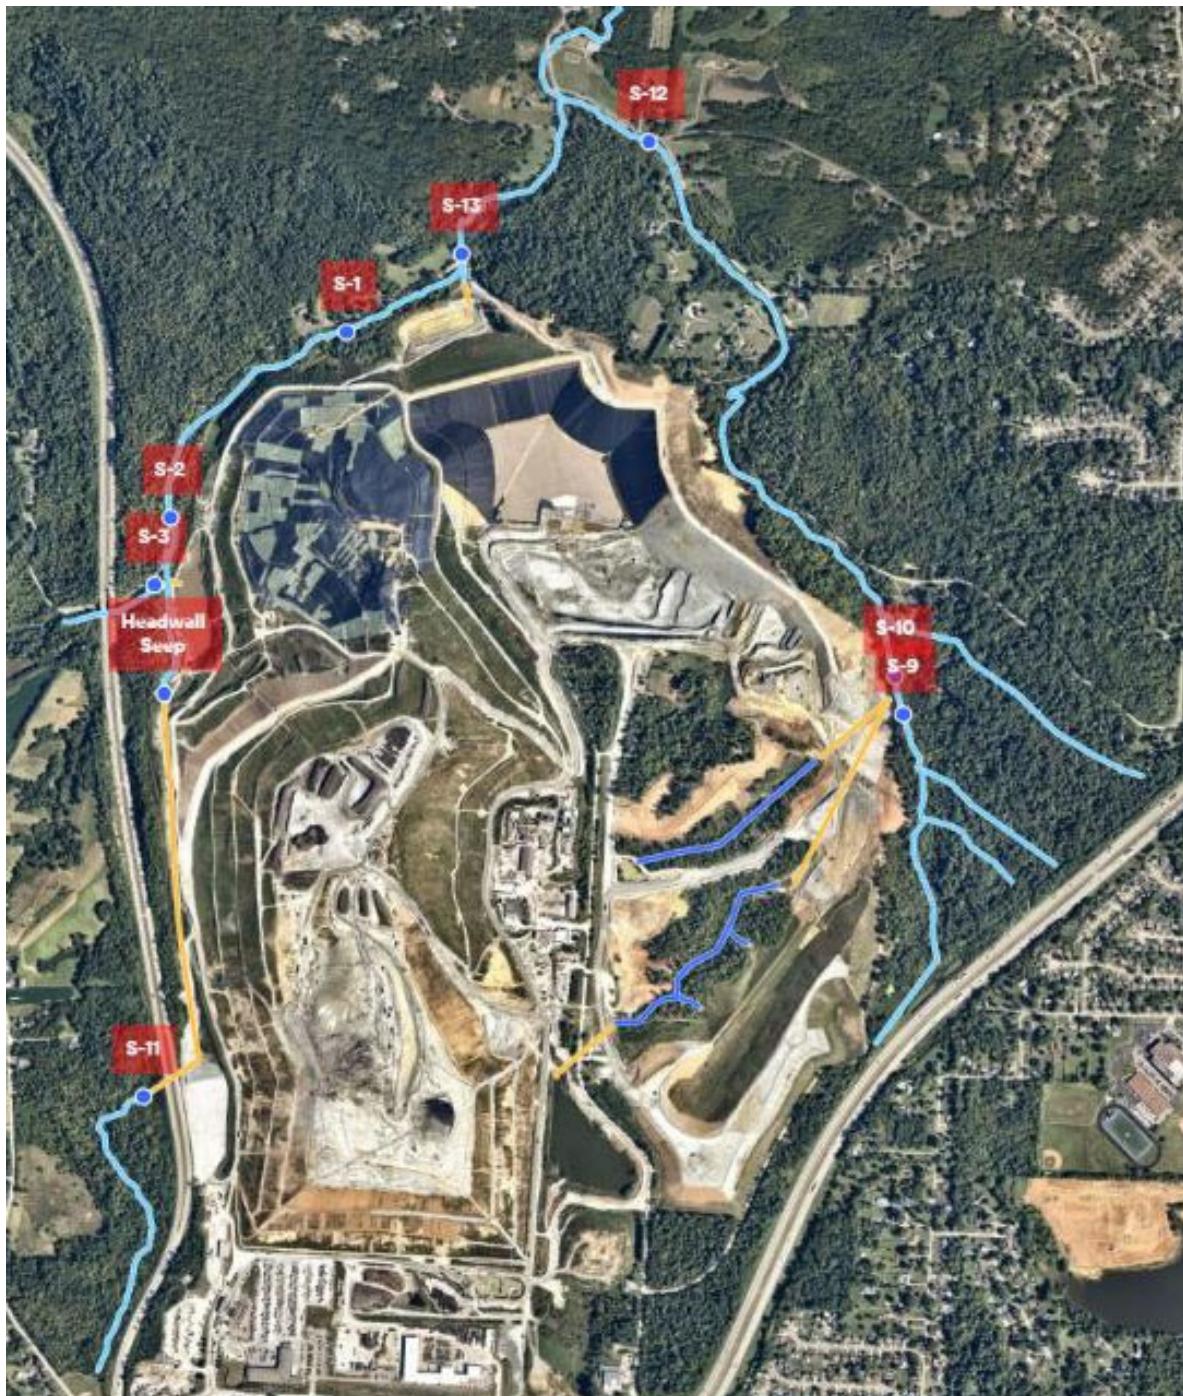
Figure 1
Rumpke Sanitary Landfill

The sampling locations around the landfill consist of the NW Pond and SE Pond outfalls, and their respective upstream and downstream locations (Figure 1).

Stream Sampling Locations

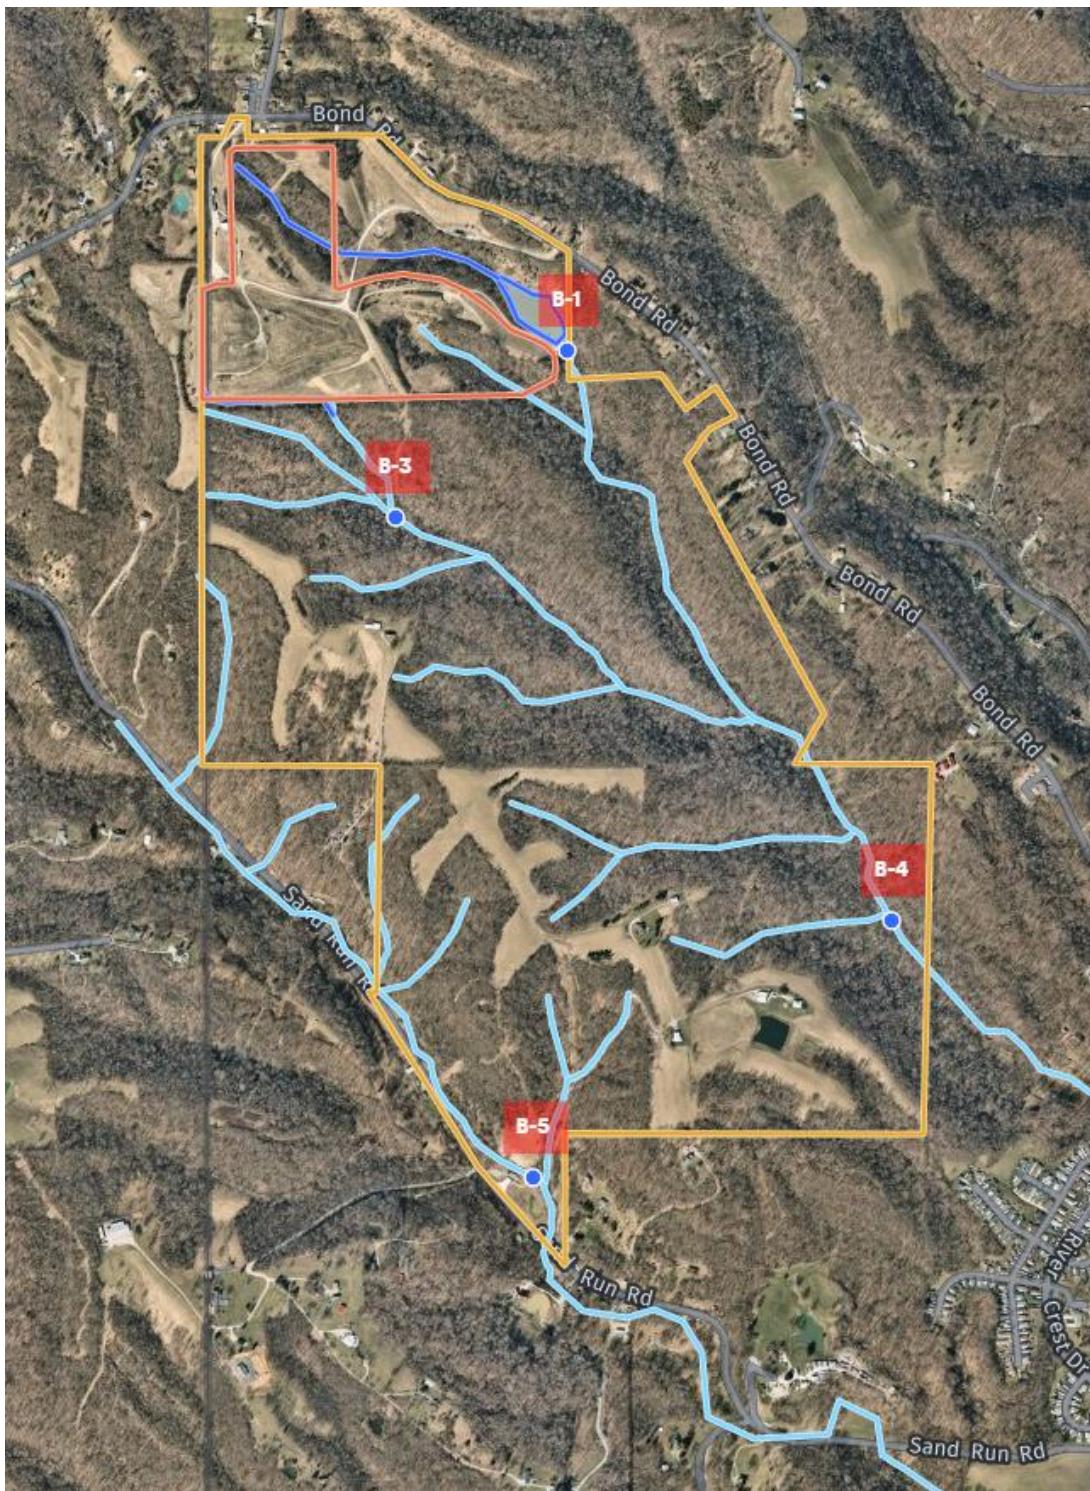
Figure 2
Bond Road Landfill

Bond Road Sanitary Landfill, located in Whitewater Township, is situated in western Hamilton County, Ohio. The landfill borders the State of Indiana to the west and Bond Road to the north. In 2021, Rumpke purchased 466 acres of land south of the existing landfill for purposes of future development and improvements, extending the southern landfill border to Sand Run Road. Improvements to the site will include the relocation of the facility entrance to Sand Run Road, accompanied by an access road to the existing limits of waste placement. Sampling locations around the Bond Road Sanitary Landfill consists of the following five sites (Figure 2):

- B-1 Located at the east end of the sedimentation pond which discharges to a tributary to Fox Run.
- B-3 Located south of the landfill in an unnamed tributary to Fox Run where most water is generated from storm swales. The sample location was added in 2022 due to proposed developments and improvements at the facility.
- B-4 Located on the southeast end of the property in Fox Run. The sample location was added in 2022 due to proposed developments and improvements at the facility.
- B-5 Located near the landfill entrance along Sand Run Road. The sample location was added in 2022 due to proposed developments and improvements at the facility.

Sampling Locations

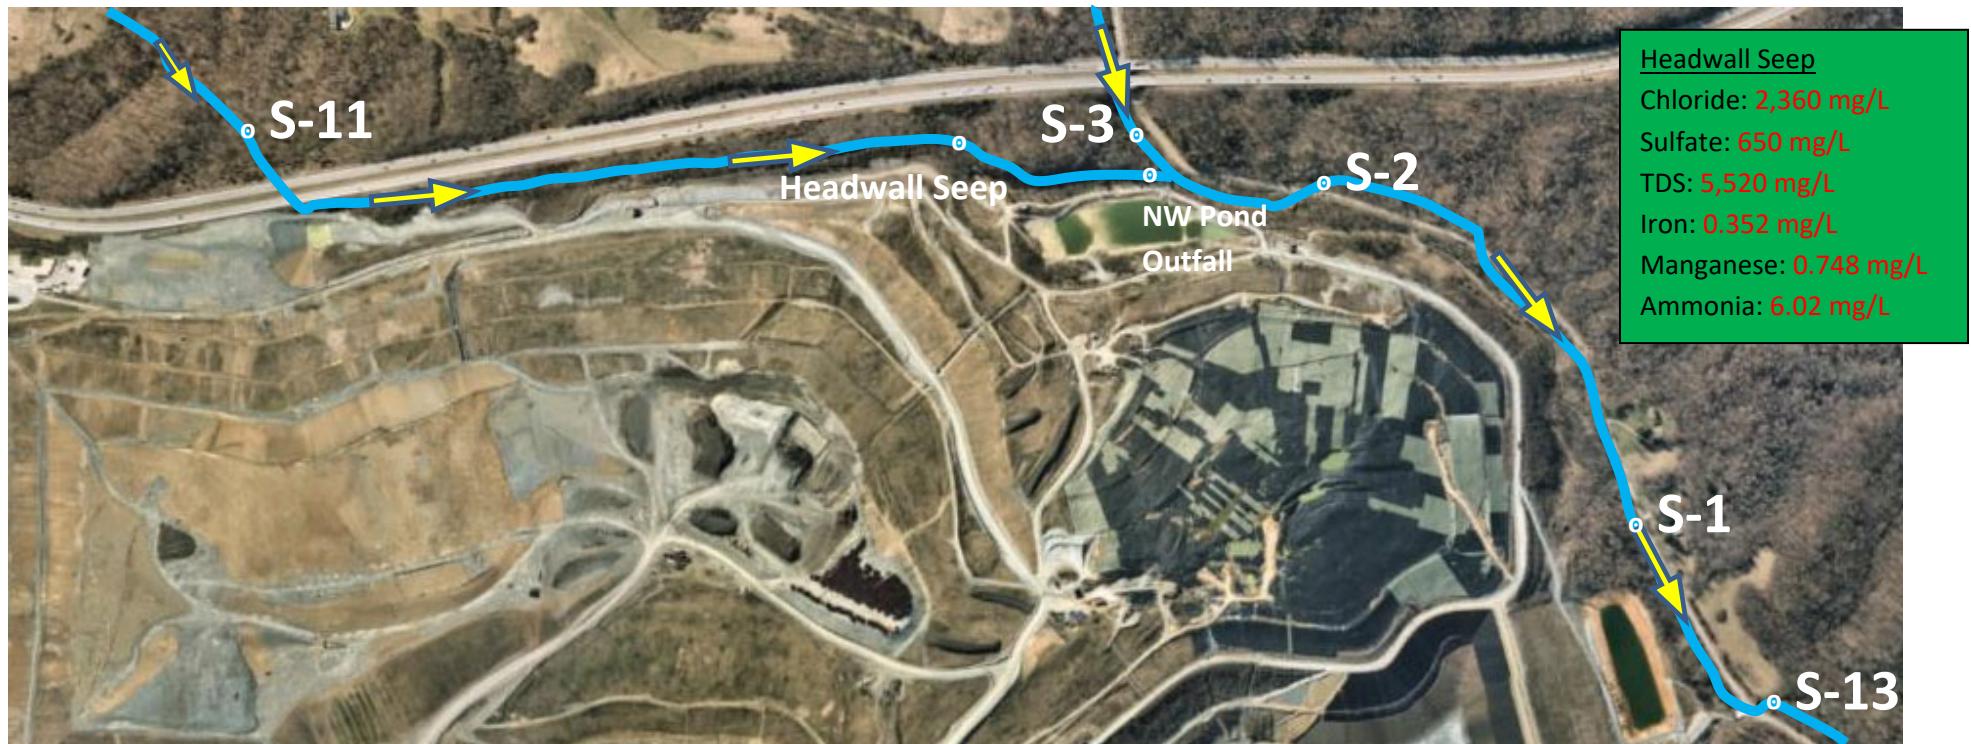
Figure 3

Comparison of Western Watershed Sampling Locations

June 27, 2024

Red indicates above the MCL/SMCL/Action Level

<u>S-11</u>
Chloride: 682 mg/L
Sulfate: 217 mg/L
TDS: 1,610 mg/L
Iron: 0.121 mg/L
Manganese: 0.0142 mg/L
Ammonia: Non-detect

<u>S-3</u>
Chloride: 243 mg/L
Sulfate: 70.1 mg/L
TDS: 783 mg/L
Iron: 0.394 mg/L
Manganese: 0.104 mg/L
Ammonia: Non-detect

<u>S-2</u>
Chloride: 1,750 mg/L
Sulfate: 869 mg/L
TDS: 4,140 mg/L
Iron: Non-detect
Manganese: 0.137 mg/L
Ammonia: Non-detect

<u>S-1</u>
Chloride: 1,820 mg/L
Sulfate: 884 mg/L
TDS: 4,020 mg/L
Iron: 0.273 mg/L
Manganese: 0.264 mg/L
Ammonia: Non-detect

<u>S-13</u>
Chloride: 1,440 mg/L
Sulfate: 518 mg/L
TDS: 2,960 mg/L
Iron: 0.291 mg/L
Manganese: 0.283 mg/L
Ammonia: Non-detect

Sampling results comparing the upstream sample locations (S-3 & S-11) and downstream sample locations (S-1, S-2 & S-13) are illustrated on Figures 3 & 4 and narrated below:

- Chloride was detected above the secondary maximum contaminant level (SMCL) of 250 mg/l in upstream sample location S-11 during the June (682 mg/l) and October sampling events (522mg/l). Chloride was not detected above the SCML in upstream sample S-3 during 2024.

- Chloride was detected above the SCML in all downstream sample locations (S-1, S-2 & S-13) during the 2024 sampling events.
- Sulfate was detected at the SMCL of 250 mg/l in upstream sample S-11 during the October sampling event (250 mg/L). Sulfate was not detected above the SCML in upstream sample S-3 during 2024.

- Similarly to chloride, sulfate was detected above the SCML in all downstream sample locations (S-1, S-2 & S-13) during the 2024 sampling events.
- All upstream and downstream sample locations were above the SMCL of 500 mg/L for total dissolved solids (TDS) during the 2024 sampling events.

- In June and October 2024, iron was detected above the SMCL of 0.3 mg/l in upstream sample location S-3 at 0.394 mg/L & 0.614 mg/L, respectively. And above the SMCL in upstream sample location S-11 during the October 2024 sampling event (0.933 mg/L).

- Iron was non-detect in downstream location S-2 during the 2024 sampling events while all other downstream sample locations were below the SMCL in 2024.

- In June and October 2024, manganese was detected above the SMCL of 0.05 mg/l in upstream sample locations S-3 at 0.104 mg/L & 0.115 mg/L, respectively. And above the SMCL in upstream sample location S-11 during the October 2024 sampling event (0.0604 mg/L).

- Manganese was detected above the SMCL in downstream sample location S-1 during both 2024 sampling events and above the SMCL in downstream sample location S-13 in June 2024. Downstream sample location S-2 was non-detect or below the SMCL for manganese during both 2024 sampling events.

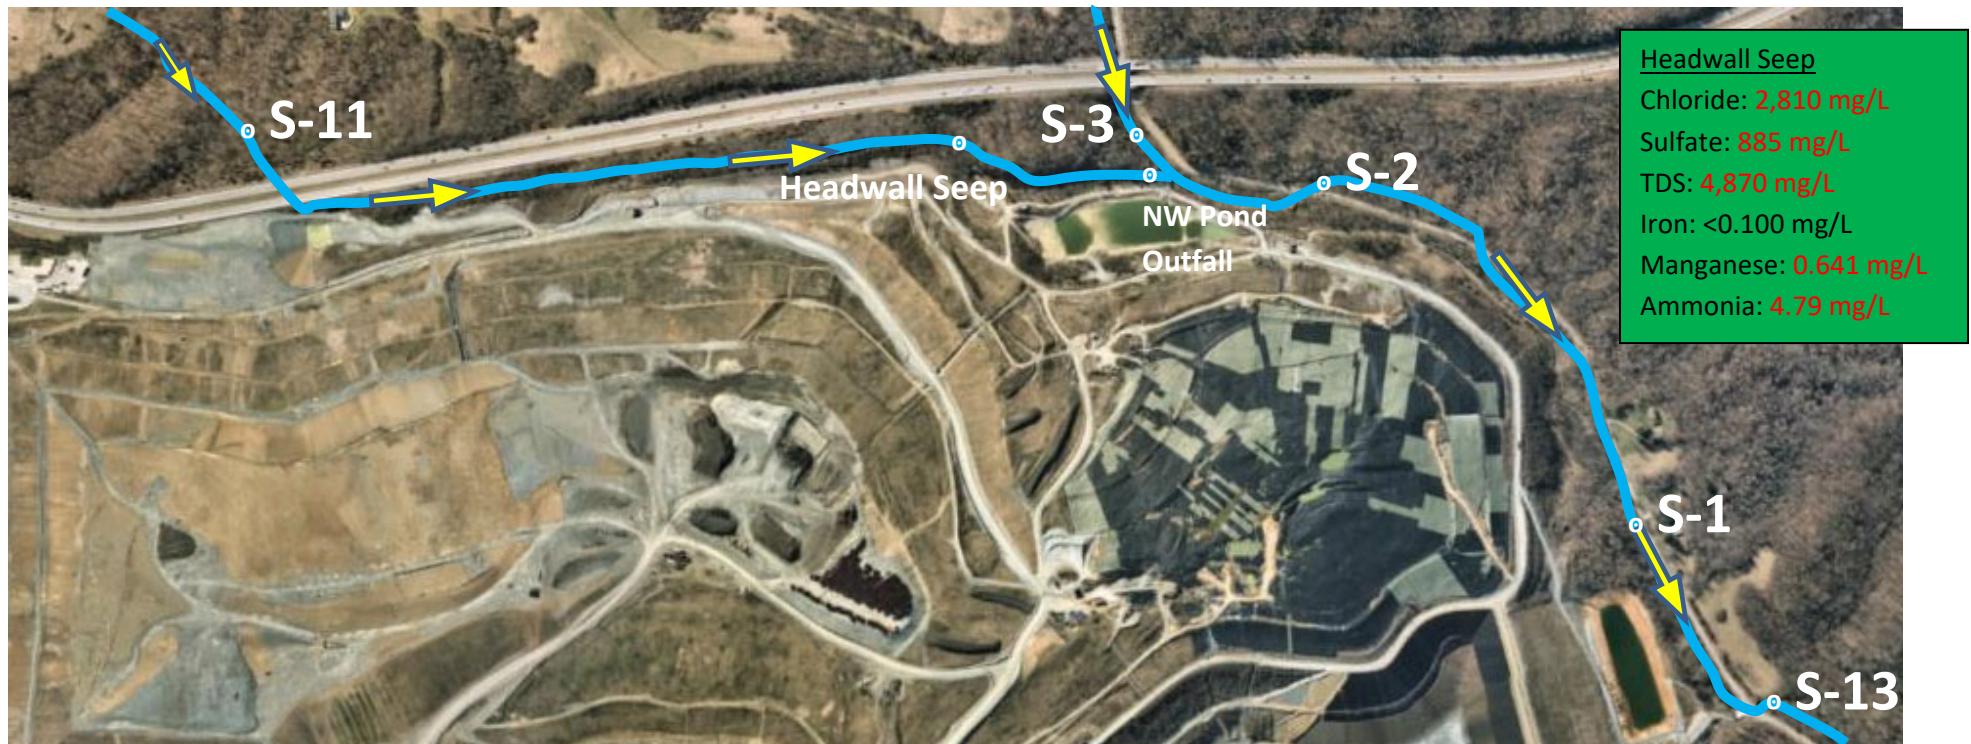
Figure 4

Comparison of Western Watershed Sampling Locations

October 24, 2024

Red indicates above the MCL/SMCL/Action Level

<u>S-11</u>
Chloride: 522 mg/L
Sulfate: 250 mg/L
TDS: 1,370 mg/L
Iron: 0.933 mg/L
Manganese: 0.0604 mg/L
Ammonia: Non-detect

<u>S-3</u>
Chloride: 172 mg/L
Sulfate: 106 mg/L
TDS: 785 mg/L
Iron: 0.614 mg/L
Manganese: 0.115 mg/L
Ammonia: Non-detect

<u>S-2</u>
Chloride: 2,480 mg/L
Sulfate: 1,310 mg/L
TDS: 4,710 mg/L
Iron: Non-detect
Manganese: 0.0221 mg/L
Ammonia: Non-detect

<u>S-1</u>
Chloride: 1,840 mg/L
Sulfate: 1,020 mg/L
TDS: 4,350 mg/L
Iron: 0.287 mg/L
Manganese: 0.515 mg/L
Ammonia: Non-detect

<u>S-13</u>
Chloride: 1,470 mg/L
Sulfate: 585 mg/L
TDS: 2,540 mg/L
Iron: 0.115 mg/L
Manganese: 0.232 mg/L
Ammonia: Non-detect

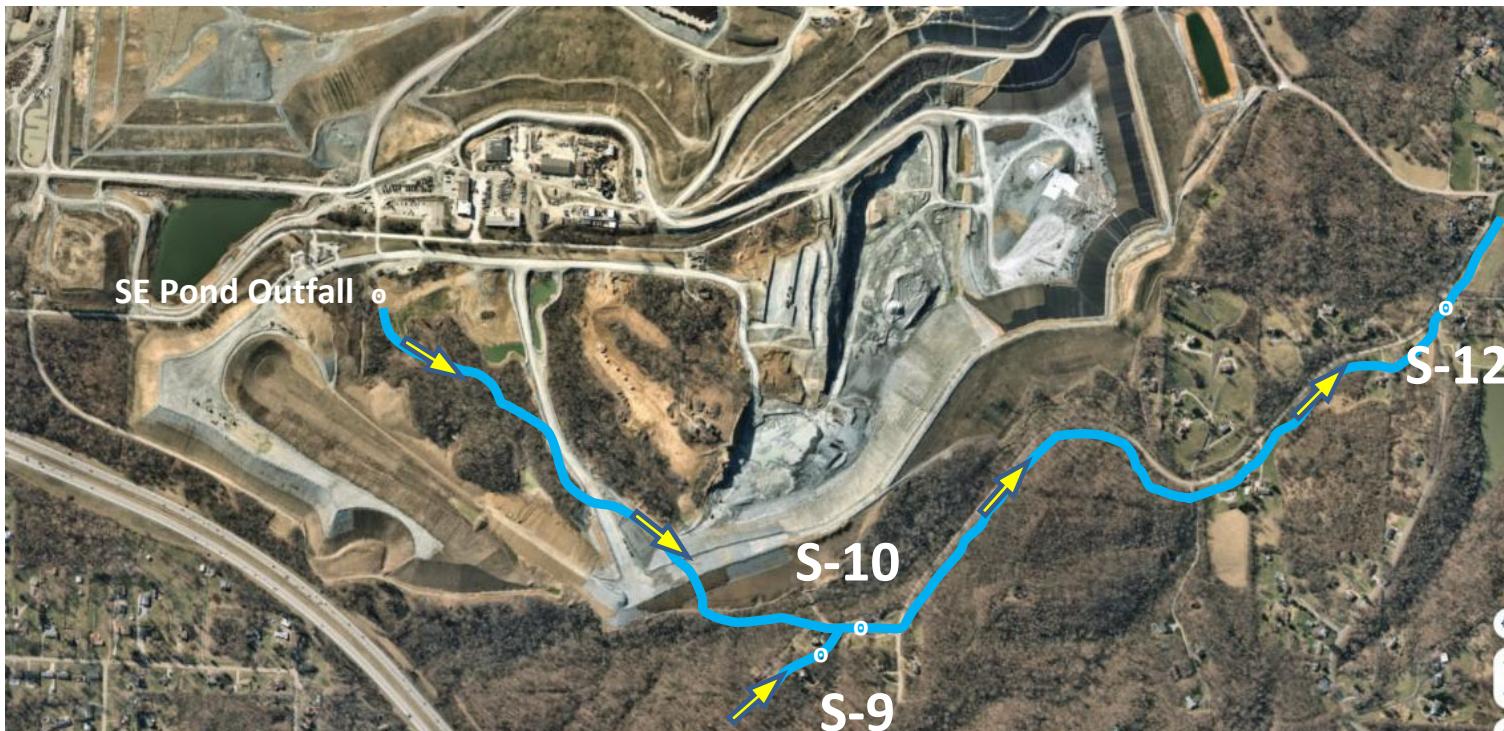
Figure 5

Comparison of Eastern Watershed Sampling Locations

June 27, 2024

→ Surface water flow direction
Red indicates above the MCL/SMCL/Action Level

No longer able to sample due to the construction of Eastern Expansion of landfill.

Chloride: 146 mg/L
Sulfate: 148 mg/L
TDS: 560 mg/L
Iron: 0.78 mg/L
Manganese: 0.0386 mg/L
Ammonia: Non-detect

Chloride: 302 mg/L
Sulfate: 241 mg/L
TDS: 974 mg/L
Iron: 0.784 mg/L
Manganese: 0.184 mg/L
Ammonia: Non-detect

Chloride: 200 mg/L
Sulfate: 154 mg/L
TDS: 676 mg/L
Iron: 0.775 mg/L
Manganese: 0.108 mg/L
Ammonia: Non-detect

The eastern watershed surrounding the landfill consists of the SE Pond discharge point, and downstream sample locations S-10 and S-12. Sample location S-9 could no longer be an effective upstream sample location during the October 2022 sampling event due to the eastern expansion of the landfill. Sampling results comparing the SE Pond and downstream sample locations (S-10 & S-12) are illustrated on Figures 5 & 6 and narrated below:

- Chloride was detected below the secondary maximum contaminant level (SMCL) of 250 mg/l in the SE Pond outfall sample during both 2024 sampling events.

- Chloride was detected above the SMCL in downstream sample location S-10 during both 2024 sampling events (302 mg/L & 614 mg/L, respectively) and downstream sample location S-12 in October 2024 (395 mg/).

- Sulfate was detected below the secondary maximum contaminant level (SMCL) of 250 mg/l in the SE Pond outfall sample in June and October 2024.
 - Sulfate was detected below the SMCL in downstream sample locations S-10 and S-12 in June 2024, but above the SMCL for sulfate October 2024.

- Total dissolved solids (TDS) was detected above the SMCL of 0.05 mg/l in all sample locations during both 2024 sampling events.
- Iron was detected above the SMCL of 0.05 mg/l in all sample locations during both 2024 sampling events.

- Manganese was detected below the secondary maximum contaminant level (SMCL) of 0.05 mg/l in the SE Pond outfall sample during the June 2024 sampling event (0.0386 mg/L) and above the SMCL in October 2024 (0.0805 mg/L).

- Manganese was detected above the SMCL in downstream sample location S-10 and S-12 during both 2024 sampling events.
- In October 2024, ammonia was detected above the 0.2 mg/l laboratory limits in the SE Pond outfall sample (0.369 mg/L) and downstream sample S-10 (0.33 mg/L). Less than 1.0 mg/L ammonia is considered usual for natural waters.

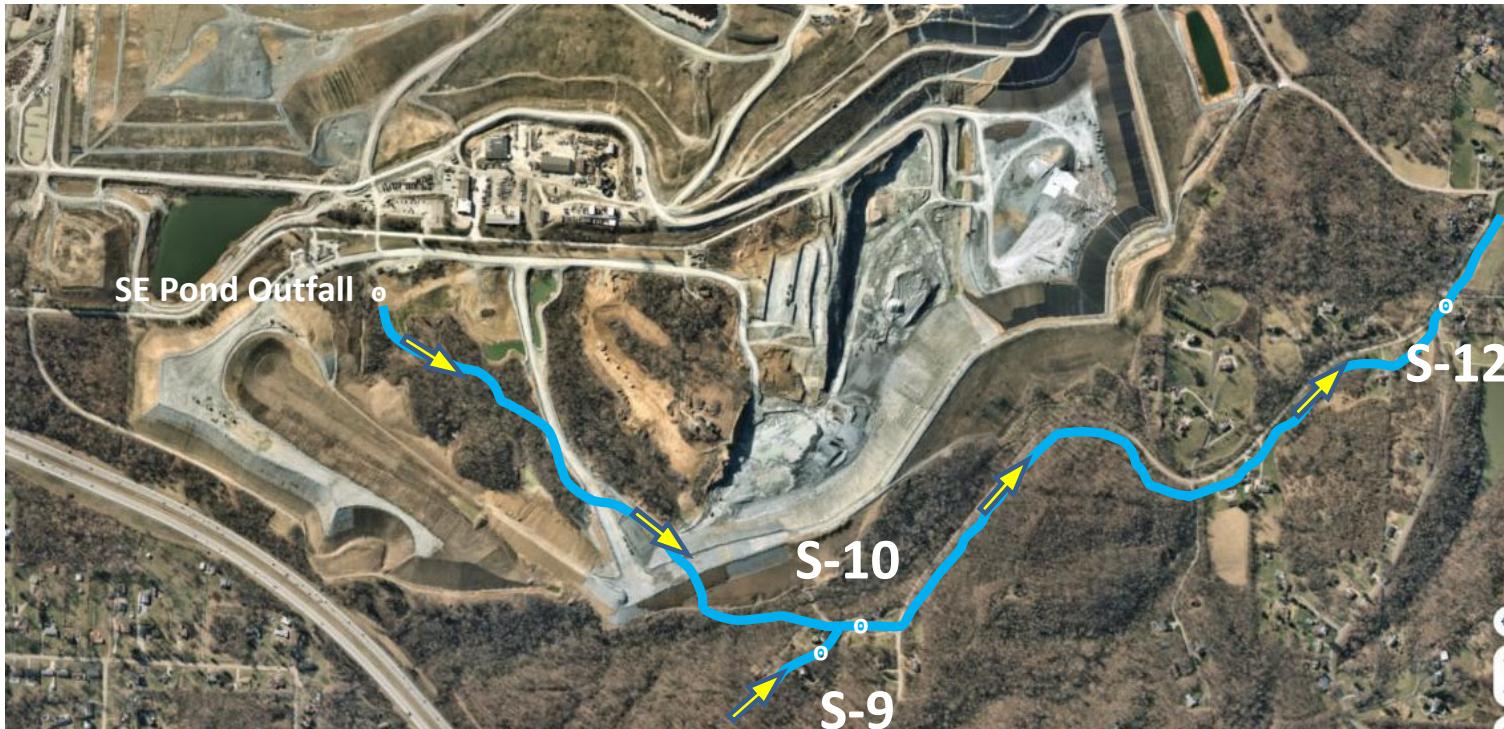
Figure 6
Comparison of Eastern Watershed Sampling Locations
October 24, 2024

No longer able to sample due to the construction of Eastern Expansion of landfill.

Chloride: 134 mg/L
Sulfate: 158 mg/L
TDS: 559 mg/L
Iron: 2.5 mg/L
Manganese: 0.0805 mg/L
Ammonia: 0.369 mg/L

Chloride: 614 mg/L
Sulfate: 428 mg/L
TDS: 1,530 mg/L
Iron: 0.541 mg/L
Manganese: 0.784 mg/L
Ammonia: 0.33 mg/L

Chloride: 395 mg/L
Sulfate: 266 mg/L
TDS: 1,140 mg/L
Iron: 0.45 mg/L
Manganese: 0.152 mg/L
Ammonia: Non-detect
