### **3.12.2 LOCKLAND INCINERATOR**

Facility Name: Lockland Incinerator

Location: West terminus of Davis Avenue along the east side of I-75 south  
339 Wilson St, Lockland OH

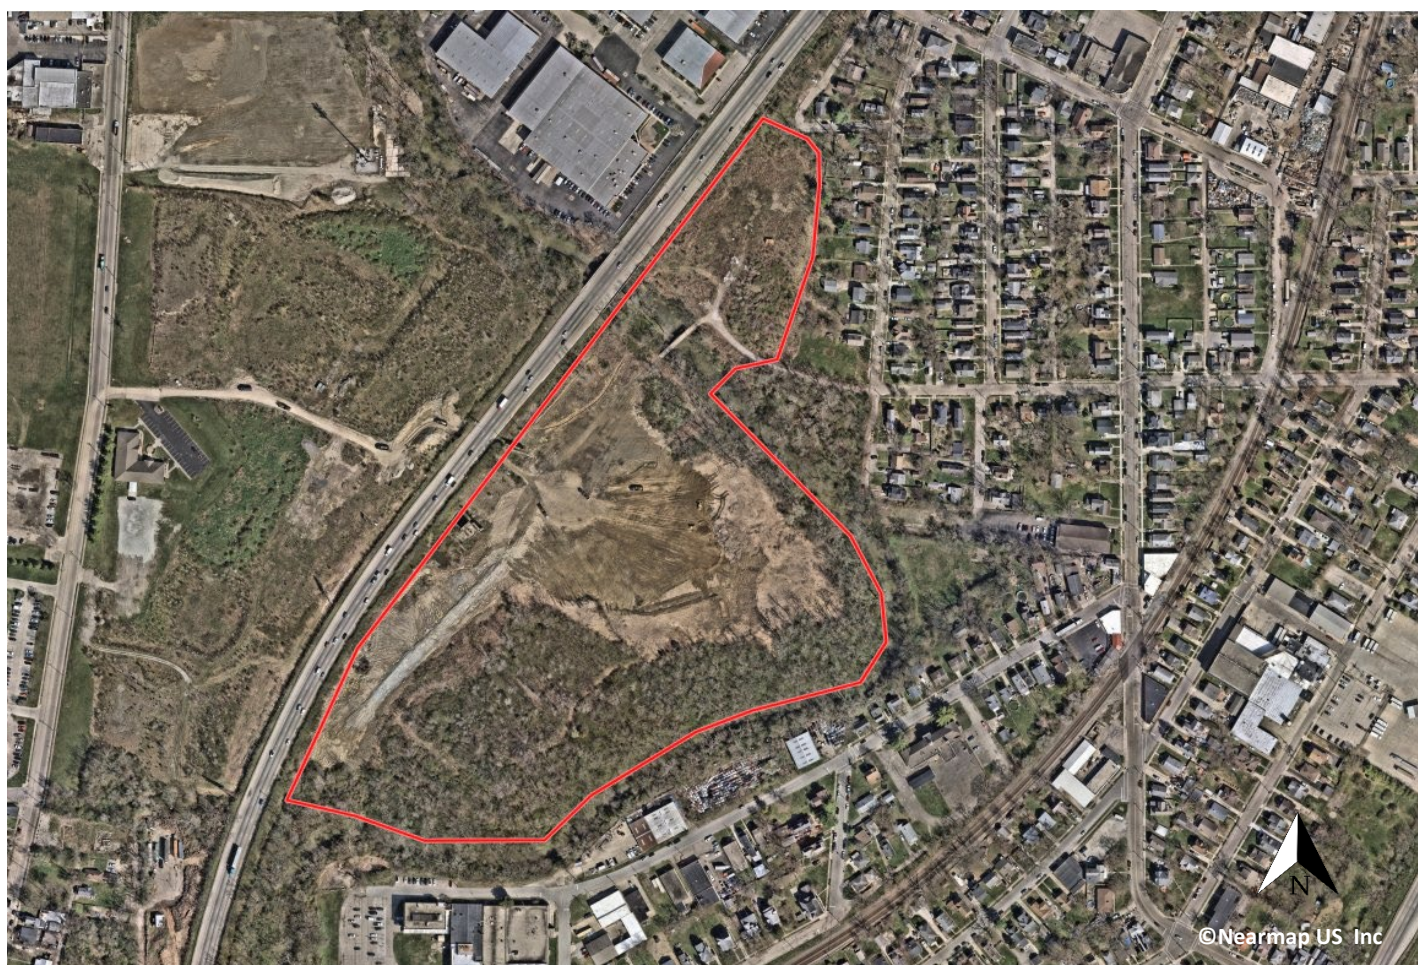
The Landfill is comprised of three parcels separated by the West Fork of the Mill Creek. The northern parcel (064100090017) is 5.28 acres bound on the north and east by residential property, the south by the West Fork of the Mill Creek, and the west by I-75S. The southern parcel (064100090011) is 25.63 acres bound on the west by I-75S and bound on the north, east, and south by the West Fork of the Mill Creek. The third parcel (064100090003) contains the old incinerator is within the 25.63-acre parcel bound on the west by I-75S.

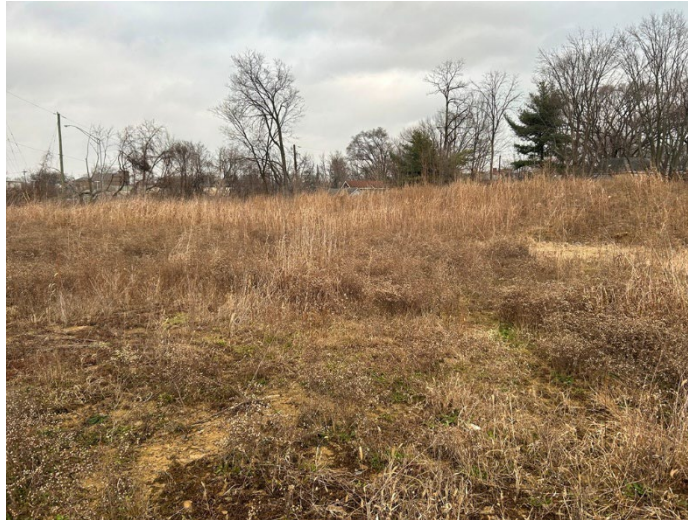
Northern Parcel

The site was inspected by HCPH on December 23, 2025. The inspector noted the northern portion of the site has grass and weed growth established over the entire area. The southern portion of the site had recently been cleared and some filling with soil had occurred along the western side of the site parallel to I-75.

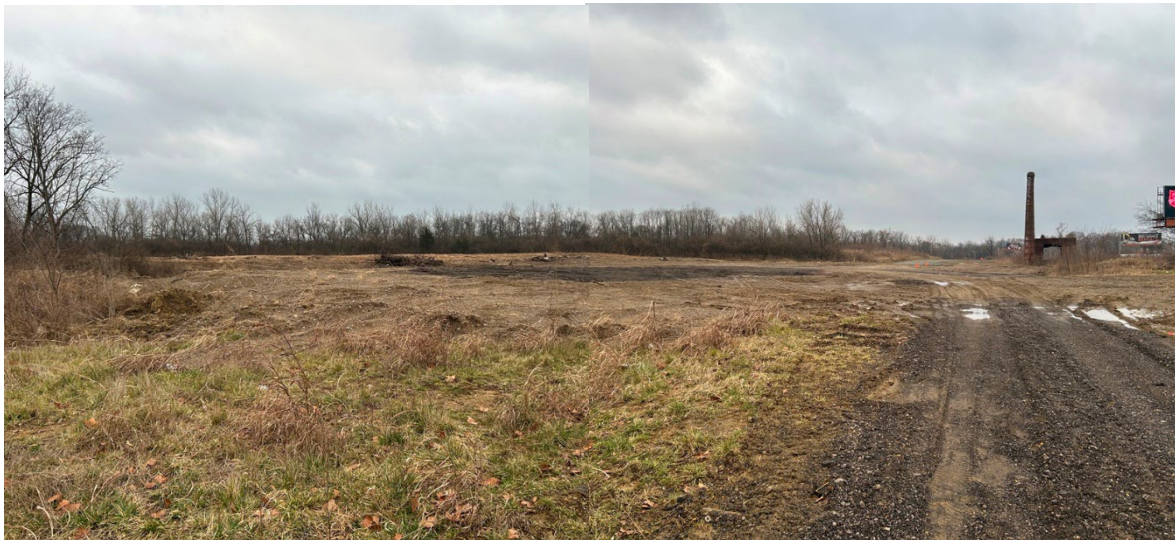
Southern Parcel

The site is currently vacant undeveloped land. The old incinerator building is still present on the southern parcel.

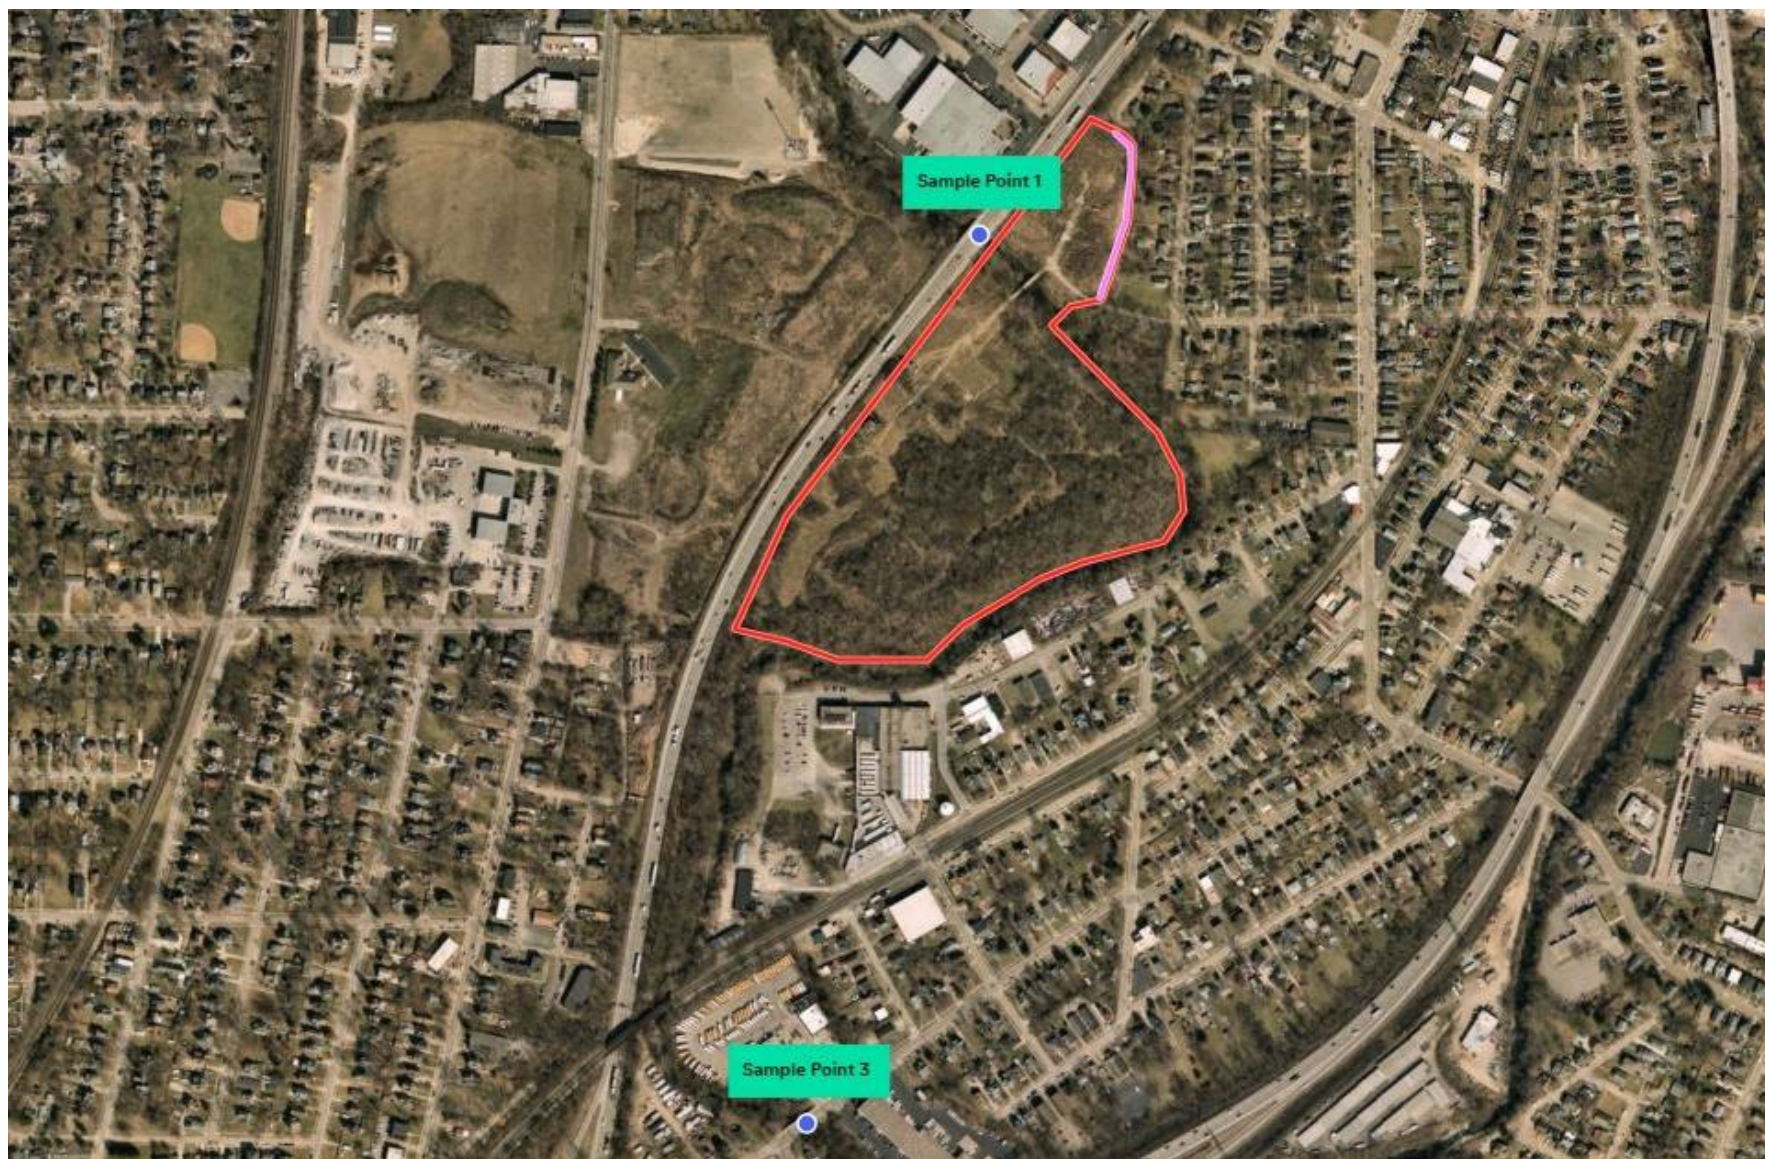
**Figure 3.12.2-C**  
**Lockland Incinerator**  
**Closed Landfill**

The West Fork of the Mill Creek flows around the Lockland (Incinerator) Landfill on the north, east and south. Historically, three sites were sampled in the West Fork of the Mill Creek above (S-1), next to (S-2), and below (S-3) the Lockland (Incinerator) landfill. Given the steady findings of S-2 and that both upstream and downstream samples are collected around Lockland (Incinerator) Landfill, sample site S-2 was removed from the sampling protocol in 2008. Samples around Lockland Incinerator Landfill were collected on October 20, 2025. The samples were collected during average to above average flow. The upstream sample location (S-1) is a low flow, shallow, rocky riffle area. The downstream sample location (S-3) has a gravel/sandy bottom with even lower flow. The referenced locations are shown on Figure 3.12.2-C.

Gas monitoring was conducted at the Lockland (Incinerator) Landfill on December 24, 2024. The areas monitored are shown on Figure 3.12.2-C and results are provided in Table 3.12.2-B. One detection at 4% LEL of methane occurred on the northern edge of the former landfill during 2025 monitoring. There were no detections of methane during 2024 monitoring. In 2023, one detection of methane occurred on the northern edge of the landfill, with a concentration of 3% LEL. One detection of methane occurred during 2022 monitoring, again on the northern edge of the landfill, at a concentration of 4% LEL.

= Surface Water Sampling Location
-

= Approximate Limits of Waste
-

= Area where gas monitoring is conducted approx. every 60 ft.
