### **3.12.3 LOCKLAND SHEPHERD LANE LANDFILL**

Facility Name: Lockland Shepherd Lane

#### **FACILITY OVERVIEW**

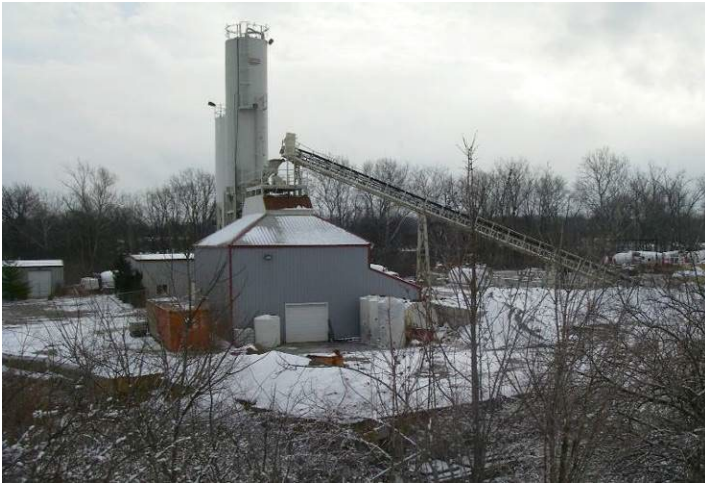
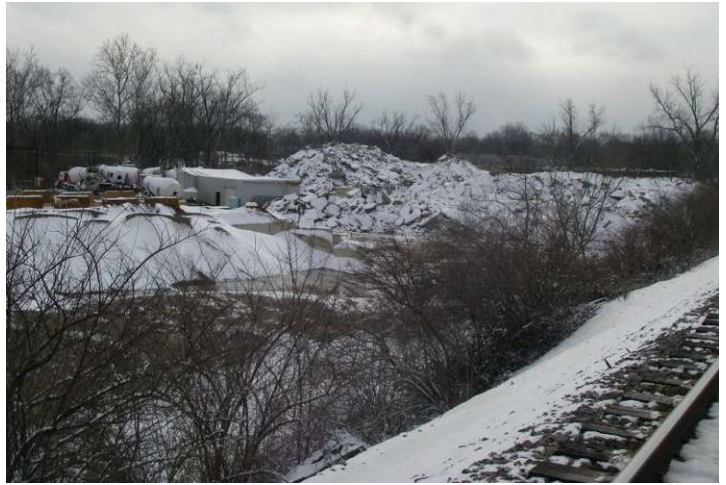
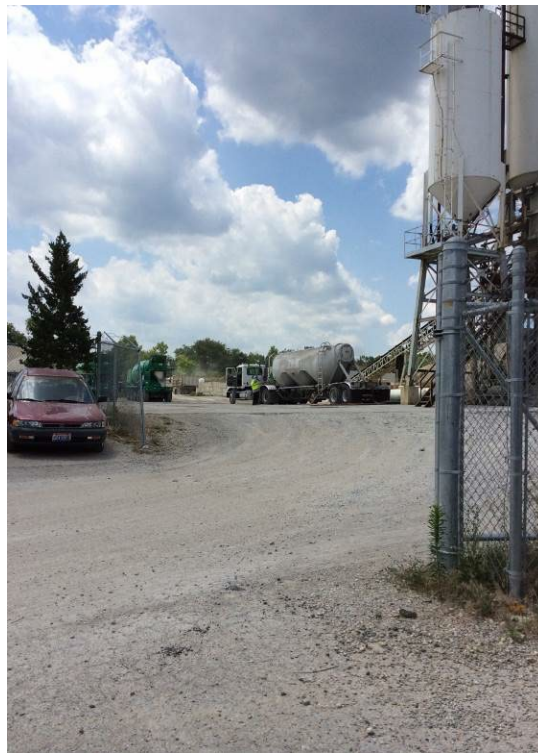
Currently a concrete company operates a plant on the site with equipment and material storage on top of the former landfill area.

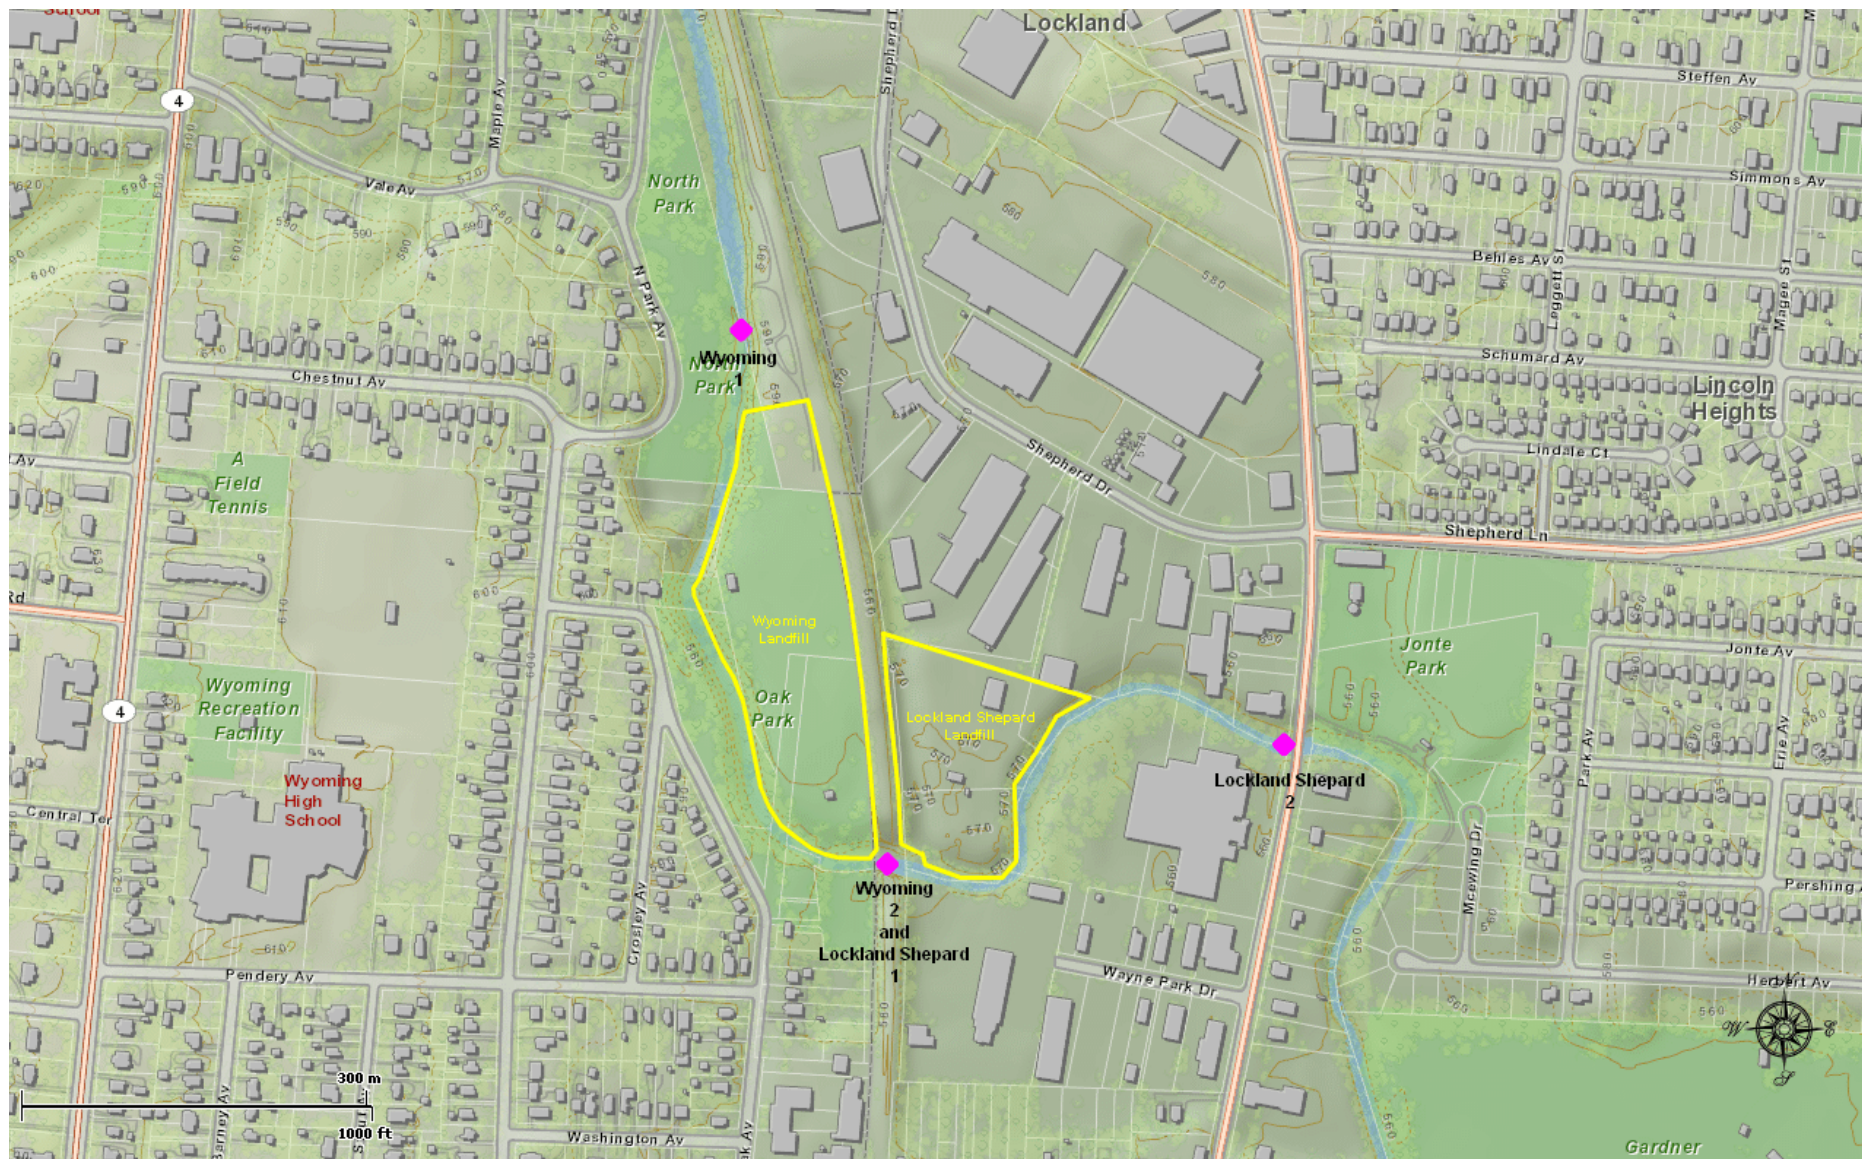
**Figure 3.12.3-D**  
**Wyoming and Lockland Shepherd**  
**Closed Landfills**

The West Fork of the Mill Creek flows along the south and east sides of the Lockland (Shepherd) Landfill. Stream samples are taken above (S-1) and below (S-2) the landfill. The Lockland landfill at Shepherd Lane is located adjacent and below the Wyoming landfill. Samples around Lockland Shepherd Lane Landfill were collected on October 20, 2025. The samples were collected during average flow. Both S-1 and S-2 sample locations consists of pools and riffles with a gravel and rocky bottom. The referenced locations are shown on Figure 3.12.3-D.

- ◆ = Surface Water Sampling Location
- = Approximate Limits of Waste
