### **3.13.3 MIAMIVIEW ASH LANDFILL**

Facility Name: Miamiview Road Ash Road Landfill

Owner: Duke Energy Miami Fort LLC

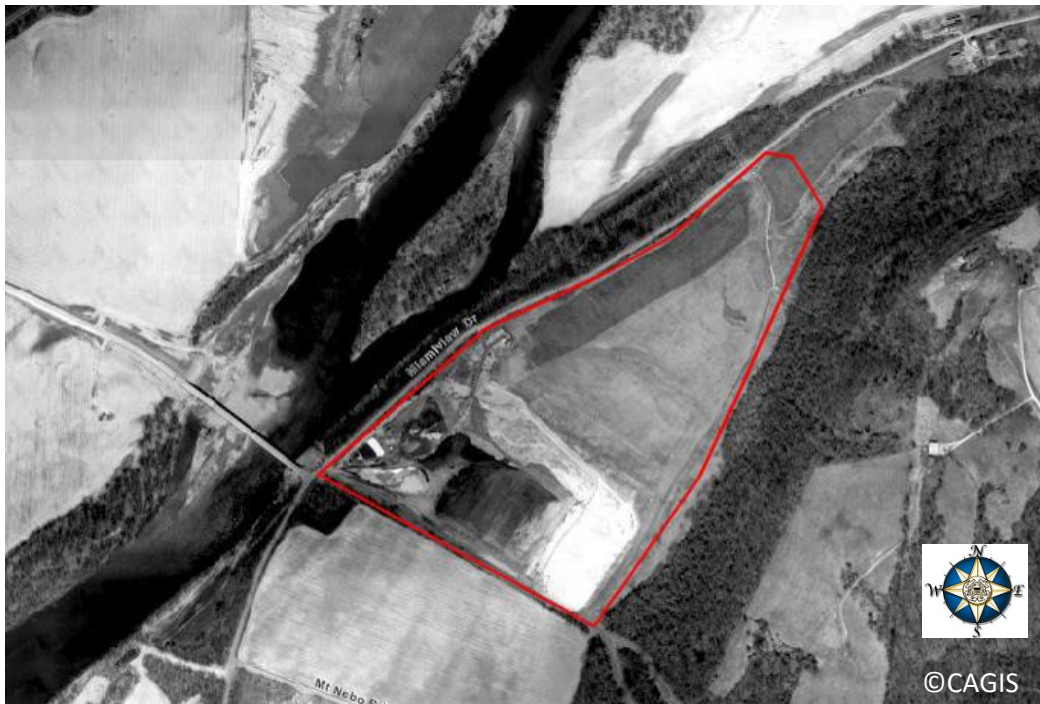
**FIGURE 3.13.3-A**

In 1993, a Permit to install (PTI) was issued for leachate collection, pH neutralization, and sedimentation systems for the landfill. NPDES monthly reports were provided to the Health District from June 1995 through April 1997. Monitoring for pH, conductivity, TSS, and Oil & Grease as part of the NPDES permit occurred at that time. The NPDES was not renewed when the site ceased operation in 1997. Figure 3.13.3-A is an aerial photograph from 1996. You can see in the aerial that the northern part of the site has been filled, and the southern end of the property is used for current disposal of the fly ash and bottom ash.

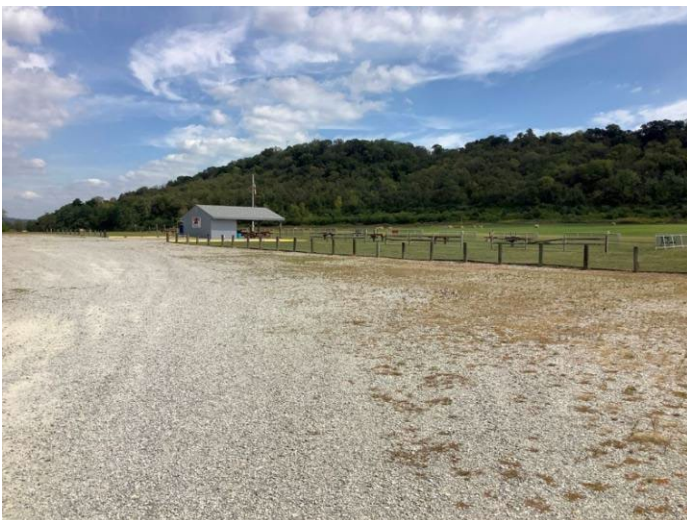
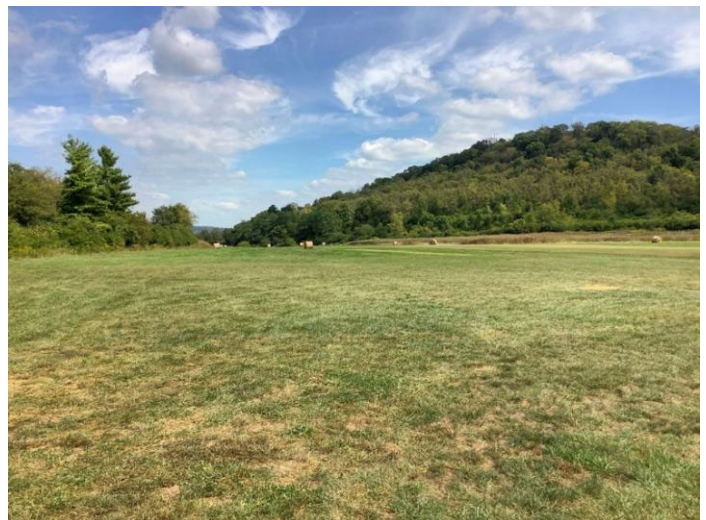
Today, the property is an open field utilized by Air Masters RC Flying Club as a model airplane flying field.
