### **3.15.2 OLD GALBRAITH ROAD LANDFILL**

Facility Name: Old Galbraith Road Landfill

Operation (yrs): 1958 – 1965

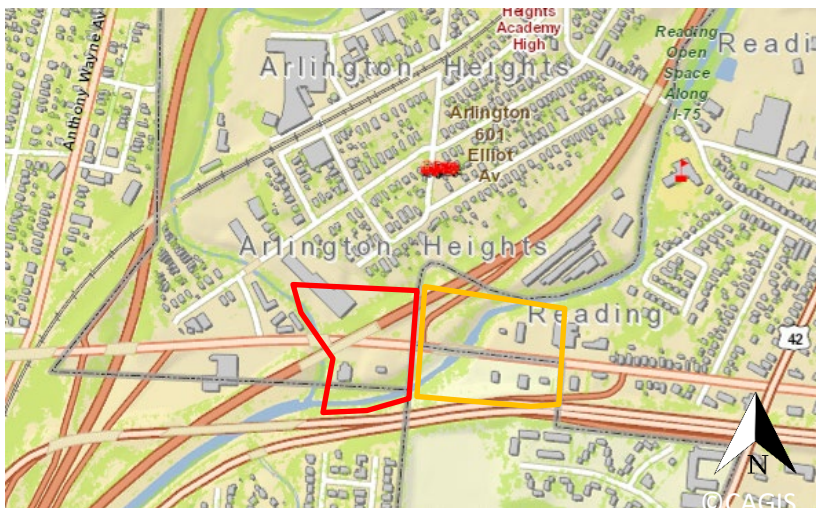
**FIGURE 3.15.2-A**

As seen in Figure 3.15.2-A that there is only a small area (outlined in red) that meets the location criteria of 200 yds. north and south of Galbraith Road, in Arlington Heights, and East of the Mill Creek. However, during review of aerial photos, it does not appear as though filling occurred on the north side of Galbraith Rd. in this area.

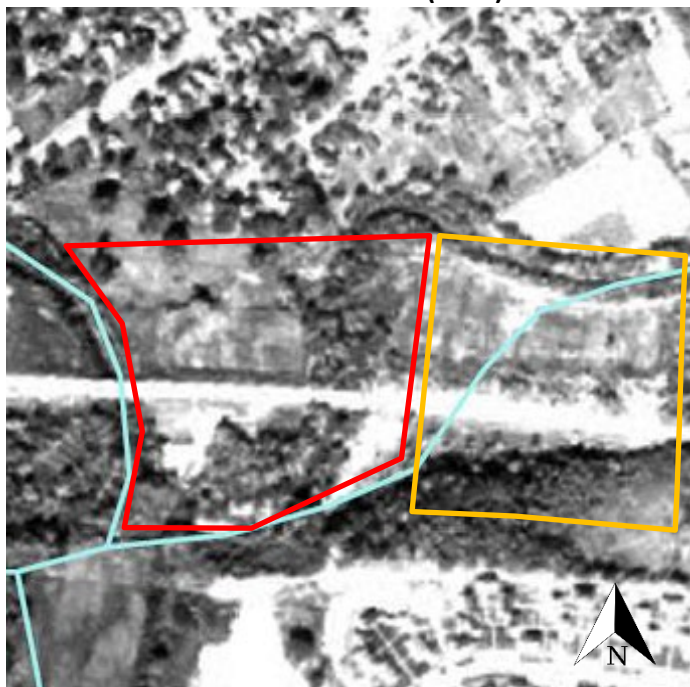
**FIGURE 3.15.2-B (1956)**

In the aerial photo from 1956 below (Figure 3.15.2-B), note that the East Fork of the Mill Creek is in its original location and I-75 North has not yet been constructed. The areas between the two forks of the Mill Creek are mostly tree covered or open land. In the aerial photo from 1968 (Figure 3.15.2-C) note that the East Fork of the Mill Creek is in its present-day location and I-75 North cuts through the area. The area between the forks of the Mill Creek has been cleared.

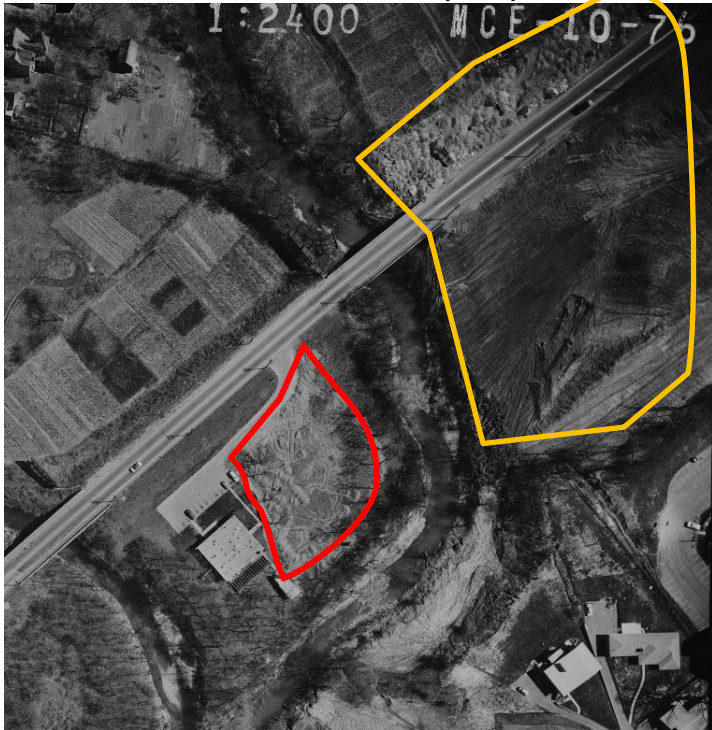
FIGURE 3.15.2-D (1960)

Review of ODOT aerial photographs from 1960 through 1969 (figures 3.15.2-D through G) reveals that filling occurred in the areas outlined in red above as well as in the areas outlined in orange. The areas outlined in orange appear to have fill placed on both the north and south side of Galbraith east of the Mill Creek but these areas are not located within Arlington Heights. It should be noted that filling in any of these areas could have been completed with clean hard fill only. Areas of filling are designated below by the colors that relate to areas in the figures above. The 1969 photograph was taken after a tornado affected the area. Debris resulting from the tornado is evident, but filling of the areas appears to be completed.
