### **3.16.1 PAUL WILLIS CLOSED LANDFILL**

Facility Name: Paul Willis Landfill

Location: 8073 Furlong Drive

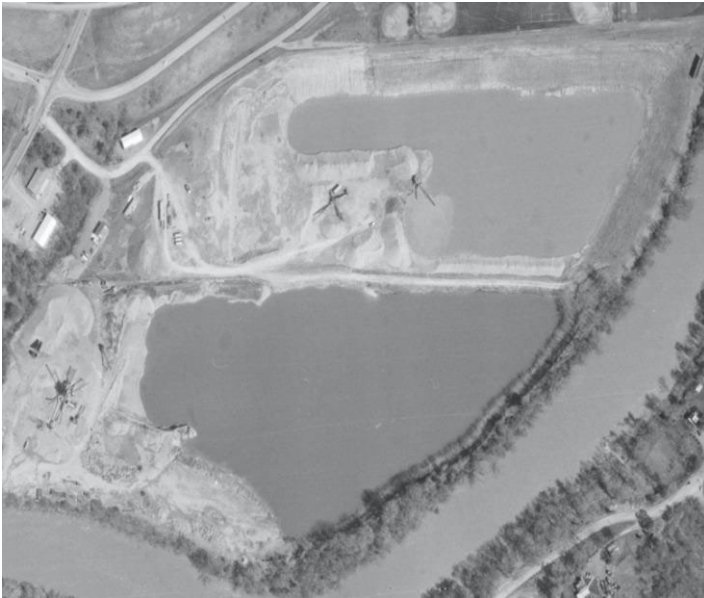
**FIGURE 3.16.1-A (1981)**

Continued mining at the property is evident through the early 1980’s (Figure 3.16.1-A) and filling is evident in the southwest portion of the property at this time. Filling of the former gravel pit occurred on a nearly continual basis but at some point transitioned to only clean hard fill. The property was eventually partially reclaimed and was used as a recreation area. Aerials from 1985 show a driving range and batting cages and by 1994 (Figure 3.16.1-B) a miniature golf course and go-kart track have been added.

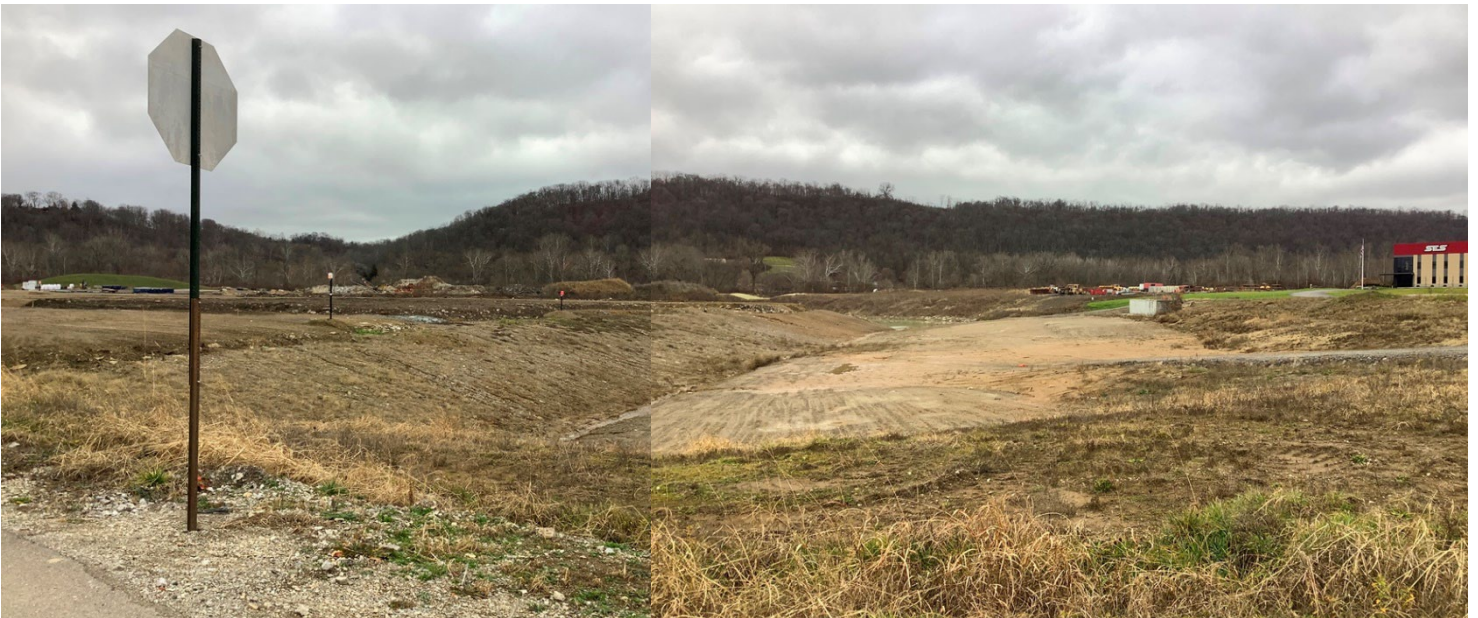
The property continues to operate as an active clean hard fill site. The western portion of the site contains several office and commercial buildings. A concrete plant with associated material and equipment storage operates on the eastern portion of the property. The central portion of the property is used for semi-trailer storage.
