### **3.23.4 WYOMING LANDFILL**

Facility Name: Wyoming Closed Landfill

Location: Situated in Wyoming's Oak Park, which is located east of Oak Avenue and northeast of the Crosley Avenue intersection in Wyoming, Ohio.

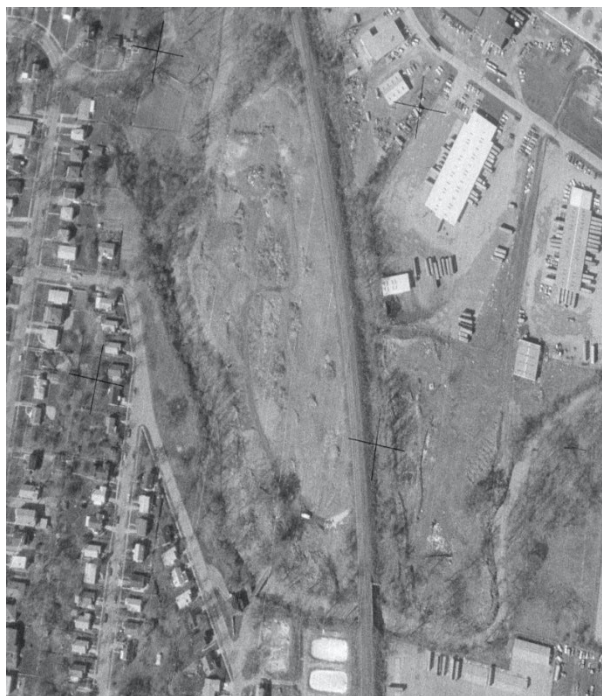
**FIGURE 3.23.4-A**

The City of Wyoming began operating the landfill sometime in the mid-1950's. Based on historic information and discussions with City personnel, the landfill was used to dispose of typical household waste (garbage), yard waste (grass cuttings, branches, leaves, etc.) and some hard fill type material (concrete, rubble, etc.). Lime from the public water treatment plant was also reportedly deposited in the northern portion of the landfill. Figure 3.23.4-A is an aerial from 1973 showing fill activities at the site. Figure 3.23.4-B is an aerial from 1986 after the area was developed as a park.

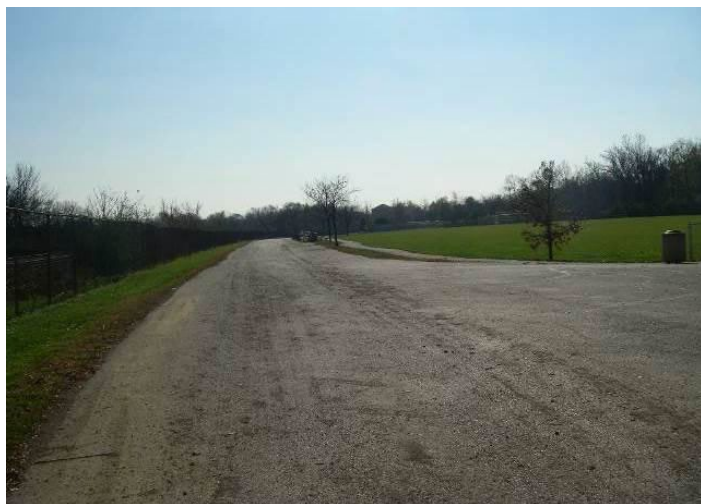
**Figure 3.23.4-C**  
**Wyoming Closed Landfill**

◆ = Surface Water Sampling Location

The West Fork of the Mill Creek flows along the west and south side of the Wyoming Landfill. Samples are taken above (S-1) and below (S-2) the landfill. Samples around Wyoming Landfill were collected on October 20, 2025 (Appendix A). The samples were collected during average flow. The S-1 sample location consisted of a series of pools and gravelly/rocky riffles located adjacent to the landfill. The Wyoming S-2 sample location is the same as the Lockland Shepherd Lane (S-1) sample location consisting of pools with a gravel/rocky bottom. The referenced locations are shown on Figure 3.23.4-C.

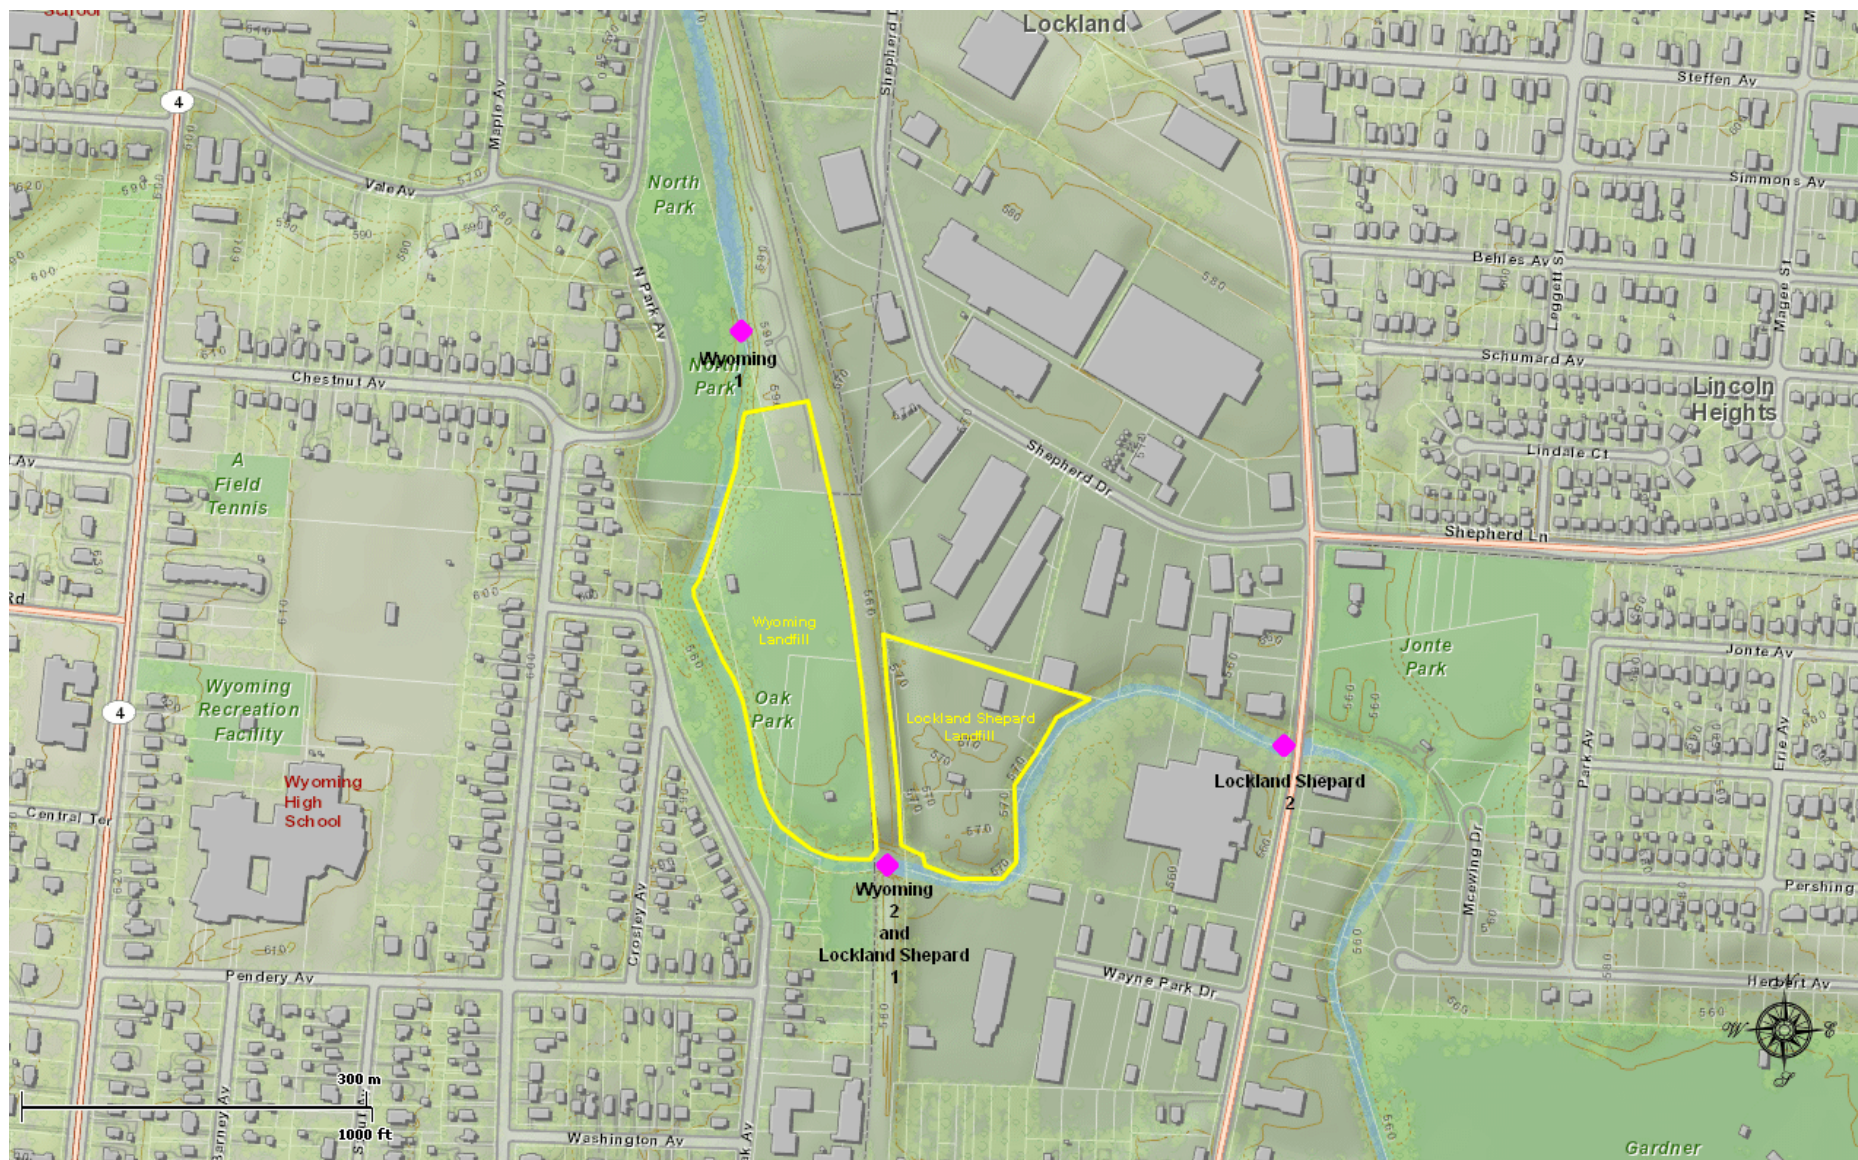
— = Approximate Limits of Waste

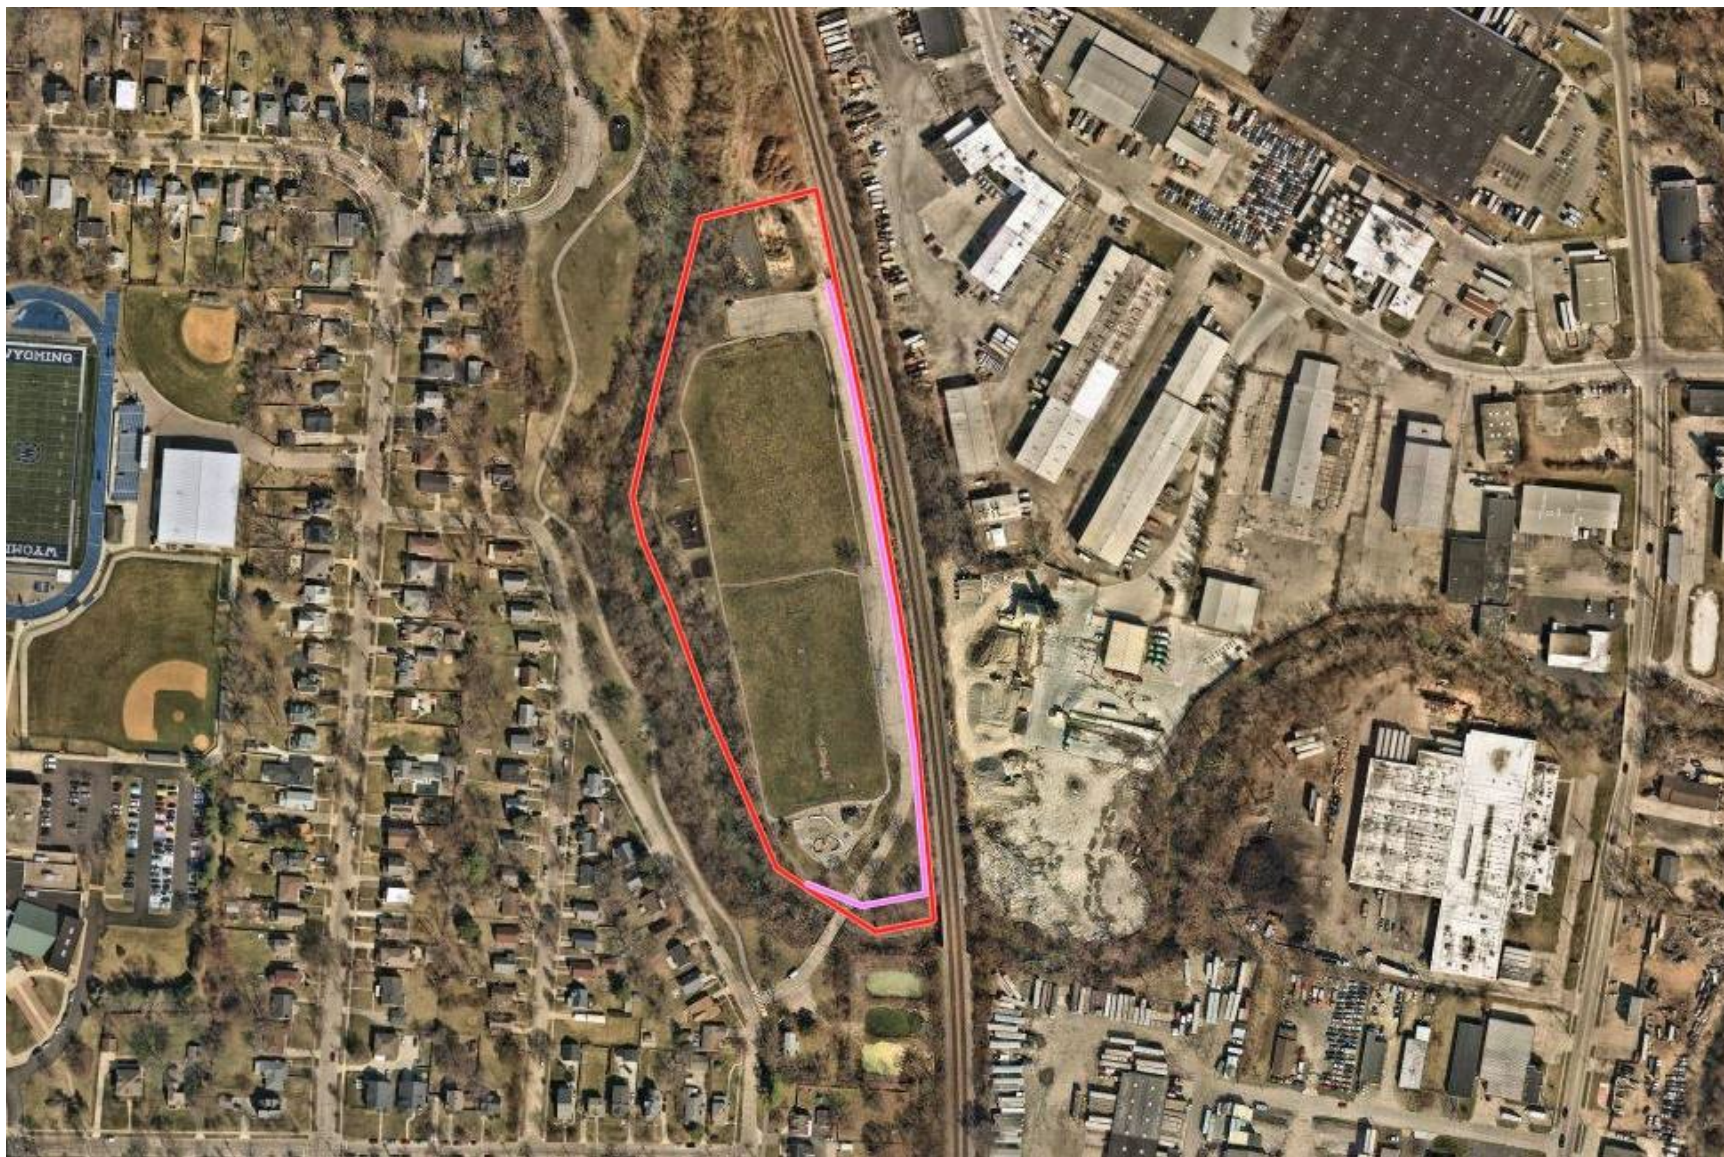
**Figure 3.23.4-D**  
**Wyoming Fall**  
**Gas Sampling**

The Wyoming Closed Landfill was monitored by HCPH for explosive gas on December 23, 2025 (Table 3.23.4-B). Monitoring took place along the southern and eastern perimeter of the property (Figure 3.23.4-D). Methane has been detected along the eastern boundary every year since 2007. During 2025 monitoring there were five detections of methane including two detections in excess of 25% LEL. Additional monitoring further out from those locations resulted in lower levels or no methane. Monitoring completed in 2024 resulted in 8 detections of methane. All detections of methane were low concentrations of <25% LEL except for a sample point along the northeast border of the landfill which had a concentration of 100% LEL and a sample on the west side of the parking lot which had a concentration of 53% LEL. Monitoring completed in 2023 resulted in 9 locations with methane detected including one sample point which had a concentration of 100% LEL. During 2025 monitoring carbon monoxide (CO) was detected at 17 of the sampling locations ranging in concentration from 7 to 301 ppm. This is similar to CO results for past monitoring events. During 2024 monitoring CO was detected at 19 of the sampling locations with concentrations between 2 and 43 ppm. During 2023 monitoring CO was detected at 20 of the sampling locations with concentrations between 2 and 81 ppm.

= Approximate Limits of Waste
-

= Area where gas monitoring is conducted approx. every 60 ft.

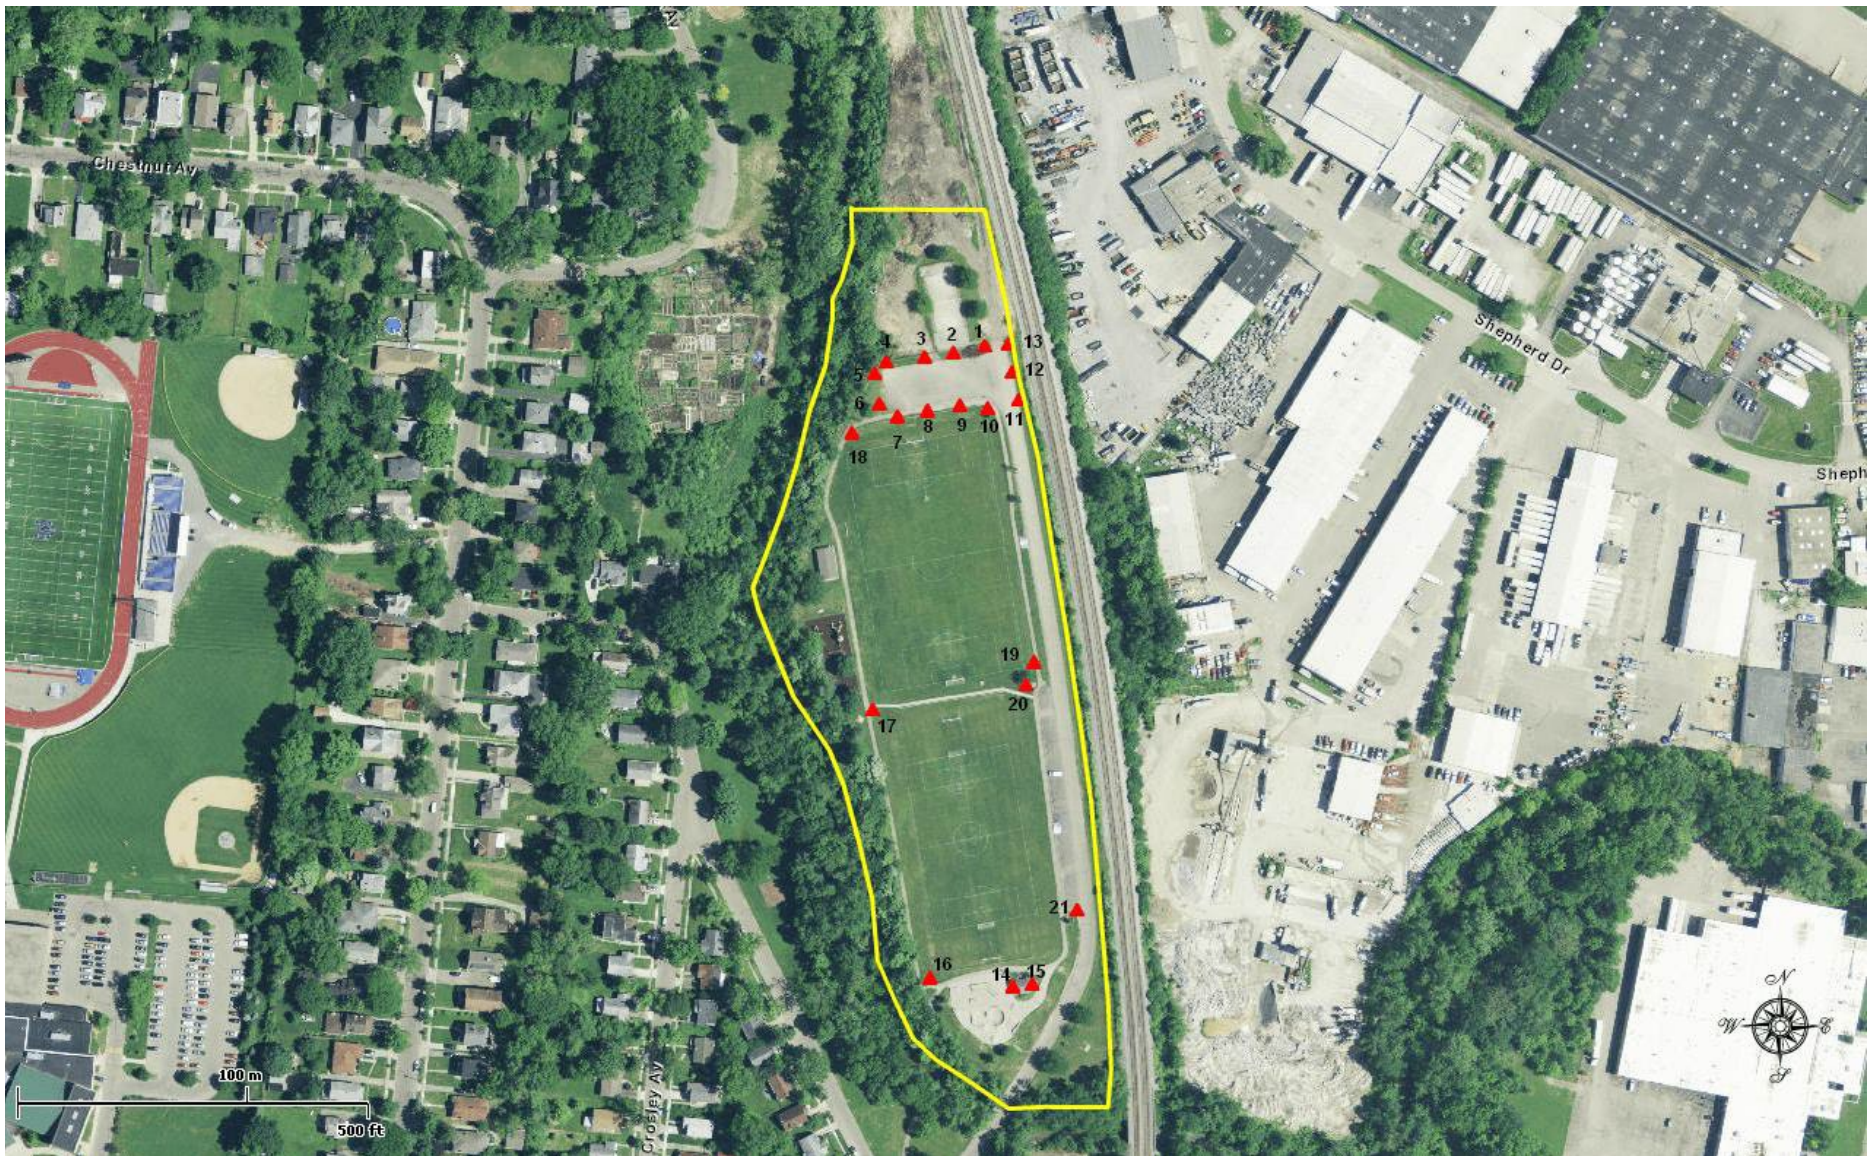
**Figure 3.23.4-E**  
**Wyoming Fireworks**  
**Gas Sampling**

The parking area at the north end of the park is likely located over waste. Punch bar sampling in this area has consistently indicated methane production and detection of carbon monoxide gas subsurface during sampling. Since 2006, WM staff have conducted additional sampling around the parking area at the north end of the park prior to the City of Wyoming using this area for fireworks launching in July. Sample locations 1-13 were sampled both at the surface and below the surface. Surface samples were taken using a 1-liter bottle placed over an area of ground (7 sq.in.). Pressure was applied to the bottle to form a semi-tight seal. A hole in the bottle allowed the sampling probe to draw from inside the bottle. Sample 14 was taken inside the women's restroom and sample 15 was taken inside the men's restroom, while samples 16 through 21 were taken from accessible sewer grates/manholes in the park. The results of the sampling are provided to the City of Wyoming prior to the event. The 2025 fireworks sampling locations are shown in Figure 3.23.4-E. The results of the June 2025 sampling are in Table 3.23.4-C. *(Sampling data for this landfill is in the files at Hamilton County Public Health).*

▲ = Approximate Gas  
Monitoring Location

— = Approximate Limits  
of Waste
