### **3.3.1 Caravella**

Facility Name: Caravella

Location: Southeast of intersection of Campbell Road and South State Street

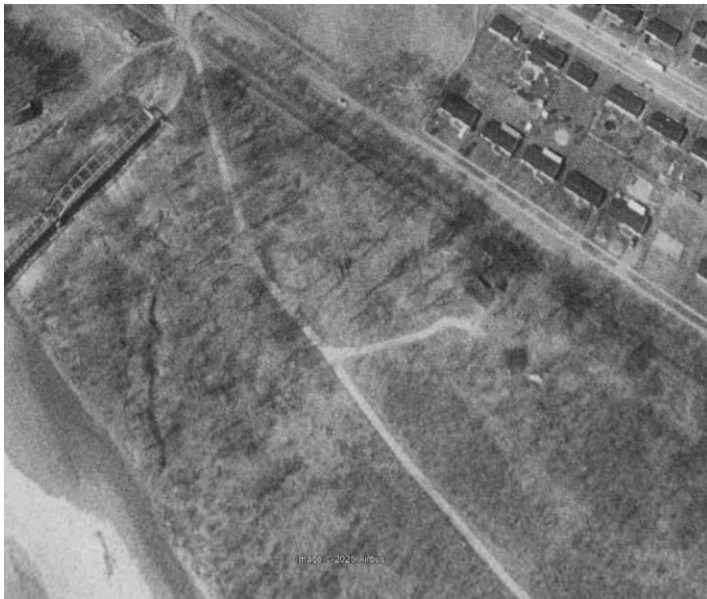
**FIGURE 3.3.1-A**

Hamilton County Public Health records for this landfill are limited. Therefore, it is unknown if waste was disposed of on the property or the exact location of disposal. Based on review of aerial photographs, in 1970 (Figure 3-3.1-A) the northwest portion of the property was cleared and had two small structures located in this area. By 1973 the structures are no longer present. An aerial from 1976 (Figure 3.3.1-B) shows a commercial building has been constructed in the far northwest corner of the parcel. Some land disturbance is evident on this aerial

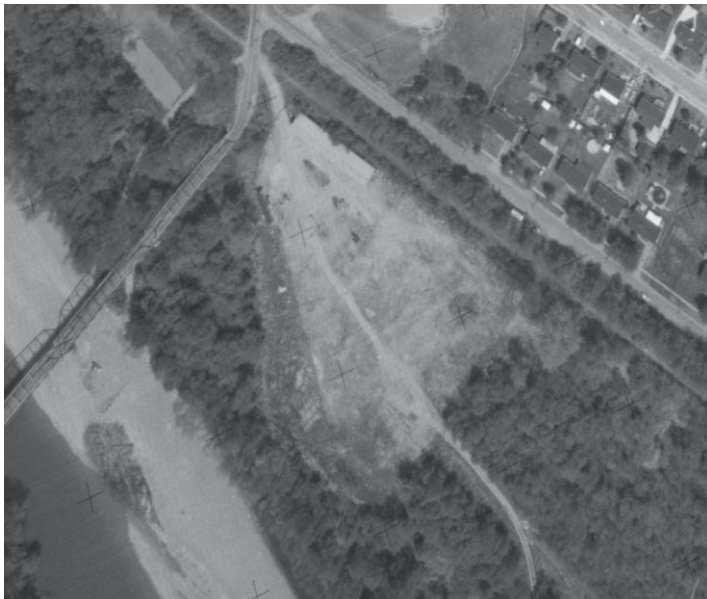
**FIGURE 3.3.1-B**

and other aerials from the 1970's. Based on records, during 1975 and 1976 Vincent Caravella inquired with the Ohio EPA about using the property as a sanitary landfill. The property was ultimately determined to be unsuitable for use as a sanitary landfill. At the time of the correspondence the property was described as a "solid fill type disposal site". During the 1970's this type of disposal may have included C&DD. The commercial building was removed sometime in the early 1980's and the property appears to be unused since then.

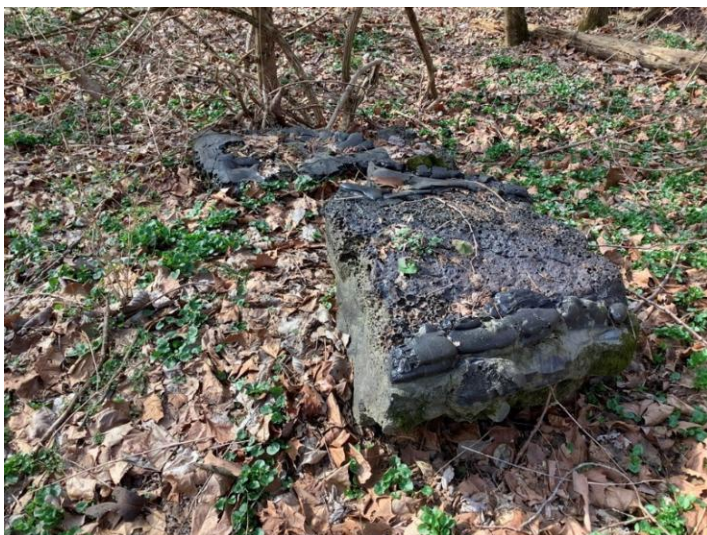
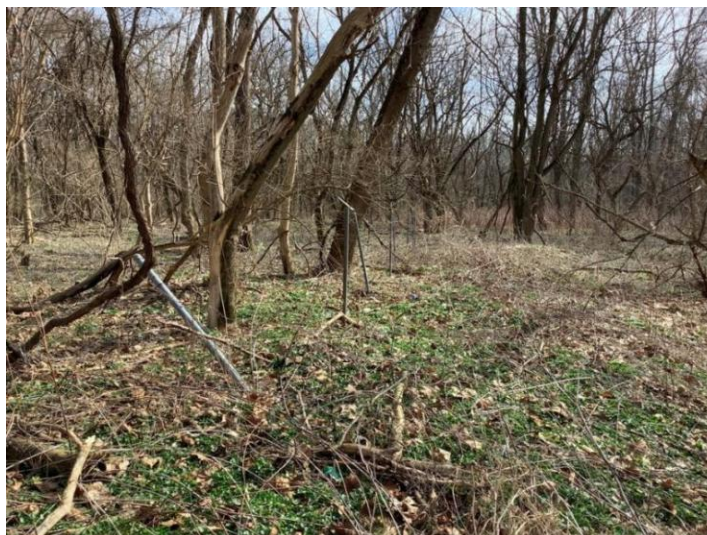
The site was inspected by HCPH on February 24, 2023. No violations or nuisance conditions related to the former landfill were observed on the site. There are various areas with some partially exposed tires, metal, foam cushions, etc. These may be remnants from filling or could be deposited during flood events since this area is in the flood plain of the adjacent Little Miami River.

At present today the property is undeveloped woodland with no direct access.
