### **3.5.1 EAST MIAMI RIVER ROAD LANDFILL**

Facility Name: East Miami River Road

Owner: Hamilton County Board of Commissioners

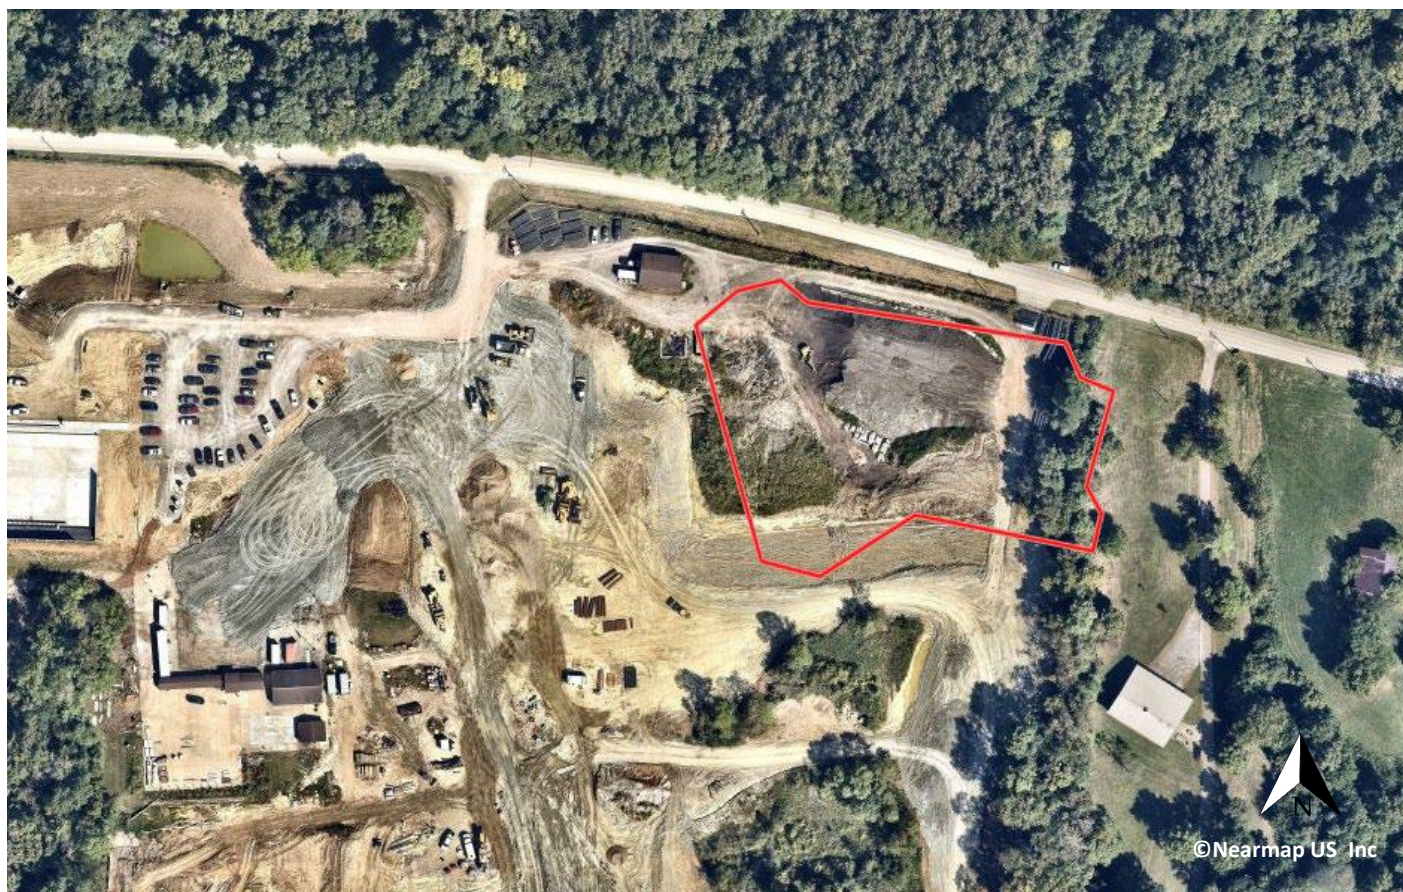
**FIGURE 3.5.1-A**

The Hamilton County Engineers office unofficially operated a landfill at the site since the 1950's. Prior to this the site was used for mining sand and gravel. The site was used to dispose of roadway, C&DD, storm debris, and litter picked up by the engineers' office. However, the site was not monitored or secured and was readily accessible to the public. Figure 3.5.1-A shows several aerals from 1976 through 1986. In the aerals filling is visible in the northeast corner of the property. Review of the aerals shows the extent of waste placement may have extended further northeast than a site characterization report completed in 1994 (figure 3.5.1-B) estimated.

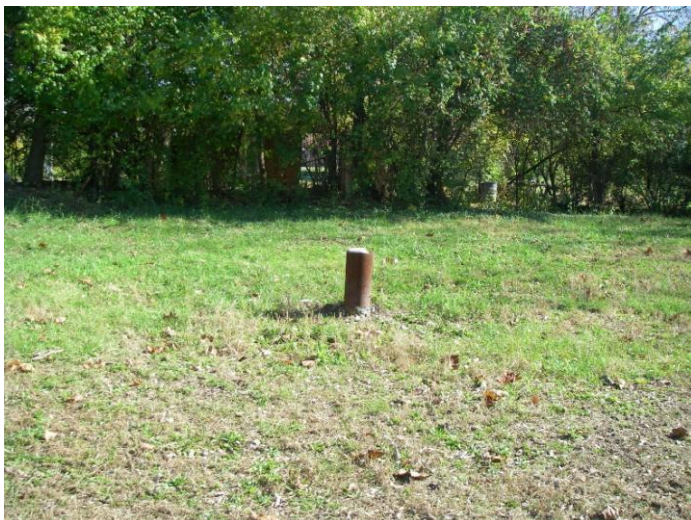
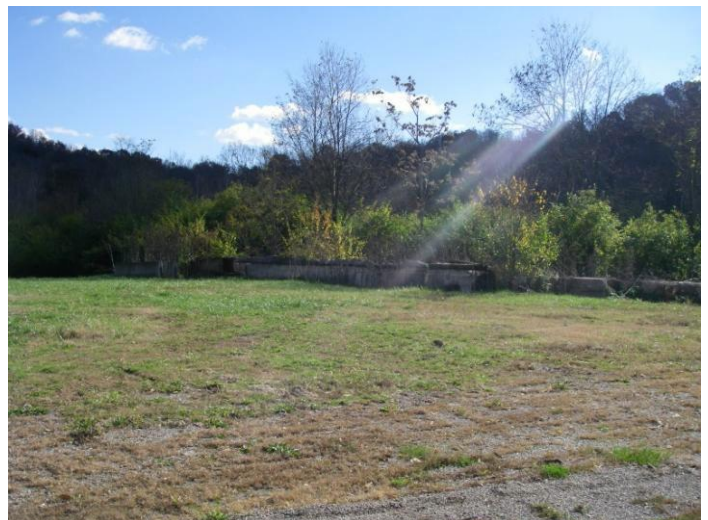
The site was last inspected by HCPH on December 16, 2025. The site was an active construction site, therefore only a limited visual inspection could be completed. Former landfill area appeared to be used mostly for storage of materials and equipment. The current status of the passive gas trench is unknown.

The site currently houses a firing range for the Hamilton County Sheriff's Office. Hamilton County is actively constructing a new "Regional Safety Complex which can be used by local, state and federal partners".
