### **3.15.3 OLD NEWTOWN LANDFILL**

Facility Name: Old Newtown Landfill

#### **FACILITY OVERVIEW**

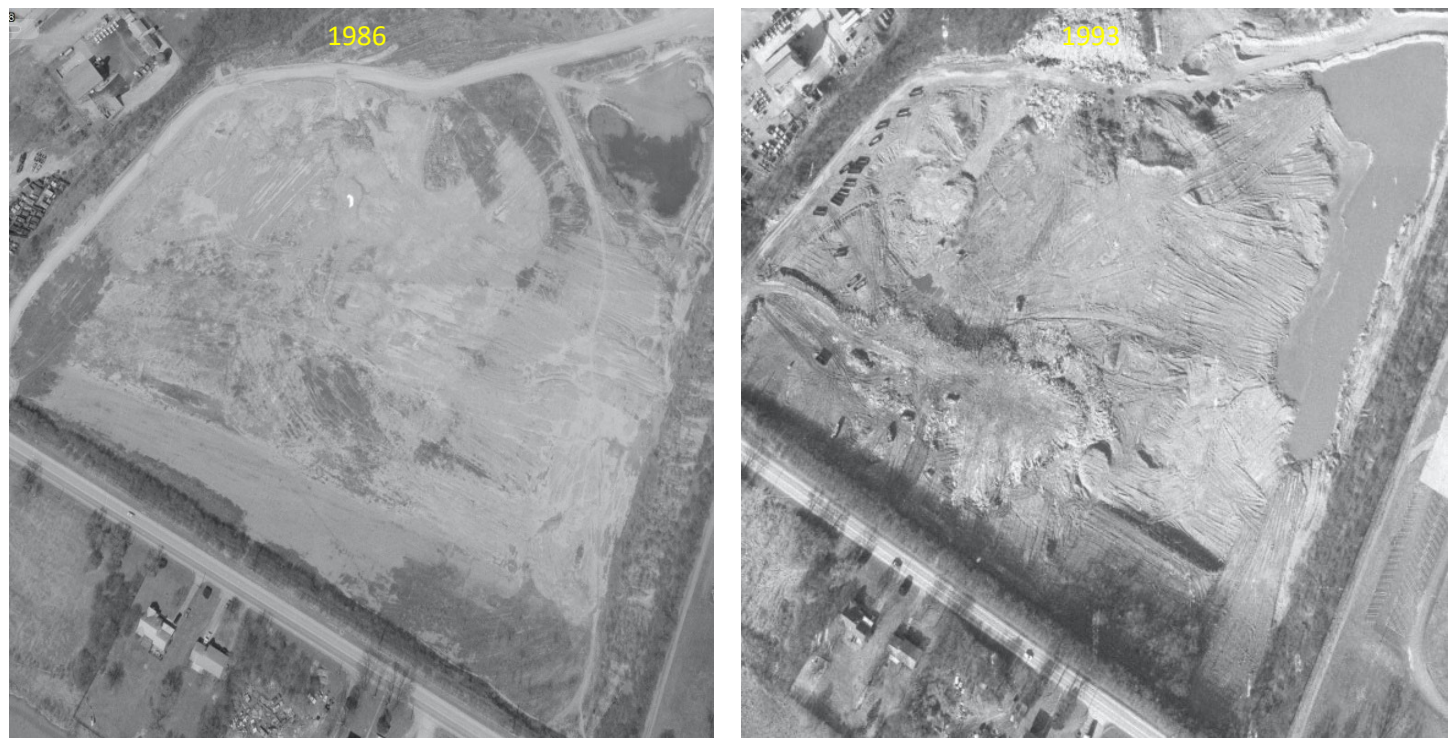
**FIGURE 3.15.3-A**

From review of aerials, it appears the gravel pit was mined in the 1970's. Filling of the former gravel pit began in the 1980's. Aerials from the 80's appear to show filling with soil. However, aerials from the 1990's appear to show filling with C&DD (Figure 3.15.3-A). An inspection completed by HCPH in 1995 described the facility as a closed C&DD landfill.

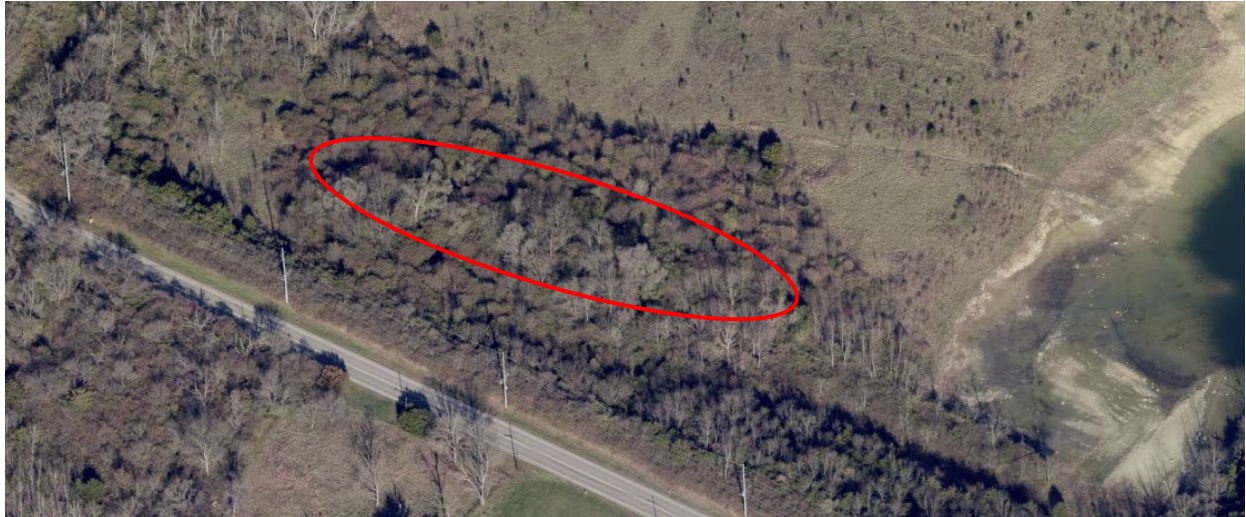
**FIGURE 3.15.3-E**

The site was inspected by HCPH on November 20, 2025. The south end of the property has become increasingly overgrown with honeysuckle, trees, and grass over the last 15 years making it more difficult to access and inspect. Areas of exposed waste which have been identified during previous inspections are still present. Some of the materials appear to be exposed from former landfill activities and other materials may be a result of past open dumping. The areas of exposed waste are completely covered with trees and Honeysuckle. Seeps have also been identified in the same general area during previous inspections but were not present at the time. Whether the seeps are naturally occurring or related to former landfill activities is unclear. The debris and seeps are located in the wooded areas on the Southern portion of the site as depicted in Figure 3.15.3-E.

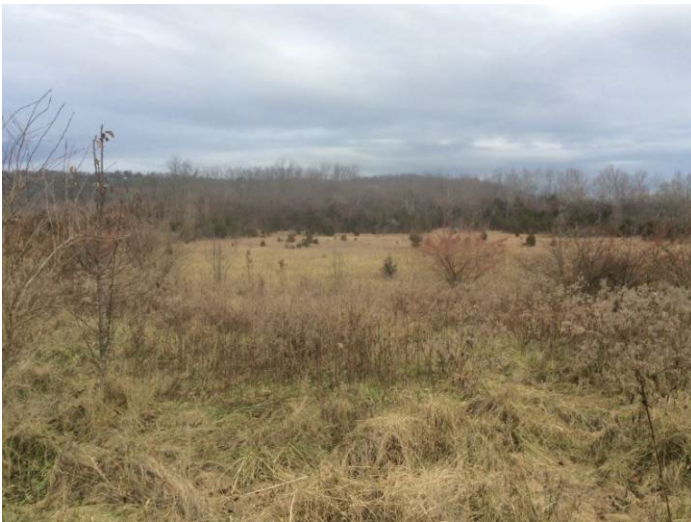
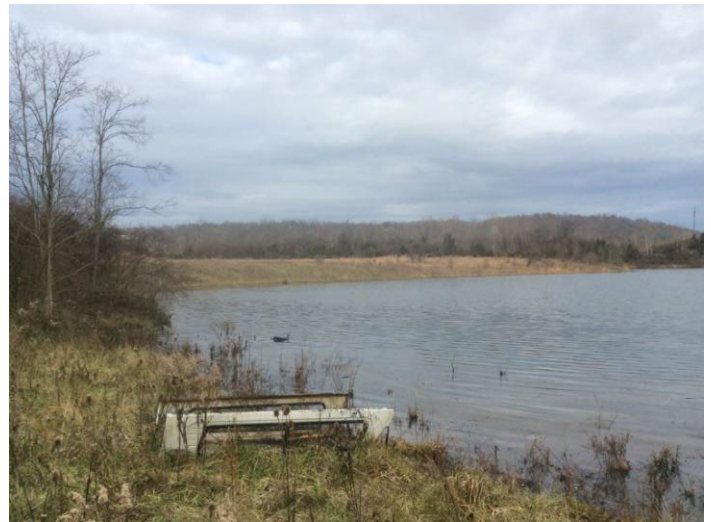
Today, the landfill area sits vacant with little to no activity at the site. The former landfill is covered with established grass, honeysuckle, and trees.

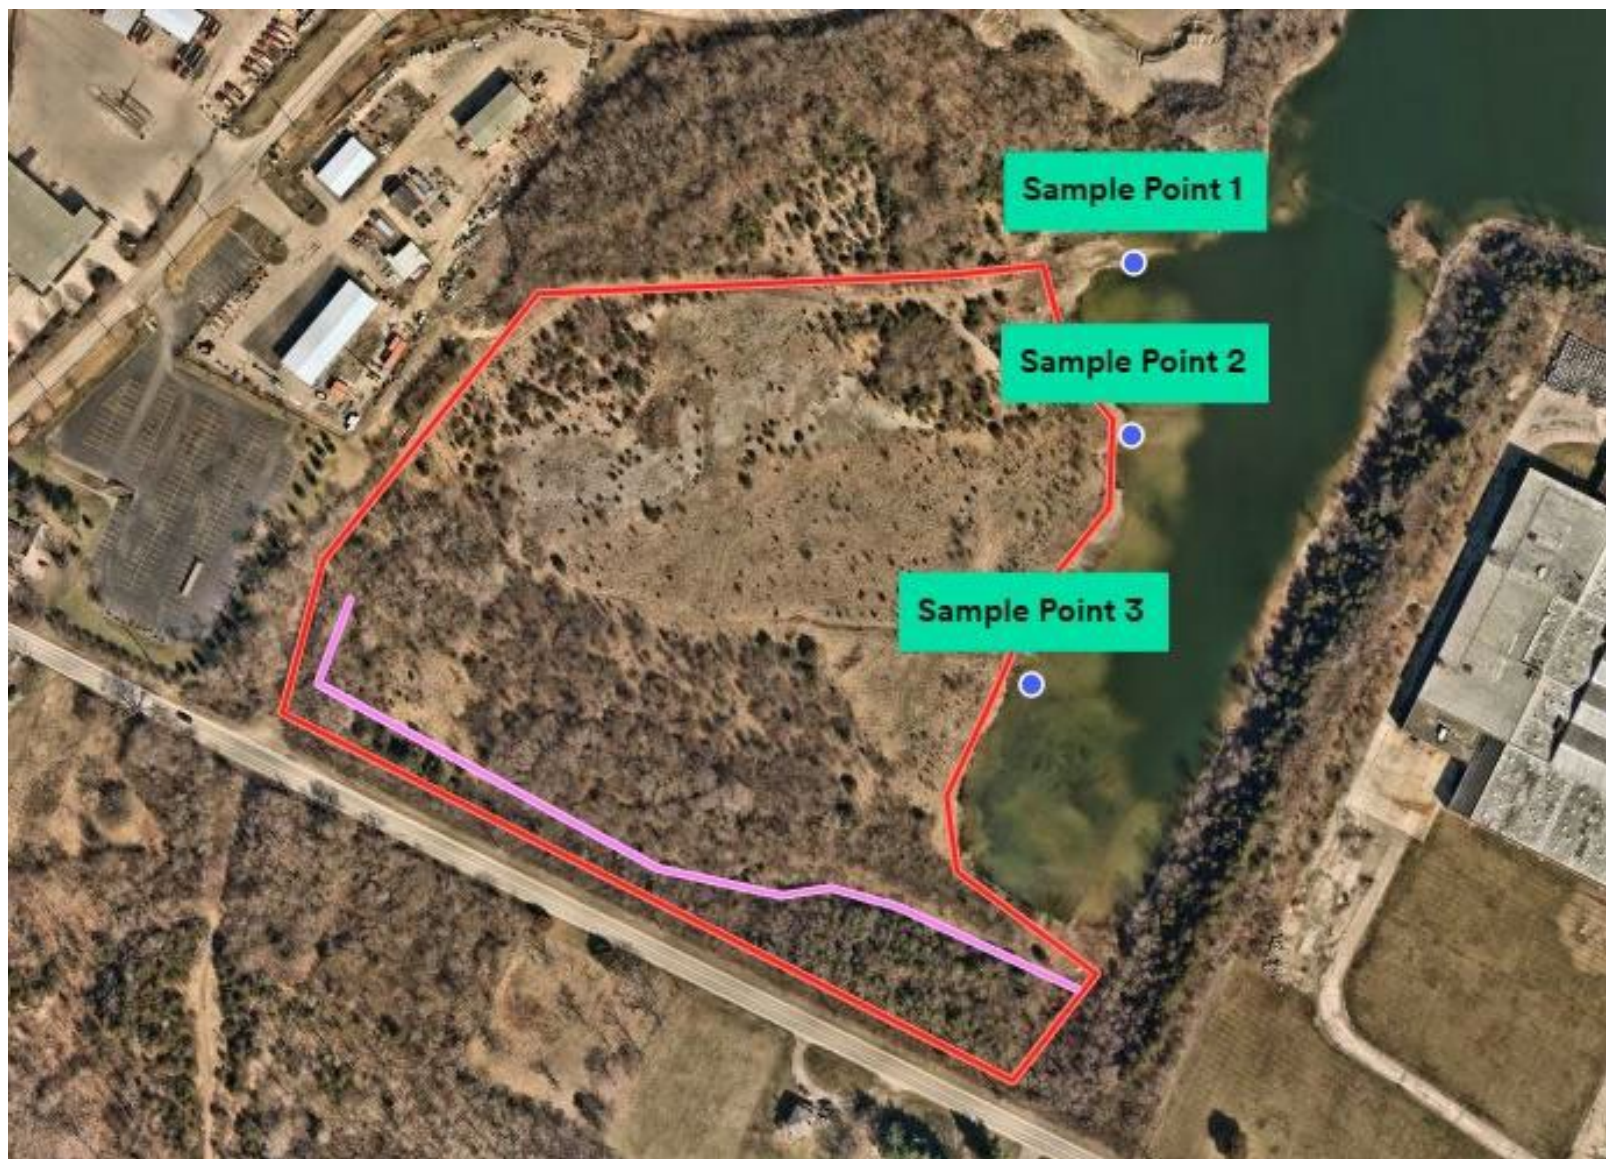
**Figure 3.15.3-F**  
**Old Newtown Closed Landfill**  
**Broadwell Road**

Gas monitoring was conducted on December 29, 2025 (Table 3.15.3-B) primarily along the southern perimeter of Old Newtown Landfill along Broadwell Road, where the closest (<200 feet) occupied structures are located (Figure 3.15.3-F). No detections of methane occurred during 2025 monitoring. Low concentrations of methane (5% LEL or less) had been detected on the far west end of the monitoring area during the previous three years (2022 - 2024) of monitoring. In 2021 methane was detected in one sample point near the center of the monitored area at 2% LEL.

= Surface Water Sampling Location
-

= Approximate Limits of Waste
-

= Area where gas monitoring is conducted approx. every 60 ft.
