### **3.5.3 EVANS LANDFILL**

Facility Name: Evans

Location: 4229 Round Bottom Road

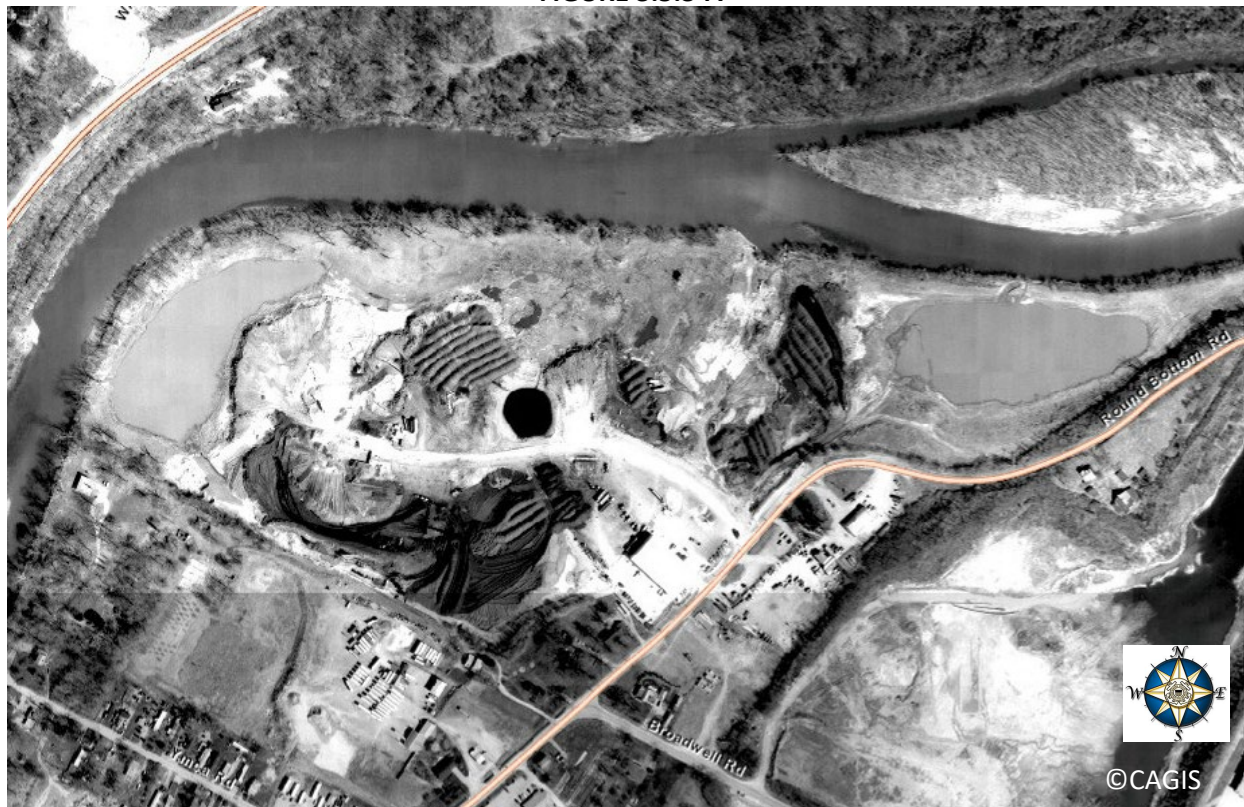
FIGURE 3.5.3-A

The 1996 aerial below (Figure 3.5.3-A) shows the suspected landfill area while in operation as a gravel pit and landscaping business:

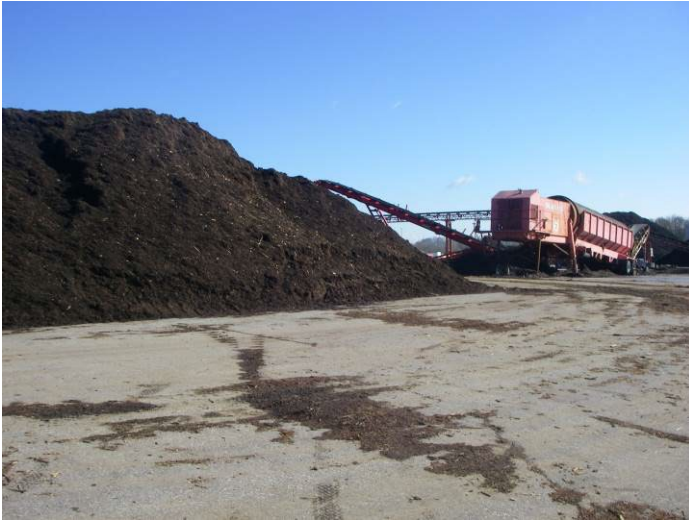
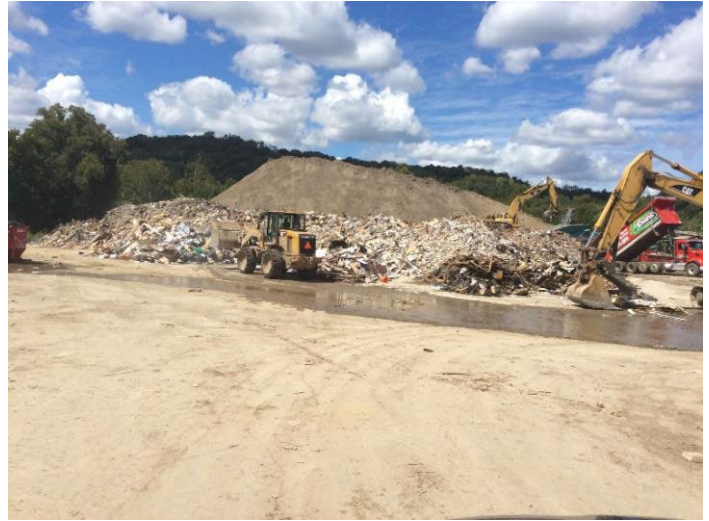
The site is currently used by Evans landscaping to store bulk materials. The former landfill area is now paved and used for storage and processing of the facility's mulch, compost, and recycling operations. The site is regularly inspected by HCPH.

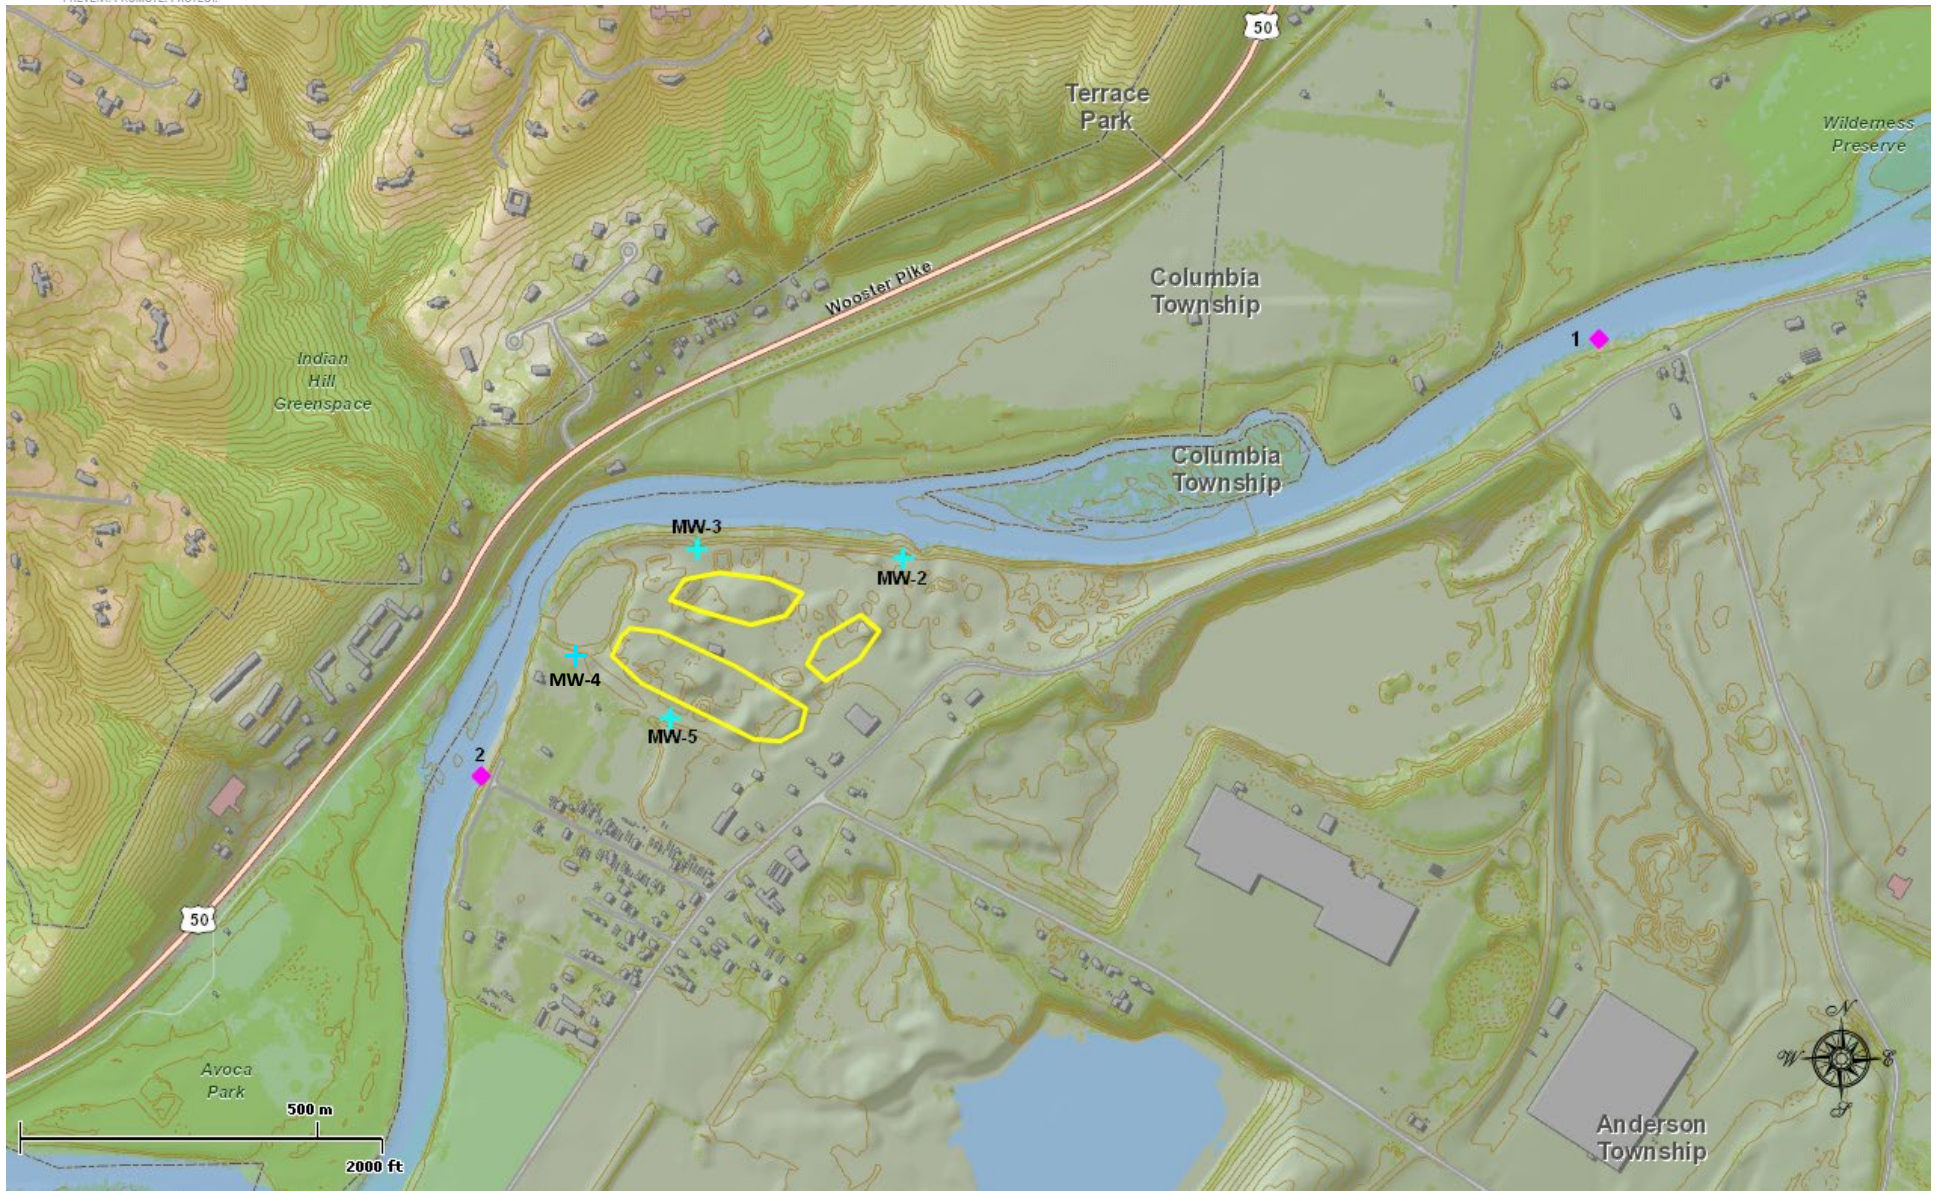
**Figure 3.5.3-B**  
**Evans Landscaping**  
**4229 Round Bottom Road**

The Little Miami River runs along the north and west sides of the Evans Landfill. Sampling was completed on October 23, 2024 (Appendix A). Samples were taken above and below the landfill and the river had below average flow on the day of sampling. The upstream sample was in a shallow (1'), gravelly, rocky riffle area of the river. The shallow area had rapid flow across the rocks. The downstream sample was taken in slightly deeper water about 1 to 2 feet deep with a rocky bottom. The referenced locations are shown on Figure 3.5.3-B.
