### **3.12.2 LOCKLAND INCINERATOR**

Facility Name: Lockland Incinerator

Location: West terminus of Davis Avenue along the east side of I-75 south  
339 Wilson St, Lockland OH

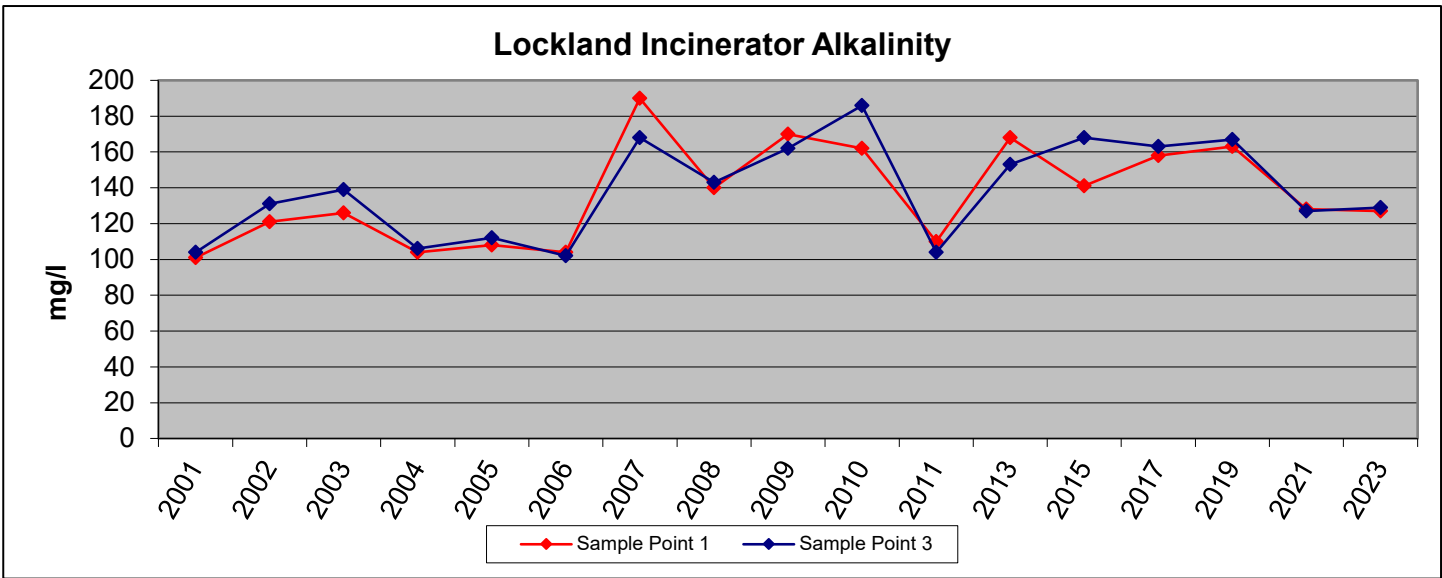
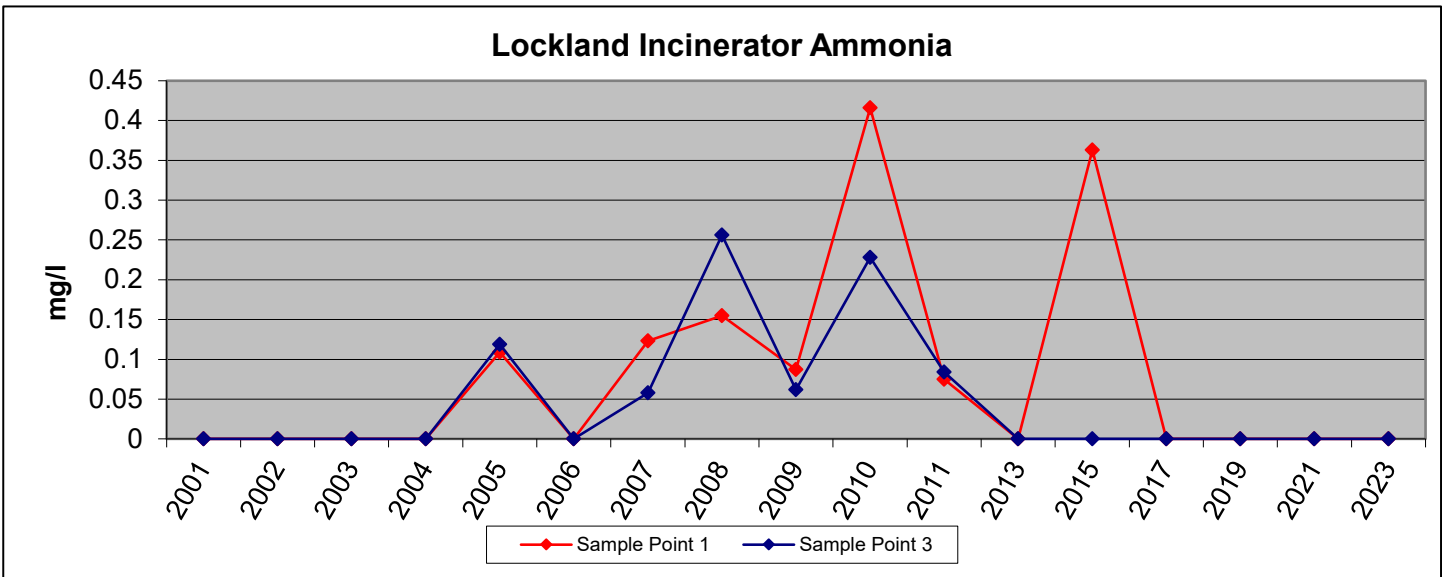
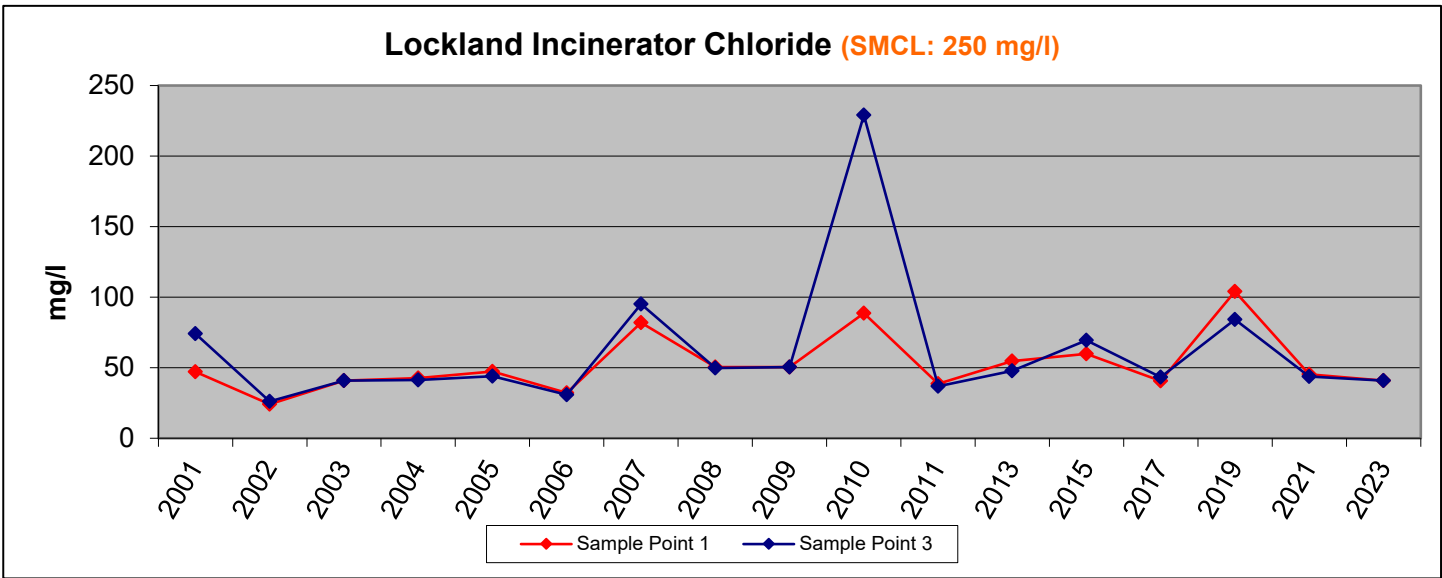
Alkalinity had a concentration of 127 mg/L at sample point 1 and 129 mg/L at sample point 3. These concentrations are similar to what was observed during 2021 monitoring. Ammonia has been below the detection limit at both sampling locations for the last four sampling events. Chloride concentrations at sample points 1 and 3 were 40.9 mg/L which is well below the SMCL of 250 mg/L. During 2019 sampling sulfate concentrations at both sampling locations, although well below the SMCL of 250 mg/L, were at historical highs. Both locations trended down during subsequent sampling in 2021 and 2023. An upstream sulfate concentration of 17.7 mg/L and a downstream concentration of 17.7 mg/L were observed during 2023 sampling. Iron has occasionally exceeded the SMCL, mostly at sample point 1 since it was added to the parameter list in 2010. Iron was below the SMCL of 0.3 mg/L at both sampling points in 2023. Manganese concentration at sample point 1 was below the SMCL (0.05 mg/L) for only the second time since sampling for that parameter began in 2010. Sample point 3 remained below the SMCL for the fourth consecutive sampling event. All other compounds remained below their respective MCL, secondary MCL, or action level. Surface water chemical data is illustrated for Lockland Incinerator Landfill in the graphs on the subsequent pages.
