### **3.7.2 GLENDALE LANDFILL**

Facility Name: Glendale Landfill

Location: North Troy Avenue. East of the railroad and immediately south of the north corporate line of the Village of Glendale.

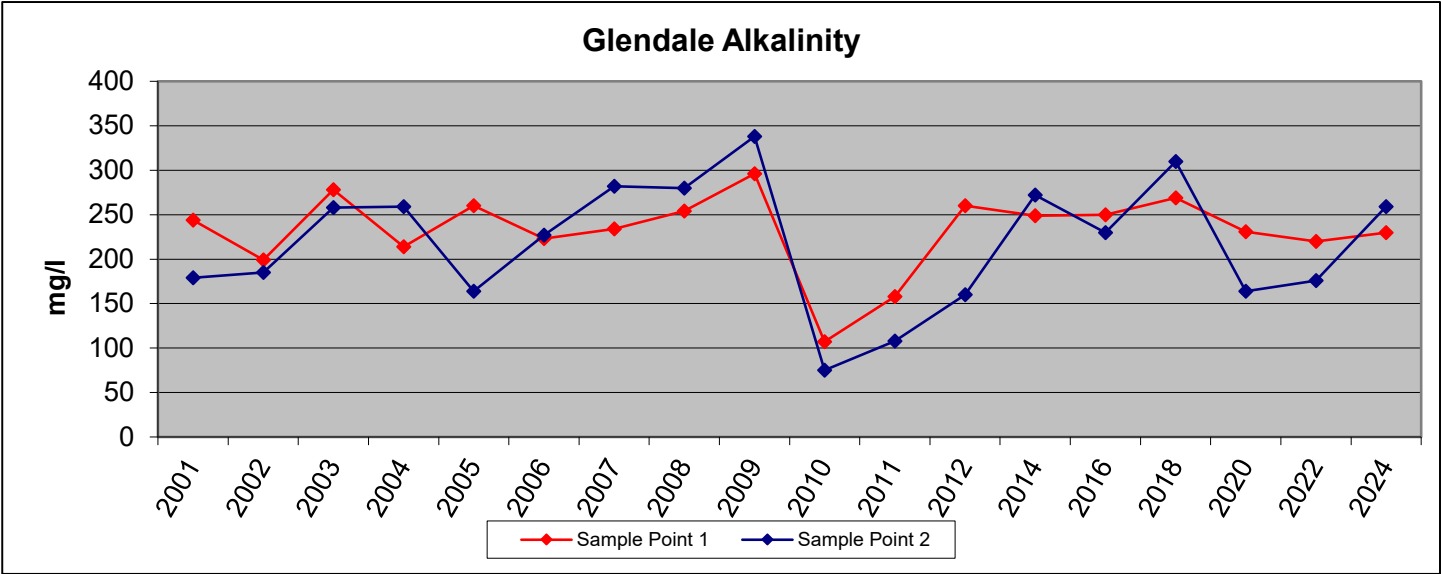
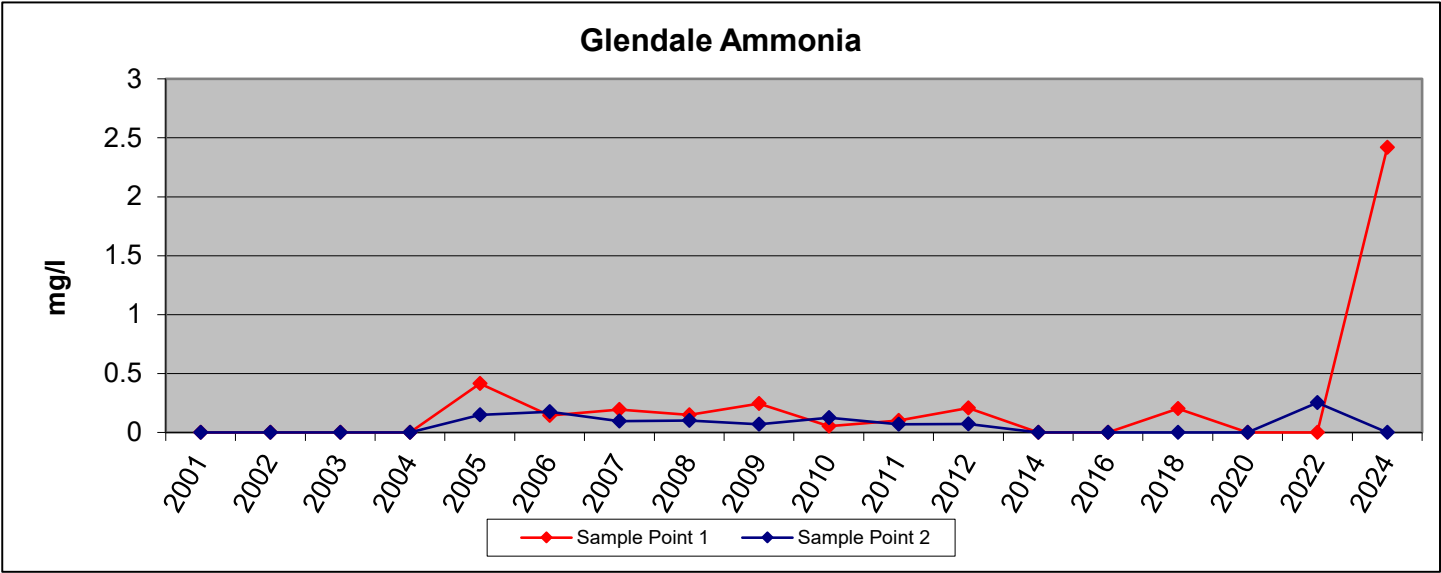
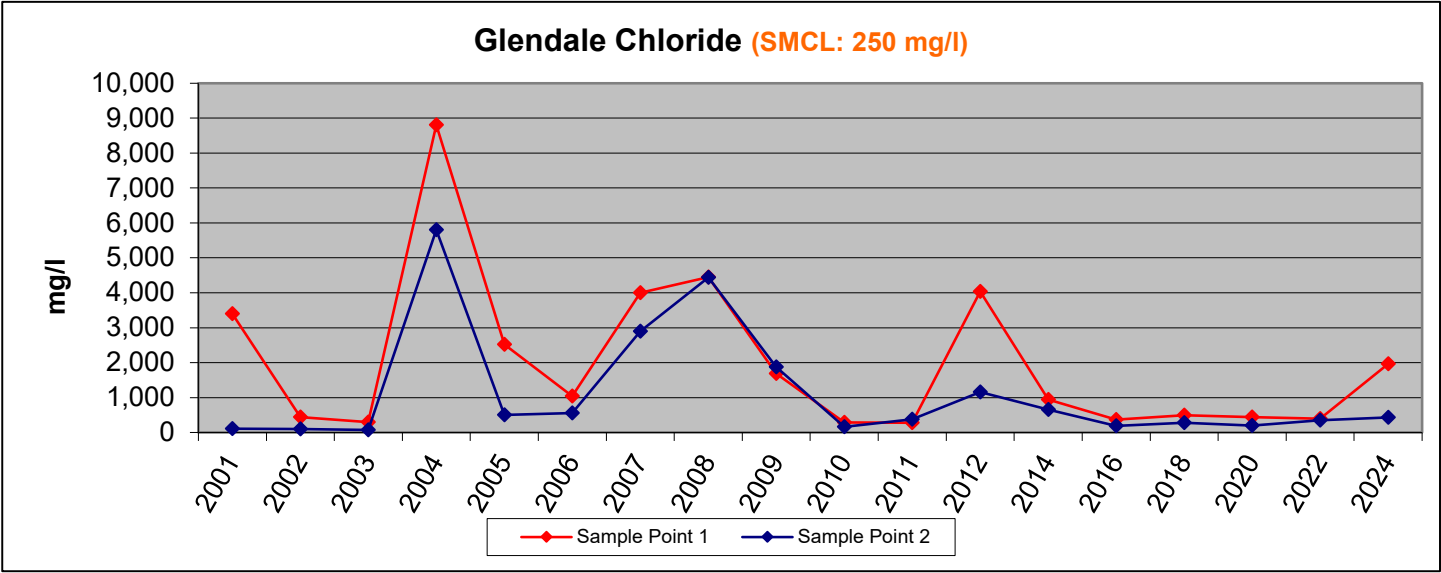
Both sample points have historically resulted in elevated concentrations of chloride, sodium, and TDS. From 2004 through 2009, sample points demonstrated high levels of these parameters relative to the secondary drinking water standards. In 2010, concentrations dramatically dropped and were below the drinking water standards at S-2 for the first time in seven years. However, in 2011 concentrations of these parameters were again observed at elevated levels although not quite to the levels seen prior to 2010. These parameters have remained at these high concentrations through 2022 sampling. This trend holds true for S-1 during the 2024 sampling with chloride, sodium and TDS all above their SMCLs. Respective SMCLs were exceeded for Chloride and TDS at sample point S-2. However, sodium was slightly below the SMCL at S-2. All downstream concentrations of these 3 parameters were lower than upstream concentrations.

Ammonia was detected upstream of the landfill (S-1) at 2.42 mg/L in 2024. Ammonia was detected at S-2 (0.252 mg/L) just above the detection limit of 0.2 mg/L. during 2022 sampling. After registering historically high concentrations of manganese at both sample points in 2014, concentrations at both locations have returned to levels annually observed across the watershed during the five sampling events completed since. S-1 did exceed the SMCL of 0.05 mg/L with a concentration of 0.254 mg/L in 2024. Iron concentrations have occasionally exceeded the SMCL of 0.3 mg/L at both sampling points. During 2024 monitoring S-1 exceeded the SMCL with a concentration of 0.724 mg/L. Antimony concentrations (0.00975 mg/L) were above the MCL of 0.006 mg/L at sample point S-1 during 2018 but have fell below the detection limit during the three subsequent monitoring events. Sulfate has consistently been well below the SMCL at both sampling points.

The majority of parameters observed at S-2 this year remain equal to or below the levels observed at S-1. Considering both the similarity of results for S-1 at the north end of the landfill and S-2 below the landfill and the fact that majority of parameters actually decrease when comparing S-1 to S-2, Glendale Landfill does not appear to be impacting the water quality of the stream.

Hamilton County Public Health has hypothesized that the historical cause of generally higher parameters was likely due to an undetermined upstream source. In the past, staff had explored areas, which drain to this stream location, for any other signs of dumping, spills, or misuse. No clear source could be identified at the time. Starting in 2014 Ohio EPA, Springdale Public Works, HCPH's Water Quality Division, and MSD began working to determine the source of the elevated parameters. This work included reviewing processes at businesses and installing monitors in various locations upstream from sample point 1. The investigation did discover some improper discharges from upstream industry which have been corrected. Staff will continue to monitor this stream. Surface water chemical data is illustrated for Glendale Landfill in the graphs on the subsequent pages.
