### **3.2.3 Bevis Towing**

Facility Name: Bevis Towing  
A.K.A.: N/A  
Location: 11594 & 11586 Old Colerain Avenue.  
Parcel(s): 51002800082  
Lat, Long: 39.296992 -84.619890  
Region: Colerain Township, OH 45252  
Owner: Douglas Bevis  
Operation (yrs): Approximately 1990 – 1996 (based on aerial photos)

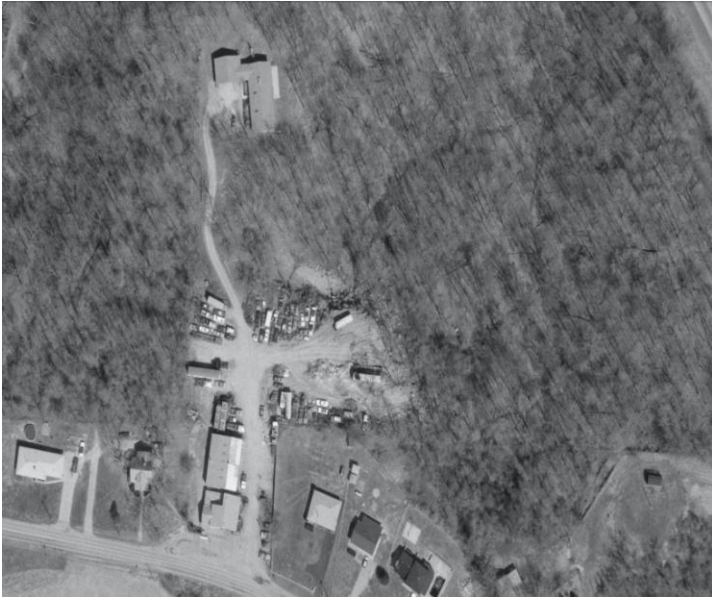
**FIGURE 3.2.3-A (1986)**

Review of ODOT aeriels shows no fill activity occurring at the site in 1976. The residence northwest of the fill is present by 1980. Figure 3.2.3-A from 1986 shows a small area of filling occurring in the southwest corner of the approximate limits of fill. By 1992 (Figure 3.2.3-B) a large area of fill is visible. Figures 3.2.3-C and 3.2.3-D show the progression of filling in 1996 and 2009 respectively. Filling with clean hard fill has continued intermittently.
