3.4.1 DEBOLT LANDFILL

Facility Name: Debolt Landfill

Location: 3711 Debolt Street. Northeast corner of the intersection of Debolt Street and the railroad tracks in Newtown, Ohio; Short Park.

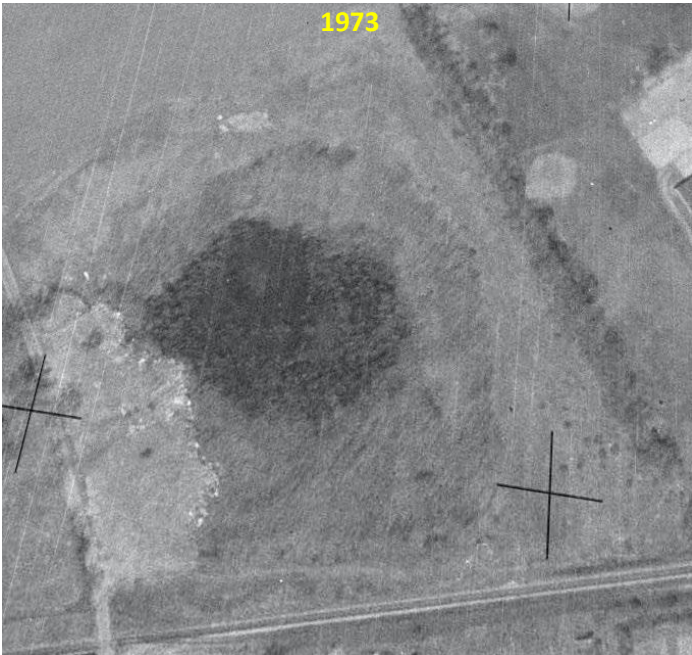
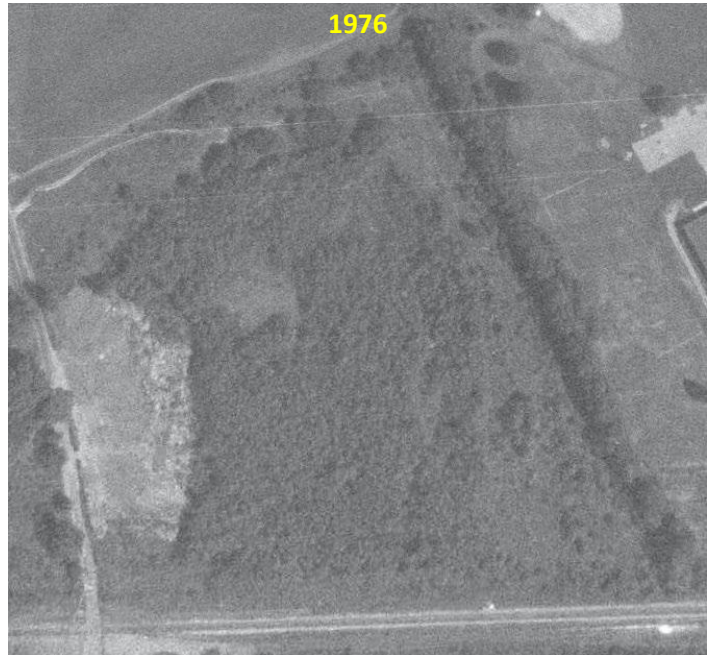
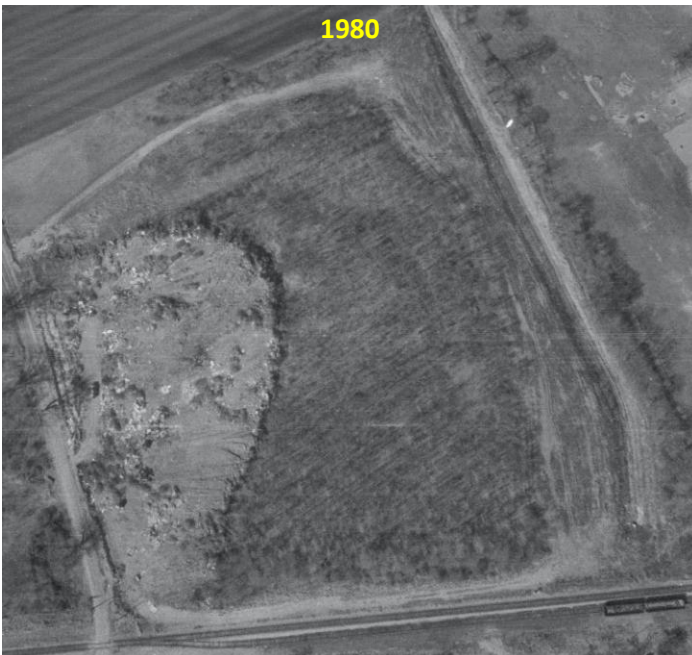
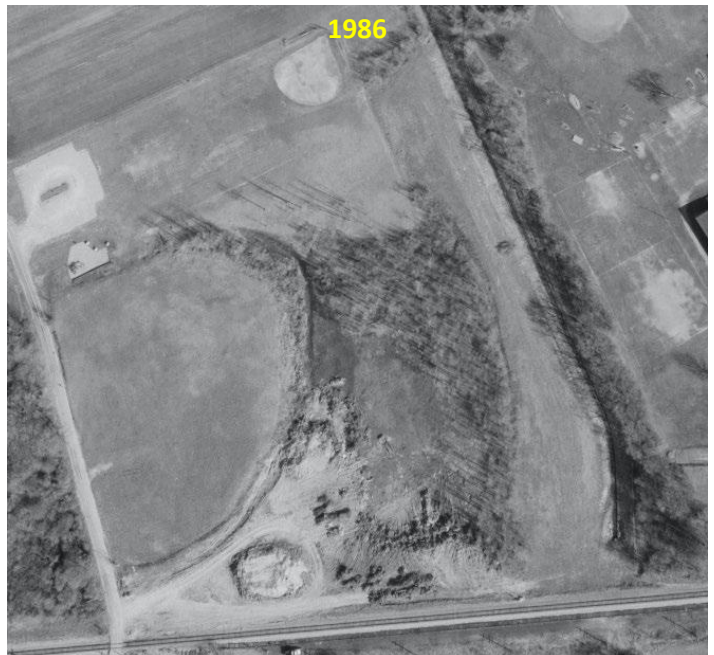
According to a 2017 Rule 13 request the site began operating as a landfill between 1962 & 1964 and ceased operations sometime between 1975 & 1977. However review of aerials (below) shows filling at the site continued until at least the late 1980's although the site may have transitioned to C&DD or clean hard fill. An Ohio EPA letter dated February 3, 1975 indicates that the area was used principally by Hamilton County and the Village of Newtown for the disposal of demolition debris, stumps, brush and solid fill. The information also notes that the area had problems with open dumping at this time. Control measures such as fencing, signage, and routine covering were recommended by Ohio EPA.

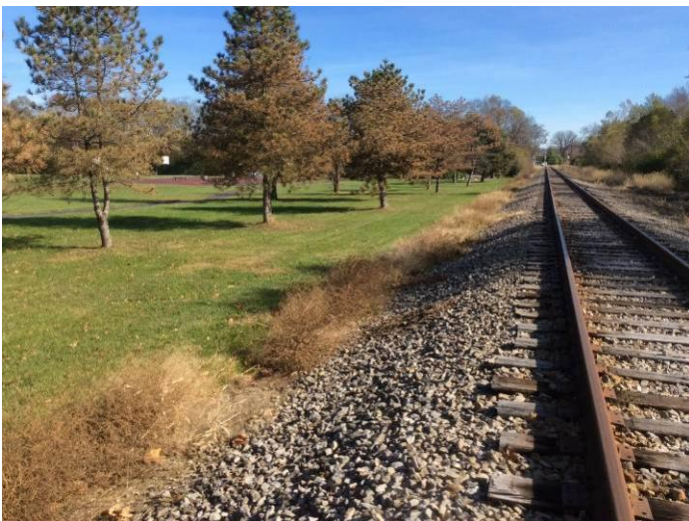
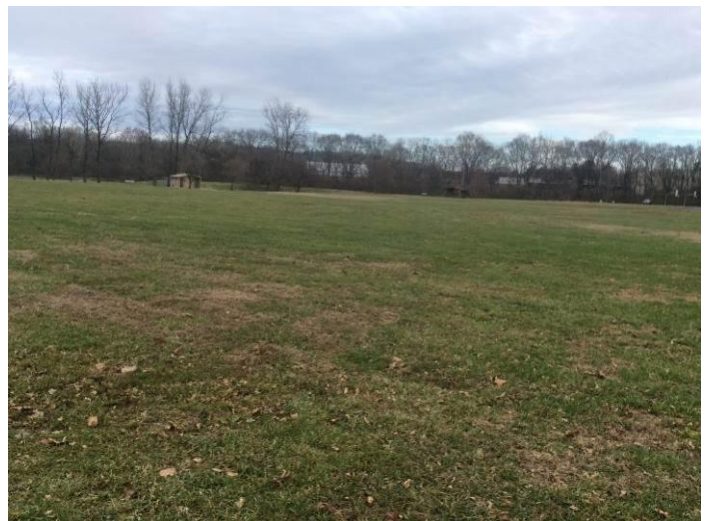
The property is currently used by the Village of Newtown as a recreational area, known as Robert W. Short Park. A paved trail, parking lot, bathroom, basketball courts and gazebo exist on the property. One may access the park off Debolt Street or Church Street.

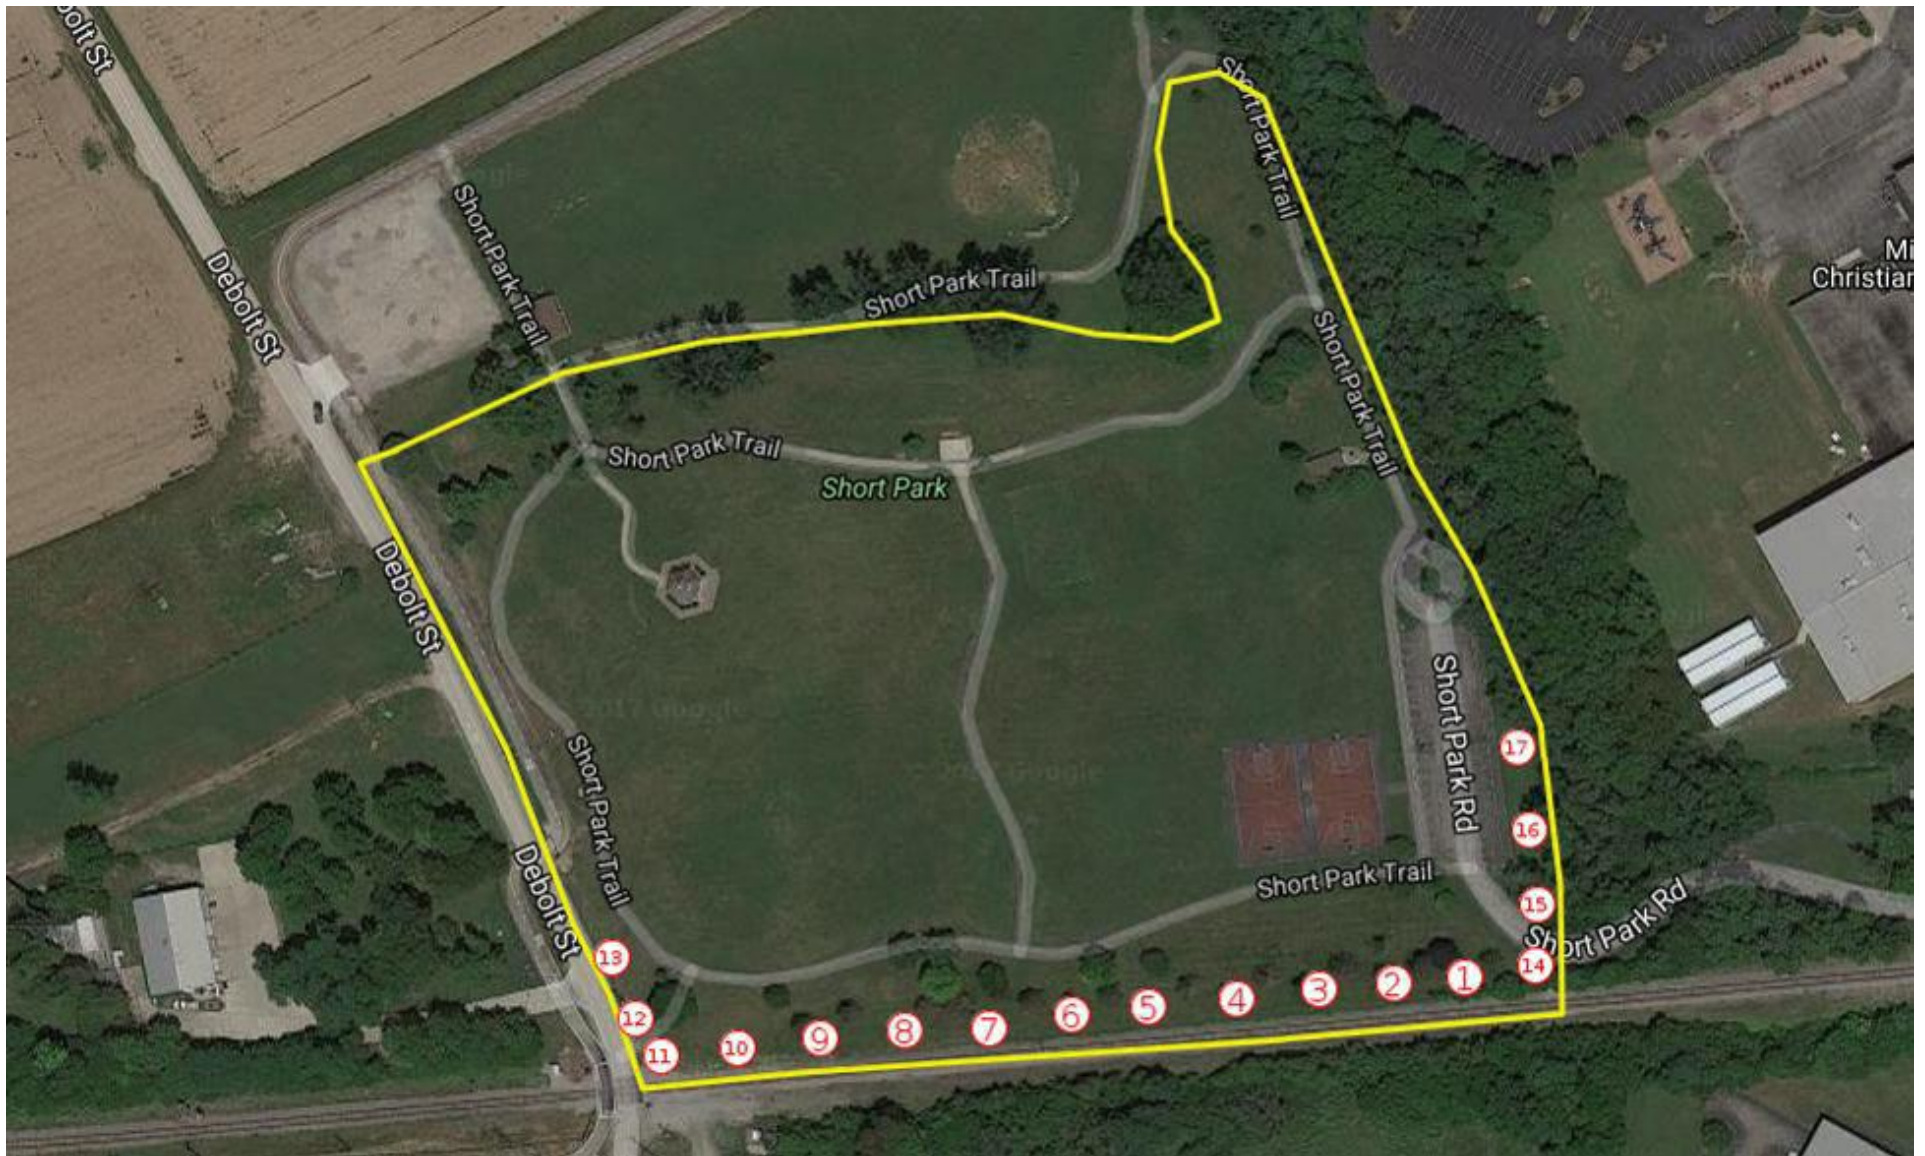
Figure 3.4.1-B
Debolt Closed Landfill
3711 Debolt Street

= Approximate Limits of Waste
-

= Gas Monitoring Location
