### **3.8.4 HARRISON LANDFILL**

Facility Name: City of Harrison Municipal Landfill

Location: 10999 Campbell Road.

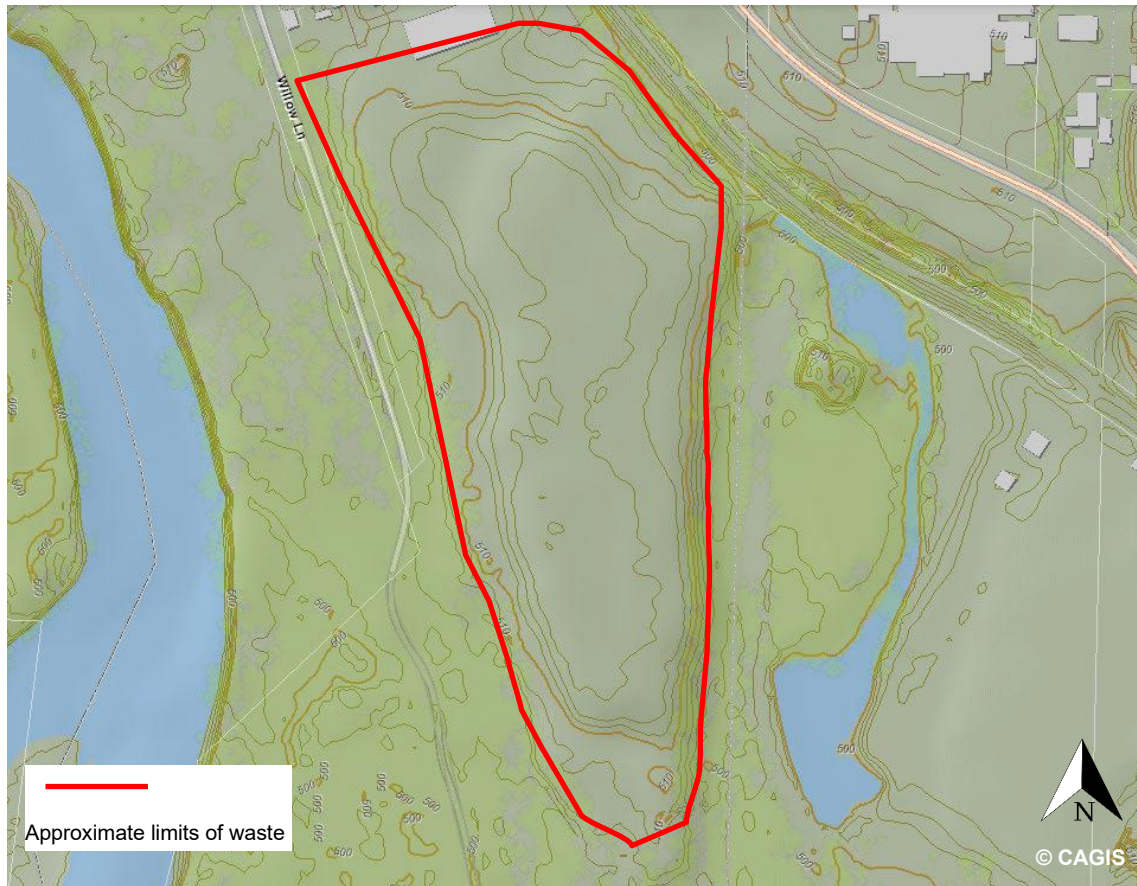
**FIGURE 3.8.4-A**

placed on existing grade with no excavation prior to fill placement. Topography of the former landfill is evident with a localized topographic high created in the area of waste placement; relief in the vicinity of waste placement is approximately twenty-two feet. Topography generally rises to the north and east of the landfill, and is relatively flat toward the south and west (along the Whitewater River flood plain). Figure 3.8.4-A illustrates the topography of the site:

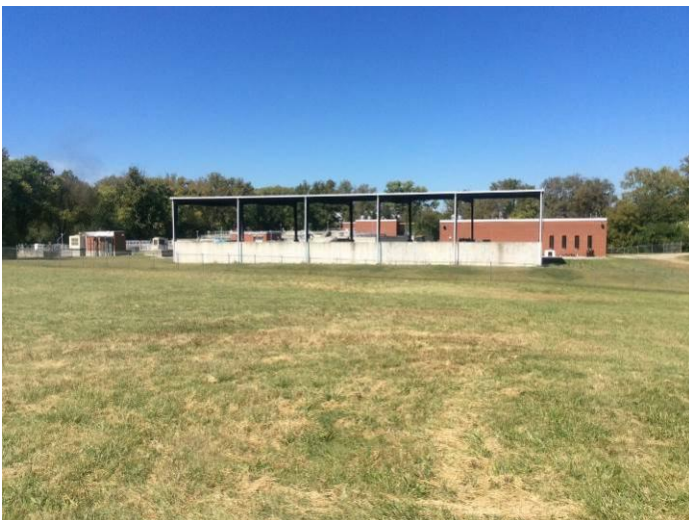
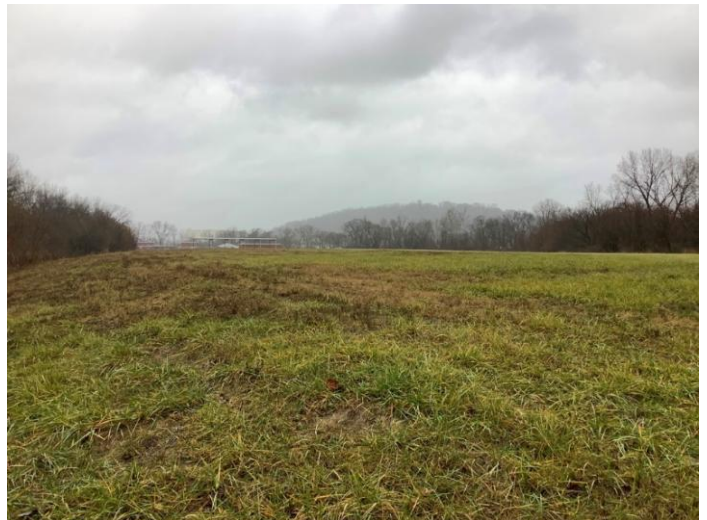
**Figure 3.8.4-B**  
Harrison Closed Landfill  
10999 Campbell Road

The original explosive gas monitoring plan (EGMP) approved in 1998 included 15 sampling locations. In 2002 MP-1, MP-2, MP-3, TP-9, and TP-10 were removed due to construction. Three replacement gas monitoring probes (MP-4, MP-5, and MP-6) were installed in 2004 to replace these removed sampling locations. City of Harrison personnel monitored the closed landfill monthly through 2014. In 2015 the Ohio EPA authorized the city to reduce gas monitoring to semi-annually. The facility submitted a revised EGMP dated November 3, 2022. Ohio EPA approved the revised EGMP on December 16, 2022. Under the current EGMP, there are a total of thirteen monitoring locations (Figure 3.8.4-B).

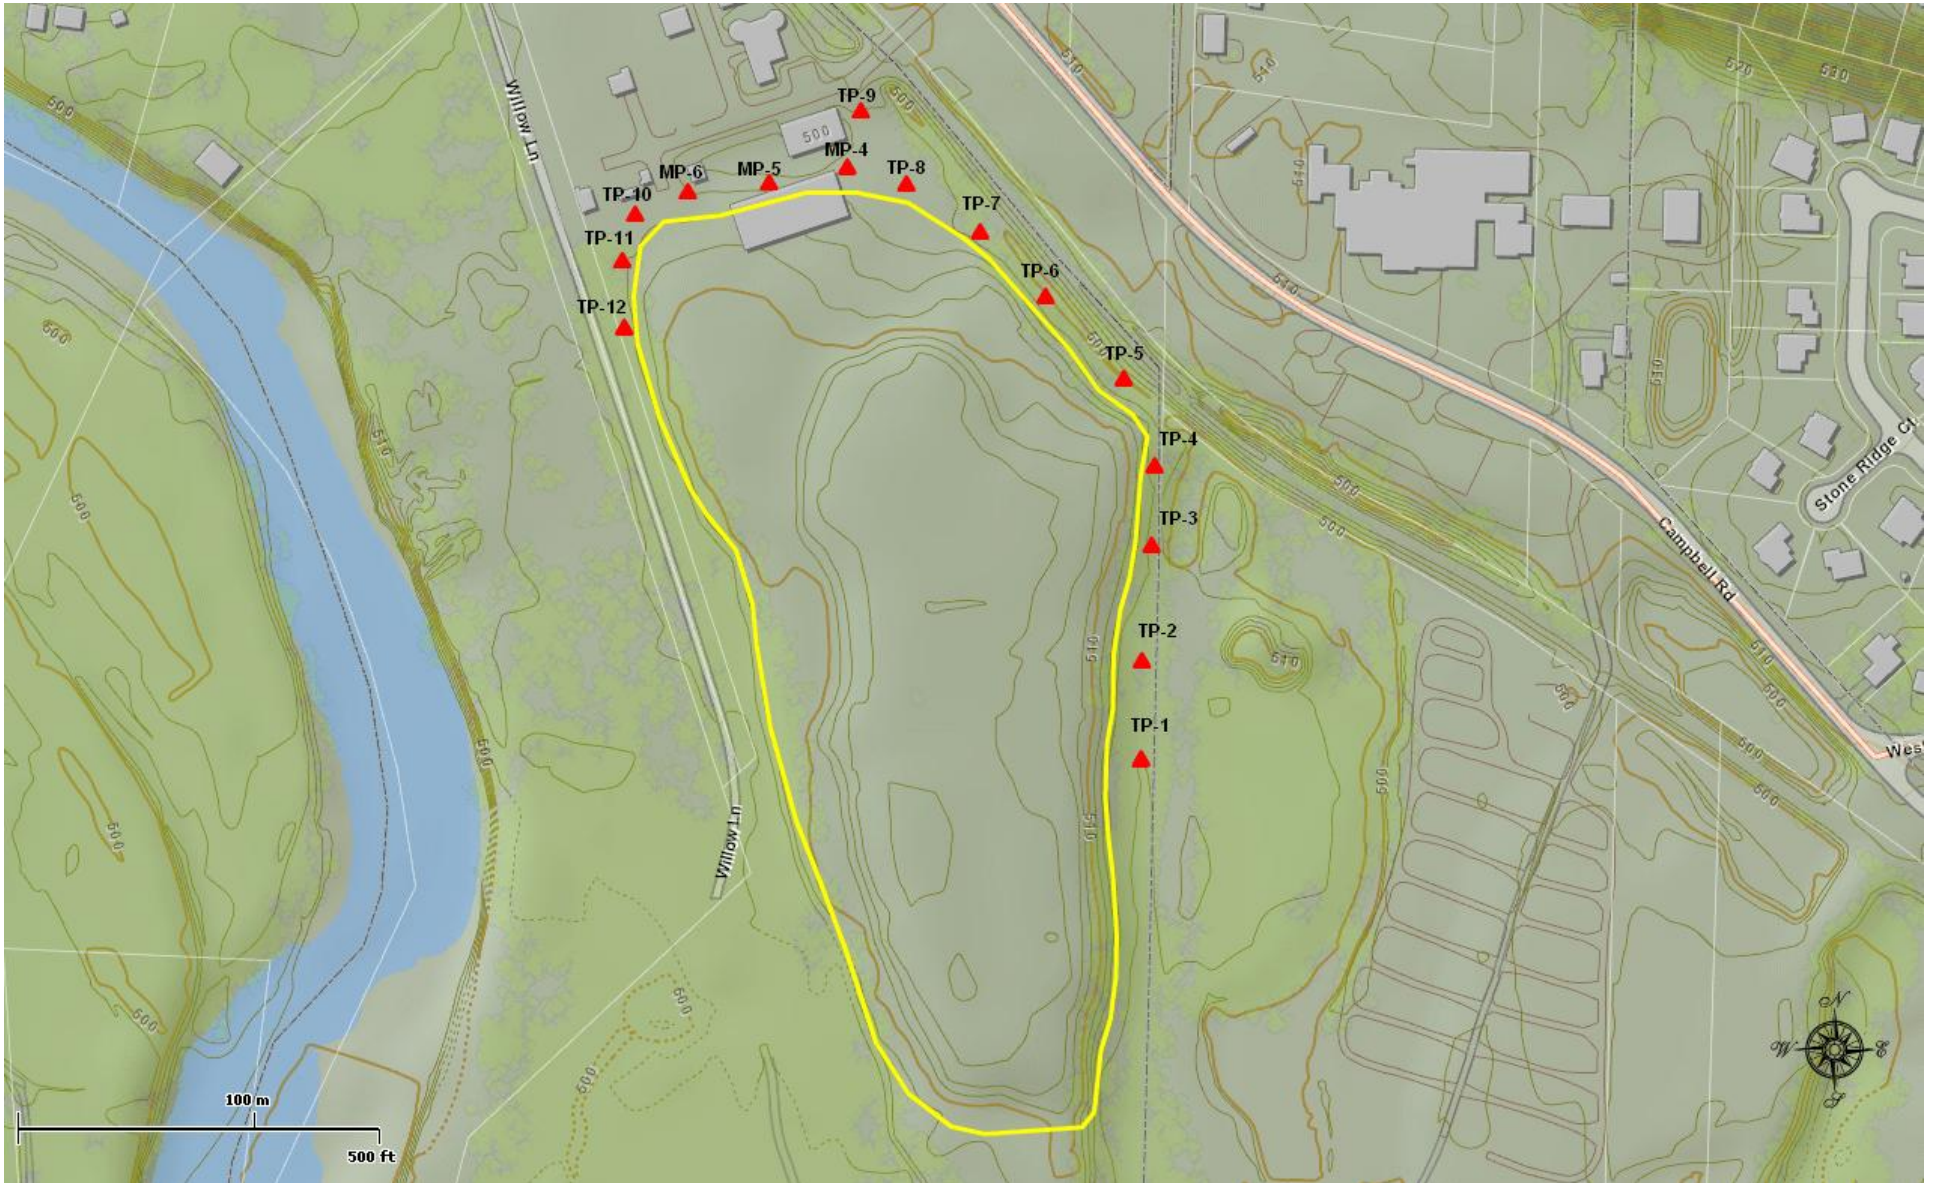
= Gas Monitoring Location
-

= Approximate Limits of Waste

The first semiannual monitoring event of 2023 was completed on June 7, 2023 (Table 3.8.4-A). During this event methane was detected in three of the monitoring points (PMP-4, PMP-5, PMP-6) at concentrations between 30% and 57% LEL. During the second monitoring event completed on December 6, 2023, there were no detections of methane (Table 3.8.4-B).
