### **3.19.2 ST. BERNARD LANDFILL**

Location: South and southwest of Bank Avenue, east of I75;  
Access from intersection of Phillips Avenue and Baker Place in St. Bernard, Ohio.

Owner: Village of St. Bernard

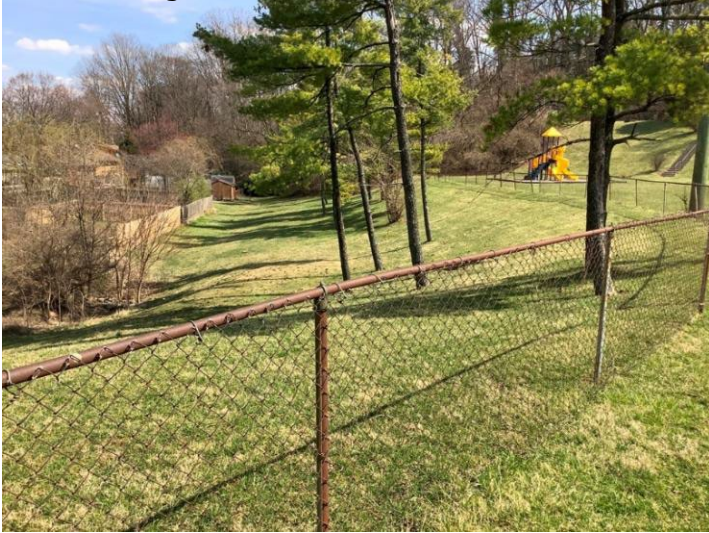
Looking East Behind Homes on Bank Ave

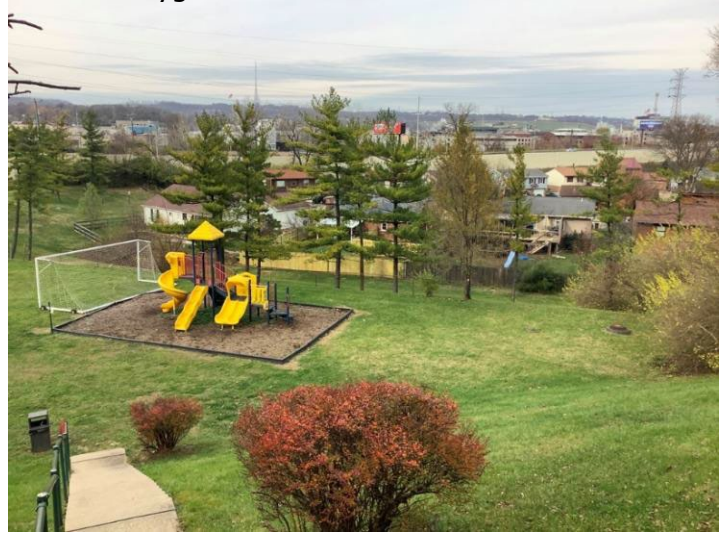
Playground near NE Corner of Landfill

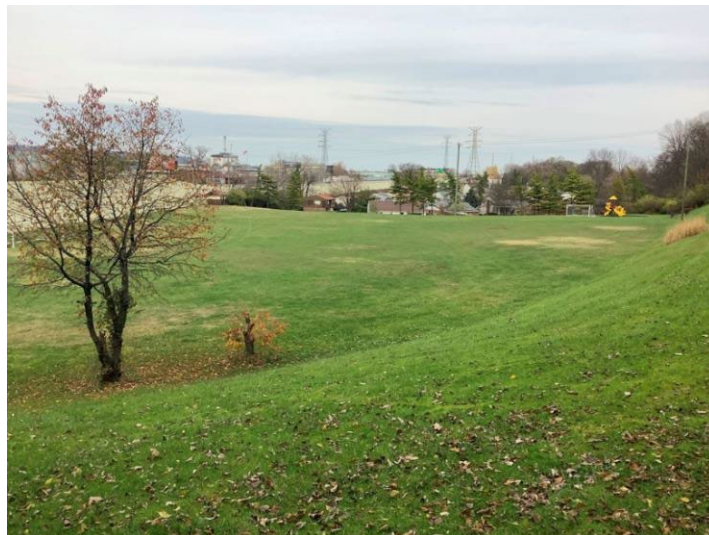
The former landfill is covered mainly with established and maintained grass and is currently used as Ludlow Grove Park. The park contains soccer fields and a playground in the lower portion while a paved walking path is located in the upper portion.

View of Former Landfill from South to North
