### **3.2.3 Bevis Towing**

Facility Name: Bevis Towing

Location: 11594 & 11586 Old Colerain Avenue.

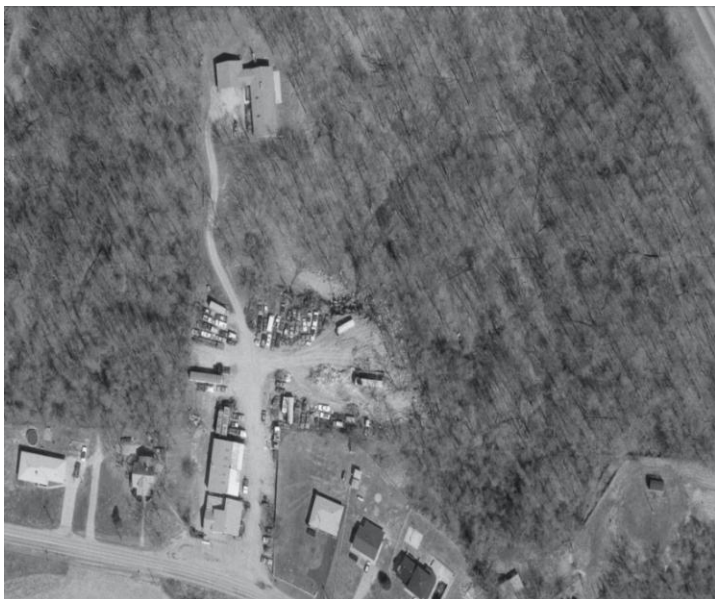
**FIGURE 3.2.3-A (1986)**

Review of ODOT aeriels shows no fill activity occurring at the site in 1976. The residence northwest of the fill is present by 1980. Figure 3.2.3-A from 1986 shows a small area of filling occurring in the southwest corner of the approximate limits of fill. By 1992 (Figure 3.2.3-B) a large area of fill is visible. Figures 3.2.3-C and 3.2.3-D show the progression of filling in 1996 and 2009 respectively. Filling with clean hard fill has continued intermittently.
